## 421 ZANG ST

LAKEWOOD CO 80228

PROPERTY TYPE  
Public Office, Medical Building...

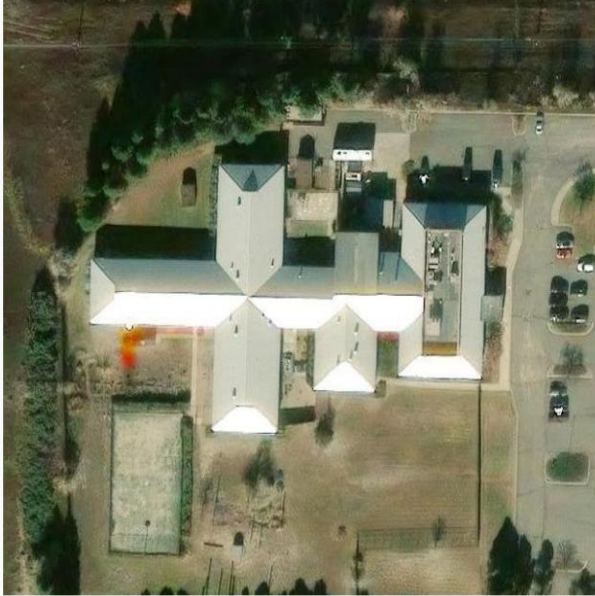
### SELECTED AERIAL IMAGE - ESRI WORLD IMAGERY

1. Visible risk factors include dark staining or inconsistent roof color, high penetration or rooftop-unit density, tree overhang or roof debris exposure.
2. Multiple roof planes and transitions are present across the complex, increasing flashing complexity.
3. Bright white roof sections dominate the image and suggest reflective roof surfaces or coating.
4. A distinct localized stain/discoloration is visible on the west side of the main roof mass.
5. Rooftop equipment/curbs and other small rooftop details appear on the central/right sections.

This commercial property shows a mixed roof configuration with several low-slope white roof areas and multiple sloped roof sections. The visible roof surfaces appear generally serviceable, but localized discoloration, numerous transitions, rooftop details, and surrounding trees increase leak and maintenance risk. Aerial imagery alone does not confirm the roof membrane type, so the system is best treated as a probable single-ply or coated low-slope roof with other roof types also present. Visible risk factors include dark staining or inconsistent roof color, high penetration or rooftop-unit density, tree overhang or roof debris exposure.

Perform a closer rooftop inspection to verify membrane type, check the stained west-side area for moisture or prior repair history, review all flashings and penetrations, and clear/monitor nearby trees and debris. If not recently inspected, evaluate drainage performance and sealant condition at roof transitions and equipment curbs. Field inspection should verify drainage, moisture, penetrations, flashing, and debris-related damage.
