## 250 S ROUTT ST

LAKEWOOD CO 80228

### OVERALL ROOF CONDITION SCORE

### ROOF INFORMATION

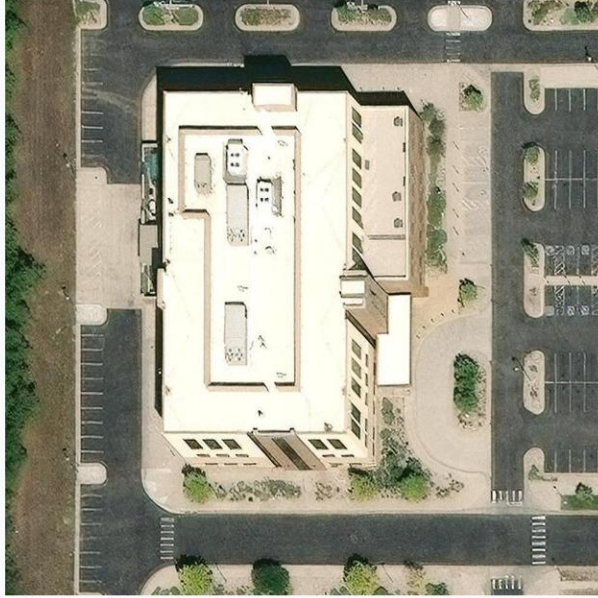
### SELECTED AERIAL IMAGE - ESRI WORLD IMAGERY

| VISIBLE CONCERNS | many penetrations/units; Multiple rooftop units, vents, and curbs are visible, increasing flashing and seal maintenance needs.; Roof surface appears generally uniform with no obvious widespread staining or ponding from this aerial view. |

1. Visible risk factors include high penetration or rooftop-unit density.
2. Large low-slope commercial roof with multiple stepped sections and parapet conditions.
3. Several rooftop mechanical units/vents/curbs are visible on the main roof areas.
4. Roof membrane appears light-colored and fairly uniform overall.
5. No obvious severe puncture damage, open tears, or major debris accumulation is visible from this imagery.

The aerial imagery shows a low-slope commercial roof with a generally uniform light-colored surface and no clear signs of major ponding or widespread discoloration. Visible rooftop equipment, vents, and roof transitions create moderate leak-risk points, so the roof appears serviceable but should be considered fair rather than excellent based on aerial-only evidence. Visible risk factors include high penetration or rooftop-unit density.

Continue routine maintenance and inspect flashing, seals, and penetrations around rooftop units, curbs, and transitions. Monitor for localized wear or future ponding after heavy rain, and verify current roof condition with a close-up field inspection, since aerial imagery cannot confirm seam integrity or subsurface moisture.
