## 143 UNION BLVD

LAKEWOOD CO 80228

PROPERTY TYPE  
Commercial Office Building 2120...

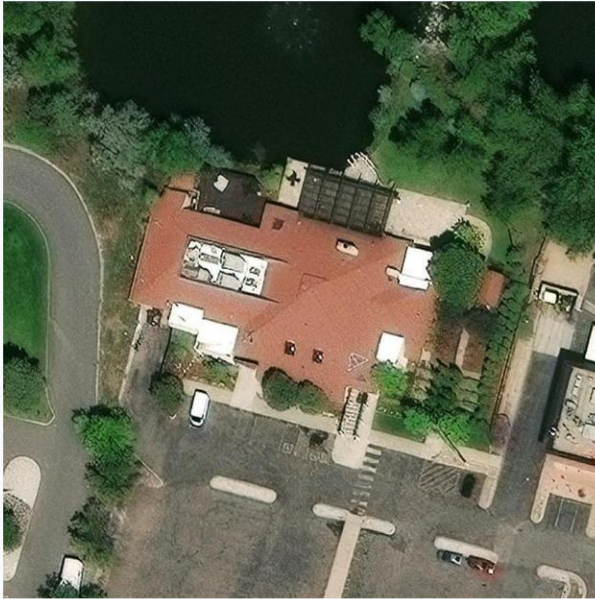
### SELECTED AERIAL IMAGE - ESRI WORLD IMAGERY

1. Visible risk factors include dark staining or inconsistent roof color, high penetration or rooftop-unit density, tree overhang or roof debris exposure.
2. The building appears to have a mixed roof form, with a large reddish textured sloped roof and smaller low-slope rooftop sections.
3. Several rooftop penetrations and mechanical units are visible, particularly near the center and upper roof areas.
4. Tree canopy is close to multiple roof edges, which may contribute debris accumulation and maintenance demands.
5. No clear standing water is visible, but darker patches and tonal variation suggest areas that should be inspected for localized wear or past repairs.

Aerial imagery shows a mixed commercial roof with a largely textured sloped roof surface and several rooftop equipment areas. The roof appears generally serviceable, but visible discoloration, multiple penetrations, and close surrounding trees increase leak and maintenance risk. No obvious ponding is visible from this image. Visible risk factors include dark staining or inconsistent roof color, high penetration or rooftop-unit density, tree overhang or roof debris exposure.

Schedule a close-up roof inspection to verify flashing, seals, and the condition of the darker roof areas, especially around equipment and transitions. Trim back nearby trees and remove accumulated debris regularly to reduce abrasion and drainage-related risk. If the roof is original or near-original to the 1981 construction date, plan for lifecycle evaluation and targeted repairs as needed. Field inspection should verify drainage, moisture, penetrations, flashing, and debris-related damage.
