## 12043 W ALAMEDA PKWY

LAKEWOOD CO 80228

### OVERALL ROOF CONDITION SCORE

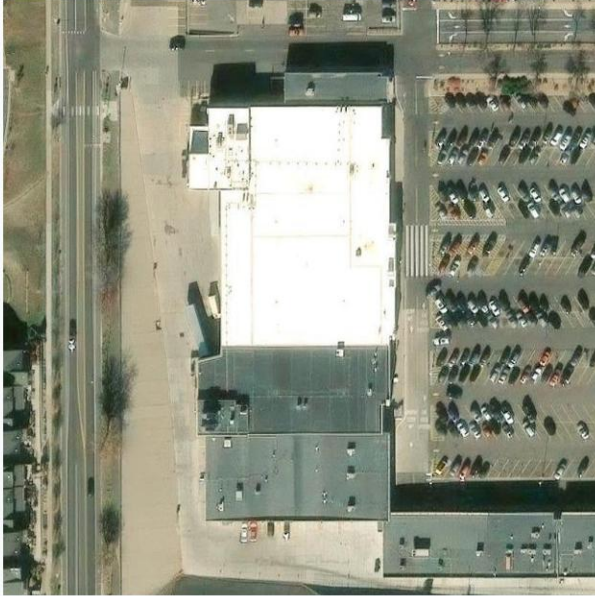
### SELECTED AERIAL IMAGE - ESRI WORLD IMAGERY

| VISIBLE CONCERNS | dark staining/color variation; many penetrations/units; Noticeable dark discoloration and uneven tonal areas on portions of the roof suggest prior repairs, staining, or localized weathering. |

1. Visible risk factors include dark staining or inconsistent roof color, high penetration or rooftop-unit density.
2. The building has a large low-slope commercial roof with a bright white central field and darker adjoining roof areas.
3. Visible rooftop penetrations include vents, small mechanical units, and several curb-like details.
4. The roof surface is generally intact from aerial view, but several dark spots and localized discoloration are visible.
5. No obvious large open tears or severe widespread membrane failure are visible in this image.

Aerial imagery shows a large commercial low-slope roof with a reflective white roof field and adjacent darker roof sections. The roof appears serviceable overall, but visible discoloration, mixed roof areas, and multiple penetrations increase maintenance and leak-risk concerns. The exact membrane type cannot be confirmed from aerial imagery alone, though a reflective single-ply or coated membrane is a plausible candidate for the main bright roof area. Visible risk factors include dark staining or inconsistent roof color, high penetration or rooftop-unit density.

Recommend a closer field inspection of the roof surface, penetrations, and transitions between roof sections, with particular attention to stained/discolored areas and flashing condition. Verify drainage performance, check for concealed ponding-related deterioration, and inspect any patched or coated areas for adhesion and watertightness.
