## 13165 W OHIO AVE

LAKEWOOD CO 80228

PROPERTY TYPE  
Public School, Entire Elementary...

### OVERALL ROOF CONDITION SCORE

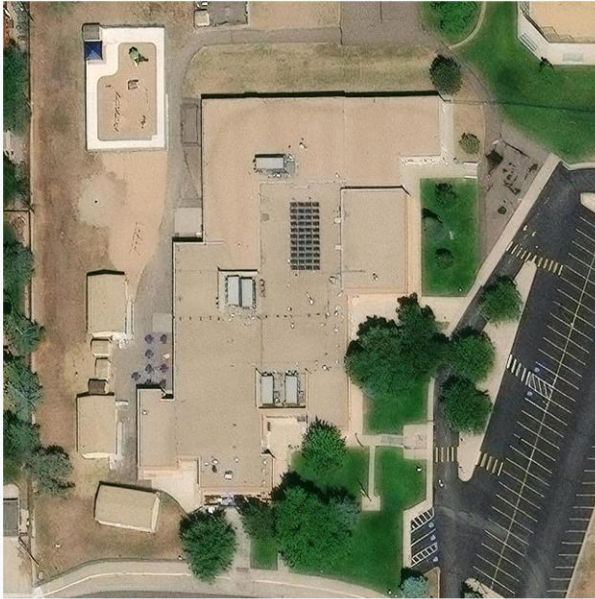
### SELECTED AERIAL IMAGE - ESRI WORLD IMAGERY

| VISIBLE CONCERNS | dark staining/color variation; many penetrations/units; tree/debris exposure |

1. Visible risk factors include dark staining or inconsistent roof color, high penetration or rooftop-unit density, tree overhang or roof debris exposure.
2. The roof is a large low-slope commercial roof with multiple stepped sections and several rooftop appurtenances.
3. Visible surface is generally uniform and serviceable, but there are scattered darker areas and seam/patch-like features that suggest prior maintenance or localized weathering.
4. Several mechanical units/curbs are present, especially near the roof center and lower-middle area.
5. Perimeter landscaping includes mature trees close to the building, with potential leaf litter and branch contact risk.

This appears to be a low-slope commercial roof, most consistent with a single-ply membrane-type system or coated membrane, based on the light uniform roof surface and flat roof geometry. Visible condition is generally serviceable, but localized discoloration, multiple penetrations and rooftop units, and nearby trees add maintenance and leak-risk concerns. No major catastrophic defect is apparent from the aerial image, though the view is limited and cannot confirm membrane chemistry or hidden moisture issues. Visible risk factors include dark staining or inconsistent roof color, high penetration or rooftop-unit density, tree overhang or roof debris exposure.

Recommend a closer drone or roof-level inspection to verify membrane type, inspect seams and flashing at curbs and penetrations, and evaluate the darker stained areas for ponding history or repair needs. Trim back overhanging vegetation and confirm drainage paths are clear of debris. Field inspection should verify drainage, moisture, penetrations, flashing, and debris-related damage.
