## 13175 W GREEN MOUNTAIN DR

LAKEWOOD CO 80228

Public School, Entire Elementary...

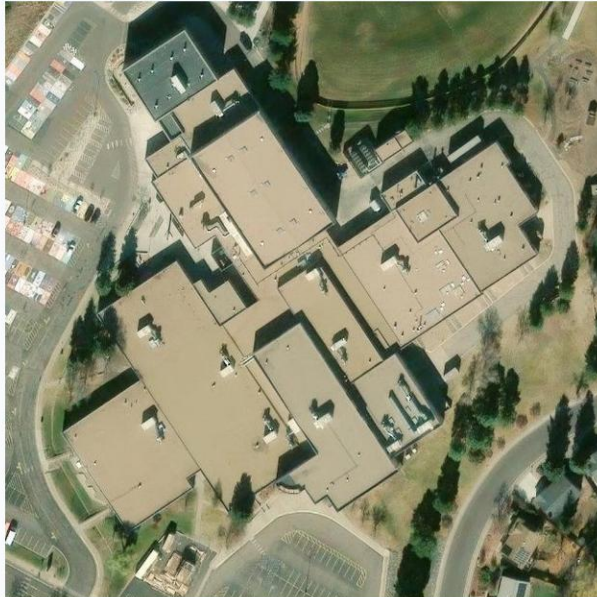
1. Visible risk factors include dark staining or inconsistent roof color, high penetration or rooftop-unit density, tree overhang or roof debris exposure.
2. The complex consists of multiple connected low-slope roof sections with parapets and many rooftop penetrations.
3. Roof surface appears generally serviceable and intact from this altitude, with no obvious catastrophic membrane failure.
4. Color variation and localized darker patches are visible on several sections, especially near edges and around roof features.
5. The site has substantial tree coverage adjacent to the roof perimeter, which may contribute organic debris to roof drains and edges.

The aerial image shows a large, older low-slope school roof system that appears generally intact but actively maintained. Visible roof color variation, darker stained areas, and many penetrations lower confidence in long-term watertight performance. Tree adjacency adds debris and maintenance risk. Exact membrane type cannot be confirmed from overhead imagery, but the roof is most consistent with a single-ply or coated low-slope membrane. Visible risk factors include dark staining or inconsistent roof color, high penetration or rooftop-unit density, tree overhang or roof debris exposure.

Recommend a closer roof inspection focused on seams, flashings, penetrations, drains, and the darker-discolored roof areas. Check for signs of prior repairs, trapped moisture, or recurring drainage issues. If this is an older membrane, consider documenting remaining service life and planning for maintenance or targeted restoration based on field inspection findings.
