## 13410 MORRISON RD

LAKEWOOD CO 80228

### ROOF INFORMATION

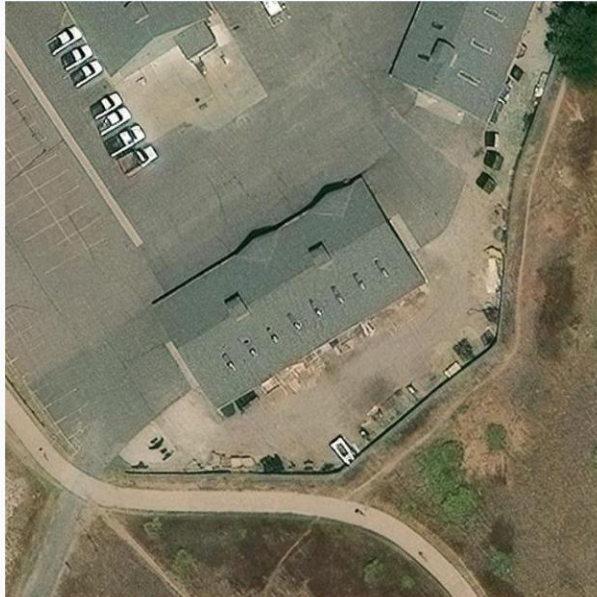
### SELECTED AERIAL IMAGE - ESRI WORLD IMAGERY

| VISIBLE CONCERNS | dark staining/color variation; possible ponding; many penetrations/units |

1. Visible risk factors include dark staining or inconsistent roof color, possible ponding or drainage stress, high penetration or rooftop-unit density.
2. Main building appears to have a large low-slope roof with multiple rooftop penetrations.
3. Visible discoloration and darker areas on the roof surface reduce confidence in uniform membrane condition.
4. The roof geometry includes multiple sections and transitions, which can create additional flashing and seam risk.
5. Surrounding site has open exposure with no obvious heavy tree canopy over the roof.

The aerial image shows a low-slope commercial roof that appears generally serviceable, but with visible tonal inconsistency, darker discoloration, and multiple roof penetrations that raise leak-maintenance risk. The roof likely consists of a single-ply or similar membrane system, though aerial imagery alone cannot confirm membrane chemistry. The visible staining/discoloration suggests possible ponding or past repair areas, so the roof should be considered fair rather than clean or high-performing. Visible risk factors include dark staining or inconsistent roof color, possible ponding or drainage stress, high penetration or rooftop-unit density.

Recommend a closer roof inspection, especially around penetrations, seams, transitions, and any darker or discolored areas. Verify drainage performance and check for evidence of ponding, prior repairs, or localized membrane wear. If not recently inspected, schedule a professional walk-through and moisture evaluation to confirm whether the visible discoloration is superficial or associated with active defects. Field inspection should verify drainage, moisture, penetrations, flashing, and debris-related damage.
