## 4201 E 72ND AVE

COMMERCE CITY CO 80022

PROPERTY TYPE  
Commercial Government Building

### SELECTED AERIAL IMAGE - ESRI WORLD IMAGERY AS OF 11/13/2025

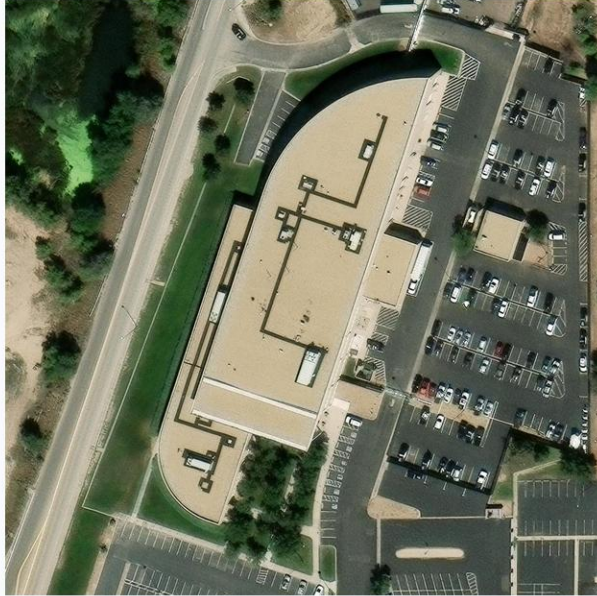
| VISIBLE CONCERNS | dark staining/color variation; many penetrations/units; tree/debris exposure |
| ROOF AGE EST. | Appears mature/older in aerial appearance; exact age unknown. The 11/13/2025 imagery shows weathered aggregate and multiple rooftop penetrations, but age cannot be determined from imagery alone. |

1. Visible risk factors include dark staining or inconsistent roof color, high penetration or rooftop-unit density, tree overhang or roof debris exposure.
2. Main roof field is a continuous tan/brown aggregate-surfaced low-slope assembly.
3. Several attached smaller roof sections are visible, including a rounded southern/western addition and smaller connector areas, and they appear to share the same aggregate surface or transition into smoother low-slope material.
4. Rooftop equipment, vents, and curbs are numerous across the roof, creating multiple flashing and seal points.
5. Perimeter and transition lines are visible, but seam or lap detail is not sufficiently resolved to confirm a specific hidden membrane beneath the aggregate.

Esri World Imagery dated 11/13/2025 shows a commercial government building with a predominantly ballasted or gravel-surfaced low-slope roof and smaller attached roof sections of similar appearance. Visible risk factors include dark staining or inconsistent roof color, high penetration or rooftop-unit density, tree overhang or roof debris exposure.

Based on the visible aerial evidence, this roof should be treated as a mixed low-slope assembly with a dominant aggregate-surfaced roof and smaller attached sections that may be membrane or coated membrane. A qualified commercial roof-coating contractor should perform an onsite inspection, moisture testing where warranted, confirmation of the visible roof system and warranty eligibility, required repairs and preparation, and a reliable project-price proposal. If the aggregate-surfaced areas are structurally sound and moisture is not widespread, evaluate whether a silicone roof restoration system could be a cost-effective option before overlay or replacement; a qualifying silicone system may reduce tear-off waste, cost, and disruption, create a seamless monolithic white reflective cool-roof surface, improve resistance to UV exposure and hail, withstand ponding water when properly designed and installed, and qualify for a manufacturer's 0
