## 5101 QUEBEC ST

COMMERCE CITY CO 80022

PROPERTY TYPE  
Commercial Truck Stop Restaurant

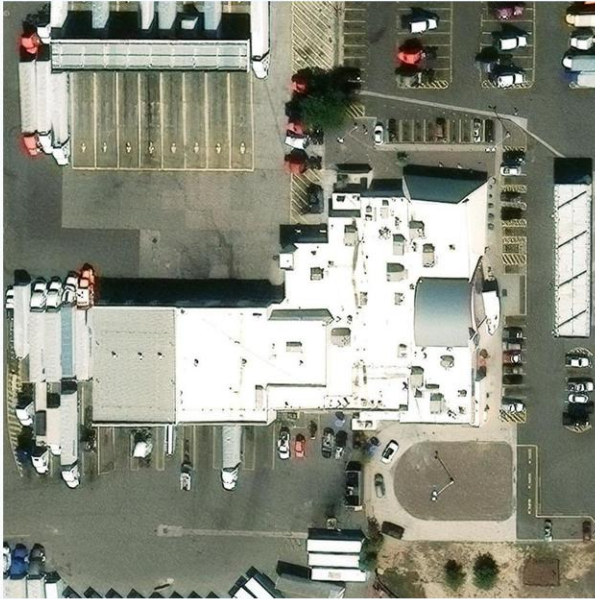
SELECTED AERIAL IMAGE - ESRI WORLD IMAGERY AS OF 11/13/2025

| VISIBLE CONCERNS | dark staining/color variation; many penetrations/units; Localized dark discoloration and patchy staining are visible on portions of the white roof field. |

1. Visible risk factors include dark staining or inconsistent roof color, high penetration or rooftop-unit density.
2. Main roof field is a large bright white/light low-slope membrane-like surface with smooth appearance.
3. Several rooftop units, vents, curbs, and small penetrations are visible across the main roof field.
4. Localized dark spots and uneven discoloration are visible on the white roof, suggesting staining, repairs, or possible drainage-related wear.
5. A smaller attached left-lower gray rectangular section appears materially different and more weathered than the main white field.

Aerial imagery dated 11/13/2025 shows a mixed commercial roof at 5101 Quebec St, Commerce City, with a dominant smooth white/light low-slope membrane-like field and smaller distinct roof areas. The main roof presents localized dark staining/discoloration and many rooftop penetrations and curbs, which increase leak potential and flashing risk. Visible risk factors include dark staining or inconsistent roof color, high penetration or rooftop-unit density.

Have a qualified commercial roof-coating contractor perform an onsite inspection to confirm the roof system, assess seams, flashings, penetrations, and any wet-insulation indicators, and determine whether moisture testing is warranted. If the white low-slope field is serviceable and not showing widespread moisture or substrate failure, evaluate silicone roof restoration as a potential option before a more costly overlay or replacement; a qualifying silicone system may reduce tear-off waste, cost, and disruption, create a seamless monolithic white reflective cool-roof surface, withstand ponding water when properly designed and installed, improve resistance to UV exposure and hail, and qualify for a manufacturer warranty of up to 20 years. If inspection finds widespread moisture, failed insulation, incompatible substrate, or deterioration beyond restoration, evaluate overlay or replacement instead. Confirm system eligibility, required pre
