## 6345 COLORADO BLVD

COMMERCE CITY CO 80022

PROPERTY TYPE  
Commercial Office Building

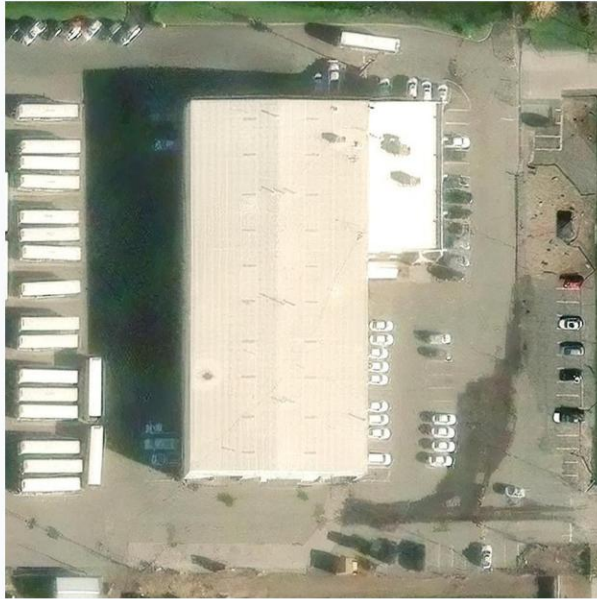
SELECTED AERIAL IMAGE - ESRI WORLD IMAGERY AS OF 11/13/2025

| VISIBLE CONCERNS | dark staining/color variation; possible ponding; many penetrations/units |

1. Visible risk factors include dark staining or inconsistent roof color, possible ponding or drainage stress, high penetration or rooftop-unit density.
2. Main central roof field is a large smooth light membrane-like area with faint linear seam/lap patterns.
3. Right/east attached roof section is brighter white and visually distinct from the main field.
4. Localized dark blotches/discoloration are visible on the attached white section.
5. Multiple rooftop units, vents, and curbs are present, creating numerous flashing locations.

Esri World Imagery dated 11/13/2025 shows a mixed low-slope commercial roof at 6345 Colorado Blvd, Commerce City, CO. The dominant field appears to be a smooth light single-ply membrane, best fit TPO from aerial evidence, while the attached bright white section could be TPO, PVC, or a coated roof. Visible risk factors include dark staining or inconsistent roof color, possible ponding or drainage stress, high penetration or rooftop-unit density.

Have a qualified commercial roof-coating contractor or membrane roofing contractor perform an onsite inspection, moisture testing where warranted, and confirmation of the roof system, flashing details, repairs, and warranty eligibility, then provide a reliable project-price proposal. Because the roof appears to be a restorable low-slope membrane system rather than asphalt shingles, evaluate whether a silicone roof restoration is feasible before considering overlay or replacement; a qualifying silicone system may reduce tear-off waste, cost, and disruption, create a seamless monolithic white reflective cool-roof surface, withstand ponding water when properly designed and installed, improve resistance to UV exposure and hail, and may qualify for a manufacturer warranty of up to 20 years. If onsite inspection finds widespread moisture, failed insulation, deck/structural deterioration, or an incompatible substrate, prioritize overlay or re,
