## 12043 W ALAMEDA PKWY

LAKEWOOD CO 80228

### OVERALL ROOF CONDITION SCORE

**58** /100  
POOR

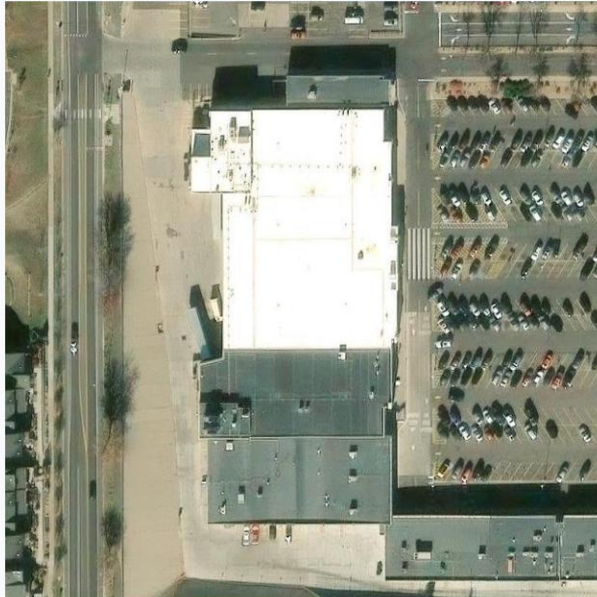
### SELECTED AERIAL IMAGE - ESRI WORLD IMAGERY

| VISIBLE CONCERNS | dark staining/color variation; many penetrations/units; Upper white roof shows scattered discoloration and small stains but no clear widespread ponding. |

1. Visible risk factors include dark staining or inconsistent roof color, high penetration or rooftop-unit density.
2. Large dominant upper roof field is bright white and smooth, consistent with a single-ply membrane or coated surface; TPO is the conservative label from aerial evidence.
3. Mid/lower central roof block is darker, matte, and visually distinct from the upper roof, supporting a separate dark membrane or asphaltic roof zone.
4. Small attached east/southeast roof strip shows straighter panel-like divisions and rigid geometry, supporting a separate metal section.
5. Scattered small stains/discoloration are visible on the white roof; no clear extensive ponding signature is resolved.

Aerial imagery dated not provided shows a mixed commercial roof with a dominant bright white low-slope membrane field, a separate dark low-slope roof section, and a small attached metal roof strip. Visible risk factors include dark staining or inconsistent roof color, high penetration or rooftop-unit density.

Have a qualified commercial roof-coating contractor or roof consultant perform an onsite inspection, moisture testing where warranted, confirm the exact systems, document repairs, and provide a reliable project-price proposal. If the dominant white low-slope roof is otherwise restorable and not asphalt shingle, evaluate whether a silicone roof restoration is appropriate before a costlier overlay or replacement; a properly designed silicone system can reduce tear-off waste, cost, and disruption, create a seamless monolithic white reflective cool-roof surface, improve resistance to UV exposure and hail, withstand ponding water when properly designed and installed, and may qualify for a manufacturer warranty of up to 20 years. If inspection reveals widespread moisture, failed insulation, deck deterioration, or an incompatible substrate, pursue overlay or replacement evaluation instead.
