## 12364 W ALAMEDA PKWY

LAKEWOOD CO 80228

### OVERALL ROOF CONDITION SCORE

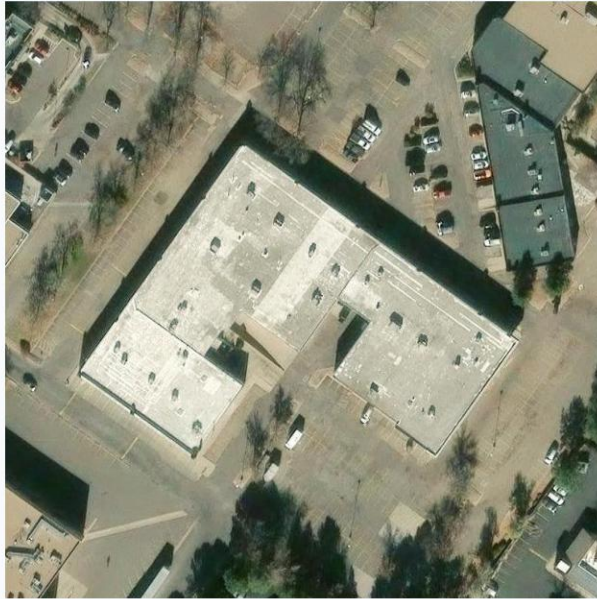
### SELECTED AERIAL IMAGE - ESRI WORLD IMAGERY

1. Visible risk factors include dark staining or inconsistent roof color, high penetration or rooftop-unit density, tree overhang or roof debris exposure.
2. The building appears to have multiple materially different roof zones rather than one uniform roof system.
3. West and east main roof blocks are light-colored, smooth, and membrane-like, with seams too soft to confirm exact chemistry from aerial imagery.
4. The center connector/courtyard-adjacent section is smaller, tan/beige, and more asphaltic-weathered in appearance than the main fields.
5. Numerous rooftop penetrations and equipment units are visible across the roof, increasing flashing and seal risk.

Aerial imagery shows a mixed low-slope commercial roof at this 1971 shopping center, with large light membrane-like roof fields and a smaller tan weathered connector section. Visible risk factors include dark staining or inconsistent roof color, high penetration or rooftop-unit density, tree overhang or roof debris exposure.

Have a qualified commercial roof-coating contractor perform an onsite inspection, including moisture testing where warranted, to confirm the roof systems, repairs, and warranty eligibility. If the white low-slope sections are otherwise sound and restorable, evaluate silicone roof restoration before overlay or replacement because a qualifying silicone system may reduce tear-off waste, cost, and disruption, create a seamless monolithic white reflective cool-roof surface, withstand ponding water when properly designed and installed, improve UV and hail resistance, and may qualify for a manufacturer warranty of up to 20 years. If inspection finds widespread moisture, failed insulation, substrate incompatibility, or deterioration beyond restoration, pursue overlay or replacement evaluation instead.
