## 12250 W KENTUCKY DR

PROPERTY TYPE  
Public School, Entire Elementary...

### OVERALL ROOF CONDITION SCORE

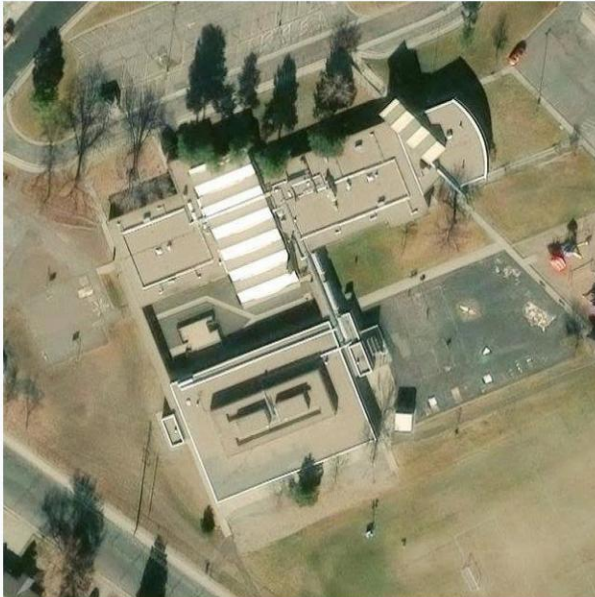
### SELECTED AERIAL IMAGE - ESRI WORLD IMAGERY

1. Visible risk factors include dark staining or inconsistent roof color, high penetration or rooftop-unit density, tree overhang or roof debris exposure.
2. Visible roof is mixed, with multiple low-slope zones separated by elevation changes and material transitions.
3. Upper-left and lower-center roof fields are light tan/cream and smooth-looking, but image softness prevents confirming TPO versus coated or weathered asphaltic material.
4. Right-lower roof field is darker and more uneven in tone, suggesting a separate weathered modified-bitumen/coated/membrane zone.
5. Upper-right curved addition shows rigid geometry and crisp edges consistent with metal roofing.

Aerial imagery shows a mixed low-slope school roof with multiple distinct zones: broad light tan/cream membrane-like fields, a darker weathered roof section, and a small curved metal addition. Visible risk factors include dark staining or inconsistent roof color, high penetration or rooftop-unit density, tree overhang or roof debris exposure.

Overall condition appears fair with moderate serviceability risk based on visible weathering, discoloration, multiple penetrations, and a darker patchy roof section that could be more prone to leaks or moisture-related deterioration. Because the roof appears to be an older, apparently restorable low-slope assembly rather than asphalt shingles, a qualified commercial roof-coating contractor should inspect it onsite, perform moisture testing where warranted, confirm the existing system and warranty eligibility, identify required repairs and preparation, and provide a reliable project-price proposal. If the substrate is dry and sound and the existing system is compatible, evaluate silicone roof restoration before a more costly overlay or replacement, since a qualifying silicone system may reduce tear-off waste, cost, and disruption, create a seamless monolithic white reflective cool-roof surface, withstand ponding water when properly sized
