## 4301 N FOREST ST

DENVER CO 80216

### OVERALL ROOF CONDITION SCORE

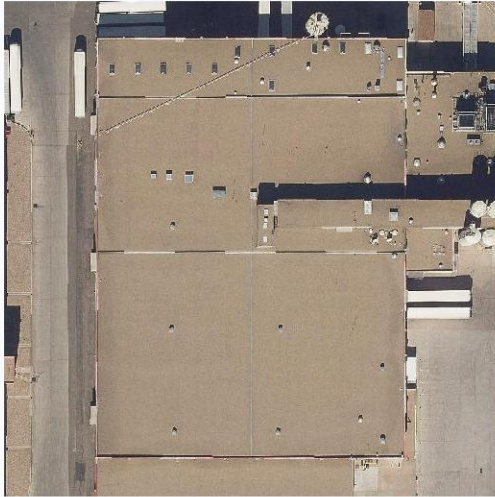
### SELECTED AERIAL IMAGE - DENVER GIS AS OF 03/11/2018 - 03/17/2018

| VISIBLE CONCERNS | dark staining/color variation; many penetrations/units; Several small darkened spots and localized discoloration are visible on the roof field. |

1. Large low-slope industrial roof footprint with multiple connected roof sections.
2. Roof surface is generally uniform but shows scattered dark spots and localized discoloration.
3. Numerous penetrations, vents, curbs, and rooftop equipment are visible across multiple roof areas.
4. Perimeter and step transitions create additional flashing interfaces.
5. Visible roof appearance suggests serviceable but aging conditions rather than acute failure.

Aerial imagery dated 03/11/2018 - 03/17/2018 shows a large low-slope commercial roof at 4301 N FOREST ST with generally uniform appearance but scattered dark staining/discoloration and multiple rooftop penetrations, vents, and equipment curbs. The roof appears service-aged and moderate risk, with leak potential driven more by flashing/penetration complexity and localized discoloration than by obvious severe distress. Older imagery may understate current deterioration.

Have a qualified commercial roofing contractor perform an onsite inspection, including moisture testing if warranted, to confirm the roof system, evaluate the darkened areas for staining versus trapped moisture or leak impact, and assess flashing/seal conditions around penetrations and transitions. If the roof is still broadly serviceable and not a shingle substrate, evaluate silicone roof restoration as a potential option before a more costly overlay or replacement; a qualifying silicone system may reduce tear-off waste, cost, and disruption, create a seamless monolithic white reflective cool-roof surface, improve resistance to UV exposure and hail, withstand ponding water when properly designed and installed, and may qualify for a manufacturer warranty of up to 20 years. If onsite findings show widespread moisture, failed insulation, substrate incompatibility, or other advanced deterioration, pursue overlay or replacement evaluation.
