## 4360 N DAHLIA ST

DENVER CO 80216

OVERALL ROOF CONDITION SCORE

**55** /100  
POOR

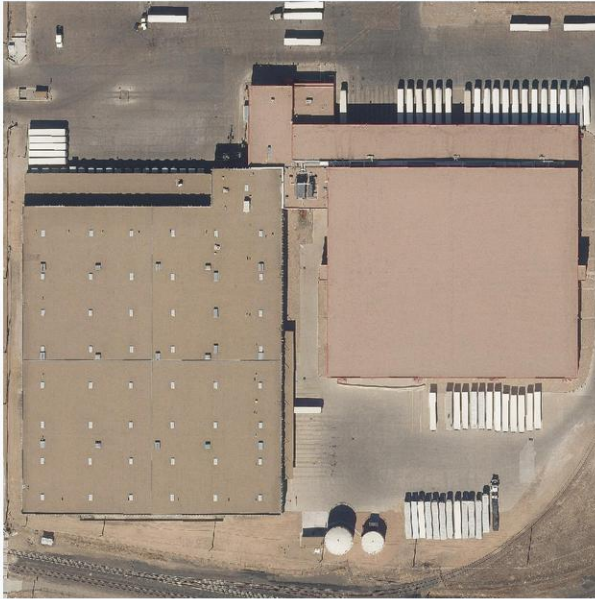
SELECTED AERIAL IMAGE - DENVER GIS AS OF 03/11/2018 - 03/17/2018

| VISIBLE CONCERNS | dark staining/color variation; many penetrations/units; Several darkened roof areas and tonal variation are visible across the large left roof field, which may reflect weathering, staining, or prior repairs. |

1. Large industrial warehouse complex with extensive low-slope roof area.
2. Left roof field shows many evenly spaced skylights/penetrations and multiple rooftop appurtenances.
3. Darkened patches and uneven coloration are visible on the left roof field, especially near seams and across broad areas.
4. Right roof field appears more uniform and lighter in color, possibly a coated or newer membrane field.
5. Perimeter edges and transitions show multiple flashing conditions, but fine-detail seal condition cannot be confirmed from aerial imagery.

Aerial imagery dated 03/11/2018 - 03/17/2018 shows a large low-slope commercial roof complex in poor current-likely condition with moderate serviceability risk. The roof appears to be a smooth membrane or bituminous system, with one field showing broad dark discoloration and tonal variation that may indicate weathering, prior repairs, or moisture-related staining. Numerous skylights, vents, and rooftop units increase flashing and leak potential. No clear tree overhang or debris buildup

Have a qualified commercial roof-coating contractor perform an onsite inspection and moisture testing where warranted to confirm the roof system, identify required repairs, and verify restoration eligibility. If the substrate is sound and the roof is otherwise suitable, evaluate a silicone roof restoration before a more costly overlay or replacement; a properly designed silicone system can reduce tear-off waste, cost, and disruption, create a seamless monolithic white reflective cool-roof surface, withstand ponding water when properly installed, improve UV and hail resistance, and may qualify for a manufacturer warranty of up to 20 years. If onsite findings show widespread moisture, failed insulation, incompatible substrate, or advanced deterioration, then an overlay or replacement evaluation is more appropriate.
