## 4275 N FOREST ST

DENVER CO 80216

PROPERTY TYPE  
INDUSTRIAL-WAREHOUSE 397: OFFICE/WA...

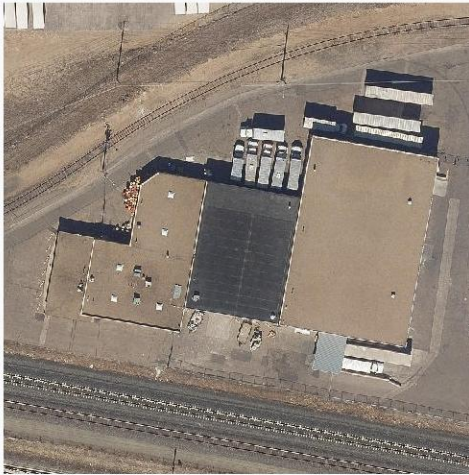
SELECTED AERIAL IMAGE - DENVER GIS AS OF 03/11/2018 - 03/17/2018

| VISIBLE CONCERNS | dark staining/color variation; many penetrations/units; Visible darkened roof field contrasts strongly with the adjacent lighter roof areas, suggesting a distinct membrane section or possible coating/weathering pattern. |

1. Industrial warehouse building with multiple low-slope roof sections.
2. One large central dark roof field is visibly distinct from the surrounding lighter roof surfaces.
3. Several vents, curbs, and rooftop units/penetrations are present on the roof.
4. Roof surfaces appear generally serviceable from aerial view, but the tonal contrast suggests maintenance or aging differences between sections.
5. No obvious tree overhang or major debris accumulation is visible at the roof edges.

Aerial imagery dated 03/11/2018 - 03/17/2018 shows a low-slope industrial roof with multiple membrane fields, including a large darker section and lighter weathered sections that may indicate different roof materials, coating, or age-related discoloration. Visible penetrations and rooftop equipment increase flashing and leak potential. No clear ponding or heavy debris is evident, but the roof presents moderate serviceability risk and the older imagery may understate more

Have a qualified commercial roof-coating contractor perform an onsite inspection and moisture testing where warranted, confirm the actual roof system and warranty eligibility, identify required repairs and surface preparation, and provide a reliable project-price proposal. If the roof is a suitable low-slope membrane in restorable condition, evaluate a silicone roof restoration option before overlay or replacement; when properly designed and installed, a qualifying silicone system may reduce tear-off waste, cost, and disruption, create a seamless monolithic white reflective cool-roof surface, withstand ponding water, improve UV and hail resistance, and qualify for a manufacturer warranty of up to 20 years. If onsite findings show widespread moisture, failed insulation, deck or structural deterioration, incompatible substrate, or other non-restorable conditions, evaluate overlay or full replacement instead.
