## 4500 N DAHLIA ST

DENVER CO 80216

### OVERALL ROOF CONDITION SCORE

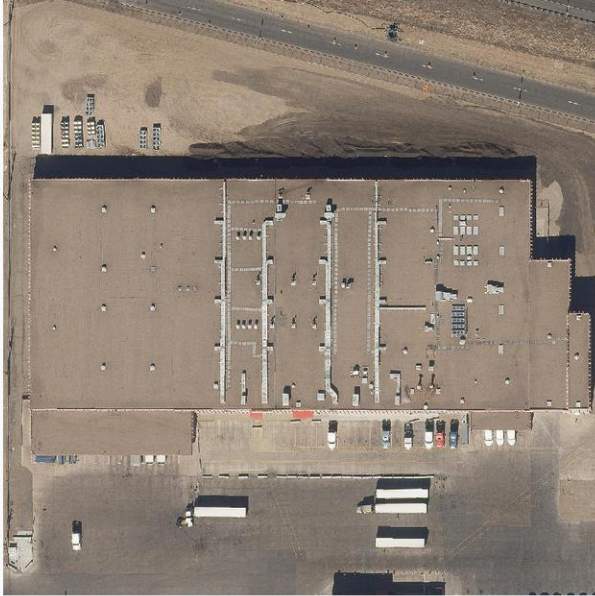
SELECTED AERIAL IMAGE - DENVER GIS AS OF 03/11/2018 - 03/17/2018

1. Large industrial warehouse with extensive flat roof area and multiple distinct roof sections.
2. Numerous rooftop penetrations, curbs, vents, and mechanical units are present across the roof field.
3. Visible darker staining/discoloration and uneven roof coloration occur in several areas.
4. No clear signs of severe membrane failure, open tears, or large exposed substrate are visible from the aerial view.
5. Image resolution does not allow reliable identification of exact membrane chemistry or hidden wet insulation conditions.

Aerial imagery from 03/11/2018 - 03/17/2018 shows a large low-slope industrial warehouse roof in poor current-likely condition with moderate serviceability risk. The roof appears to be a broad membrane-type assembly, but exact material cannot be confirmed from the aerial view. Visible dark staining/discoloration and uneven color patterns suggest possible ponding history, localized moisture retention, or prior repairs. The roof also has many penetrations, curbs, vents, and mechanical/ro

Have a qualified commercial roofing contractor perform an onsite inspection with moisture testing where warranted, verify the membrane type and flashing condition, and estimate repair scope and project pricing. If the roof is generally sound and restoration-compatible, evaluate silicone roof restoration before a more costly overlay or replacement; a qualifying silicone system may reduce tear-off waste, cost, and disruption, create a seamless monolithic white reflective cool-roof surface, withstand ponding water when properly designed and installed, improve resistance to UV exposure and hail, and may qualify for a manufacturer warranty of up to 20 years. If field testing shows widespread moisture, failed insulation, structural/deck deterioration, or an incompatible substrate, pursue overlay or replacement evaluation instead.
