## 4444 N FOREST ST

DENVER CO 80216

PROPERTY TYPE  
INDUSTRIAL-WAREHOUSE 398: WAREHOU...

YEAR BUILT  
1979

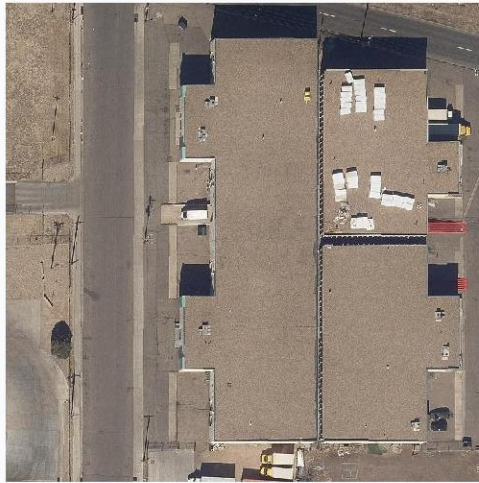
### SELECTED AERIAL IMAGE - DENVER GIS AS OF 03/11/2018 - 03/17/2018

1. Low-slope commercial warehouse roof with multiple connected roof fields.
2. Roof surface is generally intact from aerial view but not uniformly clean; several darkened patches and tonal variations are visible.
3. Several penetrations/vents/roof-mounted elements are present, especially on the right-side roof field, which raises flashing and seal risk.
4. Some areas near roof edges and field transitions appear darker and possibly moisture-affected, though aerial imagery cannot confirm wet insulation.
5. No obvious major open breaches or severe widespread collapse are visible in the provided image.

Aerial imagery of this 1979 industrial warehouse shows a low-slope roof that appears serviceable but only fair overall, with moderate risk driven by visible dark staining/discoloration, possible localized ponding or drainage-related moisture, and multiple penetrations that increase flashing and leak potential. The roof surface looks broadly intact, but the mottled appearance suggests recurring maintenance or water-management concerns on an older roof field. Because the 3

Have a qualified commercial roofing contractor perform an onsite inspection with moisture testing where warranted, confirm the exact roof system and repair history, and evaluate flashing, seams, drainage, and any suspect stained areas. If the roof is otherwise structurally sound and the substrate is compatible, consider whether a silicone roof restoration is feasible before a more costly overlay or replacement; a properly designed silicone system can reduce tear-off waste, cost, and disruption, create a seamless white reflective surface, improve UV and hail resistance, withstand ponding water when correctly installed, and may qualify for a manufacturer warranty of up to 20 years. If moisture damage, failed insulation, deck issues, or incompatible materials are found, pursue overlay or full replacement evaluation instead.
