## 5290 E 43RD AVE

DENVER CO 80216

PROPERTY TYPE  
INDUSTRIAL-WAREHOUSE 398: WAREHOU...

### OVERALL ROOF CONDITION SCORE

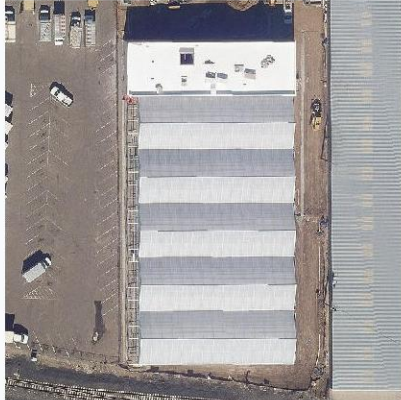
### SELECTED AERIAL IMAGE - DENVER GIS AS OF 03/11/2018 - 03/17/2018

1. The dominant roof surface shows repeated linear bands and reflective striping consistent with a metal panel roof field.
2. A separate lighter low-slope roof area is visible with a few penetrations/equipment items near the upper section.
3. No clear widespread membrane discoloration, dark staining, or debris accumulation is visible.
4. No obvious ponding areas are apparent from the overhead imagery.
5. Perimeter and adjacent site areas do not show overhanging trees contacting the roof.

Aerial imagery from 03/11/2018 - 03/17/2018 shows a generally serviceable industrial roof with a dominant metal roof field and a separate lighter low-slope roof area. Visible risk is mainly from the limited number of rooftop penetrations/equipment on the low-slope section, which increases flashing and seal vulnerability. No clear widespread staining, debris accumulation, or obvious ponding is visible in the image, though older imagery may understate current wear.

The roof appears generally sound from aerial view, but the visible penetrations and low-slope areas warrant an onsite commercial roof inspection to confirm flashing, seams, and drainage performance. If the lighter low-slope section is a qualifying membrane roof and remains restorable, a silicone roof restoration could be evaluated before a more costly overlay or replacement, as a properly designed system may reduce tear-off waste, cost, and disruption while creating a seamless reflective surface and improving UV/ponding resistance; confirm system compatibility, moisture conditions, repairs, and warranty eligibility with a qualified commercial roof-coating contractor. If onsite inspection finds hidden moisture, substrate problems, or incompatible materials, then overlay or replacement evaluation would be more appropriate.
