## 5050 E SMITH RD

DENVER CO 80216

PROPERTY TYPE  
INDUSTRIAL-AUTO SERVICE GARAGE 332:...

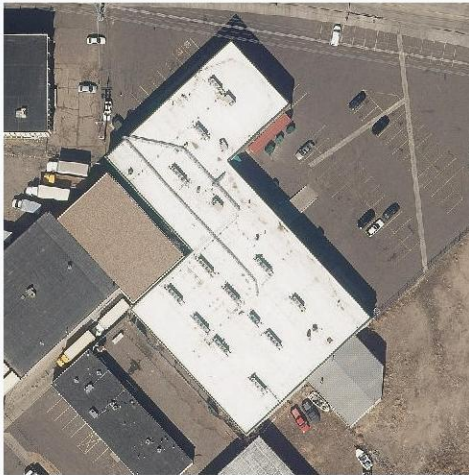
SELECTED AERIAL IMAGE - DENVER GIS AS OF 03/11/2018 - 03/17/2018

| VISIBLE CONCERNS | dark staining/color variation; many penetrations/units; Several darkened rooftop areas/discoloration spots are visible on the white roof field, suggesting possible localized staining, repairs, or moisture/ponding-related wear. |

1. White low-slope commercial roof with generally uniform reflective appearance.
2. Visible seams or joints run through the roof field, supporting a membrane or coated-membrane system.
3. Scattered dark spots and irregular discoloration are present on the roof surface.
4. Numerous rooftop units/penetrations and related curbs are visible, creating additional leak-prone details.
5. No clear standing water is visible in this aerial frame.

Aerial imagery from 03/11/2018 - 03/17/2018 shows a low-slope commercial roof that appears generally serviceable and relatively recent-looking, with a bright white reflective surface consistent with a membrane or coated-membrane system. Visible darkened spots and localized discoloration introduce some concern for staining, prior repairs, or moisture-related wear, and the roof also has multiple penetrations/equipment that increase flashing and seal risk. No obvious ponded

The roof appears to be in good-fair condition overall, but the visible staining/discoloration and multiple penetrations warrant an onsite commercial roof inspection focused on flashing, seams, and any localized moisture-related distress. If the roof is otherwise sound and restoration-eligible, have a qualified commercial roof-coating contractor evaluate whether a silicone roof restoration is appropriate before considering a more costly overlay or replacement; a qualifying silicone system may reduce tear-off waste, cost, and disruption, create a seamless reflective cool-roof surface, help with ponding water resistance when properly designed and installed, improve UV and hail resistance, and may qualify for a manufacturer warranty of up to 20 years. If field testing or onsite inspection finds widespread moisture, failed insulation, structural/deck deterioration, or an incompatible substrate, pursue overlay or replacement evaluation. A one
