## 4882 E SMITH RD

DENVER CO 80216

PROPERTY TYPE  
INDUSTRIAL-WAREHOUSE 398: WAREHOU...

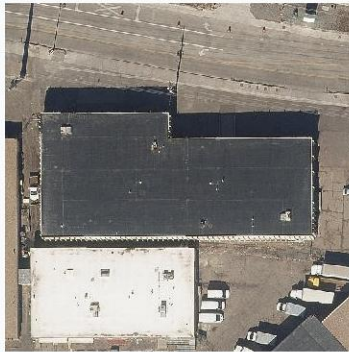
### SELECTED AERIAL IMAGE - DENVER GIS AS OF 03/11/2018 - 03/17/2018

| VISIBLE CONCERNS | dark staining/color variation; many penetrations/units; Main roof field shows localized lighter/darker patches and small discoloration areas that may reflect repairs, staining, or drainage-related wear. |

1. Main roof is a dark low-slope field with a fairly uniform membrane-like appearance.
2. Several small rooftop penetrations and equipment pads/curbs are visible across the roof.
3. Localized lighter patches and minor discoloration are visible on the main roof surface.
4. An adjacent lower roof field to the south appears much lighter/white and may be a different roof surface or a coated membrane.
5. Roof perimeter and parapet/edge details are visible but fine flashing condition cannot be confirmed from aerial imagery alone.

Aerial imagery dated 03/11/2018 - 03/17/2018 shows a low-slope commercial roof with a dark main membrane field and an adjacent lighter low-slope roof area. The main roof appears generally serviceable but has localized discoloration/patchy areas and multiple roof penetrations, which increase leak and flashing-maintenance risk. No clear large ponding is visible, though drainage performance cannot be confirmed from this view. Overall condition appears fair with moderate low

Have a qualified commercial roofing contractor perform an onsite inspection to confirm the roof system, evaluate flashing and penetration seals, and test for moisture if leaks or soft areas are suspected. If the roof is an apparently restorable low-slope membrane and not asphalt shingle, evaluate silicone roof restoration before a more costly overlay or full replacement; a qualifying silicone system may reduce tear-off waste, cost, and disruption, create a seamless monolithic white reflective cool-roof surface, improve resistance to UV exposure and hail, withstand ponding water when properly designed and installed, and may qualify for a manufacturer warranty of up to 20 years. If field testing shows widespread moisture, insulation failure, deck deterioration, or incompatible substrate conditions, an overlay or replacement evaluation is more appropriate. Confirm system eligibility, needed repairs, preparation scope, and project pricing.
