## 4902 E SMITH RD

DENVER CO 80216

### OVERALL ROOF CONDITION SCORE

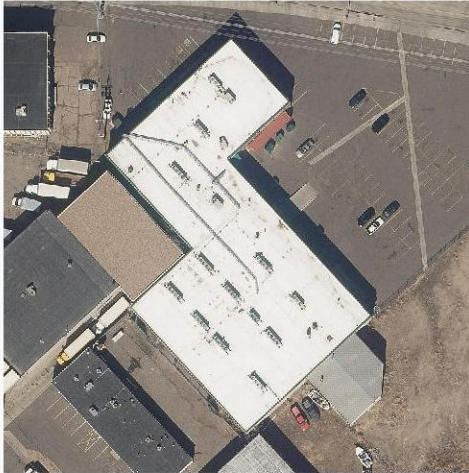
SELECTED AERIAL IMAGE - DENVER GIS AS OF 03/11/2018 - 03/17/2018

| VISIBLE CONCERNS | dark staining/color variation; possible ponding; many penetrations/units |

1. The dominant roof field appears to be a white reflective low-slope membrane roof.
2. Visible seam lines and rooftop patches/objects indicate a commercial membrane assembly with multiple penetrations.
3. Localized dark staining/discoloration is present in several areas of the roof surface.
4. No obvious tree overhang or heavy debris accumulation is visible in the aerial image.
5. The roof appears serviceable from aerial view, but the visible staining and penetrations elevate leak risk.

Aerial imagery dated 03/11/2018 - 03/17/2018 shows a low-slope commercial roof with a bright white membrane or coated membrane surface and multiple visible penetrations. The roof is generally reflective and appears serviceable, but several dark stained/discolored areas and irregular patches suggest possible ponding, localized moisture retention, prior repairs, or leak potential. Flashing and seal risk is elevated by the number of rooftop details. Because the image is 201

Recommend a qualified commercial roof-coating contractor perform an onsite inspection, moisture testing where warranted, confirmation of the existing system and warranty eligibility, required repairs/preparation, and a reliable project-price proposal. Based on aerial evidence, the roof appears to be a candidate for evaluation of silicone roof restoration if the substrate is sound and dry enough for restoration; a properly designed silicone system can reduce tear-off waste, cost, and disruption, create a seamless monolithic white reflective cool-roof surface, withstand ponding water when properly designed and installed, improve resistance to UV exposure and hail, and may qualify for a manufacturer warranty of up to 20 years. If onsite investigation finds widespread moisture, failed insulation, structural/deck deterioration, or an incompatible substrate, then overlay or replacement evaluation is more appropriate.
