## 5105 E 41ST AVE

PROPERTY TYPE  
INDUSTRIAL-WAREHOUSE 398: WAREHOU...

### AERIAL ROOF OBSERVATIONS

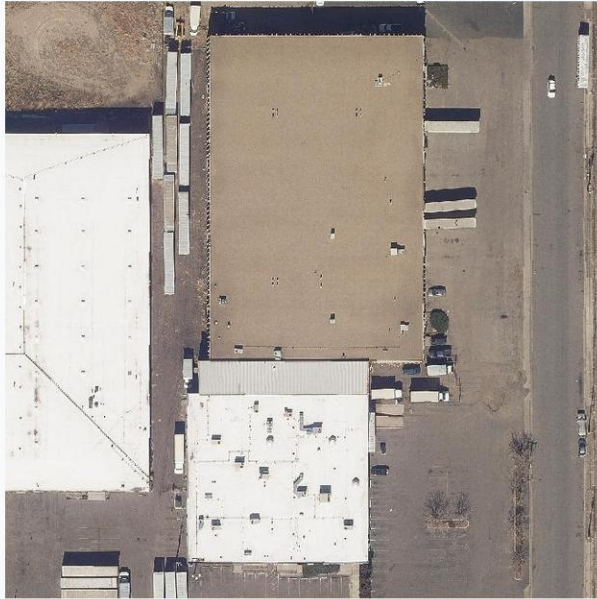
SELECTED AERIAL IMAGE - DENVER GIS AS OF 03/11/2018 - 03/17/2018

| VISIBLE CONCERNS | dark staining/color variation; many penetrations/units; Visible localized dark spots and scattered discoloration on the white roof field suggest prior repairs, weathering, or moisture-related staining potential. |

1. Large low-slope commercial roof with multiple rooftop penetrations, vents, and small equipment curbs.
2. White roof field shows scattered dark speckling, spot staining, and uneven coloration.
3. Tan roof field appears more uniform but still has several visible penetrations.
4. Perimeter drainage details are not clearly readable from this overhead image.
5. Visible rooftop components increase seal and flashing vulnerability on an older industrial roof.

03/11/2018 - 03/17/2018 Denver GIS aerial imagery shows an older low-slope industrial warehouse roof in fair overall condition with moderate serviceability risk. The white roof field has scattered dark staining/discoloration and a somewhat uneven appearance that may indicate prior repairs, weathering, or moisture-related concerns, while the tan field appears more uniform. Multiple penetrations, vents, and curbs are visible, increasing flashing and leak potential on a low

Have a qualified commercial roofing contractor perform an onsite inspection to verify membrane type, evaluate the visible staining/discoloration, check flashings and penetrations, and perform moisture testing if warranted. If the roof is a restorable low-slope membrane system and no widespread moisture, deck, or substrate failure is found, evaluate a silicone roof restoration option before a more costly overlay or replacement; a qualifying silicone system may reduce tear-off waste, cost, and disruption, create a seamless reflective surface, improve ponding-water tolerance when properly designed and installed, and may qualify for a manufacturer warranty of up to 20 years. If inspection finds widespread moisture, failed insulation, incompatible substrate, or other advanced deterioration, pursue overlay or replacement evaluation instead.
