## 5180 E SMITH RD

DENVER CO 80216

### OVERALL ROOF CONDITION SCORE

### ROOF INFORMATION

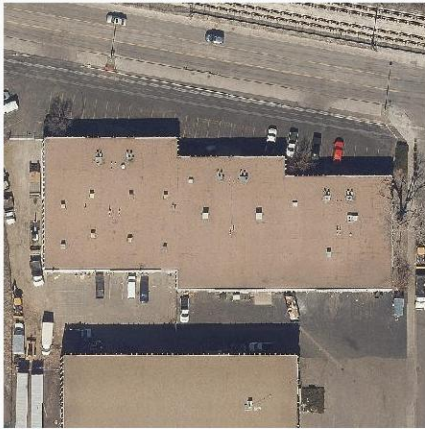
SELECTED AERIAL IMAGE - DENVER GIS AS OF 03/11/2018 - 03/17/2018

| VISIBLE CONCERNS | dark staining/color variation; many penetrations/units; Multiple small rooftop penetrations/vents/curbs are visible across the main roof field, increasing flashing and seal risk. |

1. Main roof field is a large, low-slope commercial roof with a generally uniform tan surface.
2. Numerous small rooftop penetrations and fixtures are visible, especially across the central and right roof areas.
3. Localized darker areas and slight color variation are present, but not enough from aerial imagery alone to confirm failure.
4. No obvious tree overhang touching the roof and no heavy debris accumulation are visible.
5. The image does not provide enough resolution to distinguish TPO/PVC from other membrane types with high confidence.

Aerial imagery dated 03/11/2018 - 03/17/2018 shows a large low-slope commercial roof in fair current-likely condition with moderate serviceability risk. The roof surface is generally uniform, but localized dark discoloration and several rooftop penetrations/fixtures are visible, increasing leak and flashing risk. No clear widespread ponding, heavy debris, or tree encroachment is visible, though older imagery may understate current deterioration.

Recommend a qualified commercial roofing contractor perform an onsite inspection to confirm the roof system, inspect flashing/seals around penetrations, and verify whether the localized discoloration reflects staining, prior repairs, or moisture-related issues. If the roof is a restorable low-slope membrane and not an incompatible substrate, evaluate silicone roof restoration as a potential option before overlay or full replacement; a properly designed system can reduce tear-off waste, cost, and disruption, create a seamless reflective surface, and may improve resistance to UV exposure and hail, with manufacturer warranties up to 20 years when eligibility criteria are met. If moisture, insulation failure, structural/deck deterioration, or substrate incompatibility is found, pursue overlay or replacement evaluation instead. Confirm required repairs, preparation, moisture testing if warranted, and obtain a reliable project-price proposal.
