## 4100 N DAHLIA ST

DENVER CO 80216

### OVERALL ROOF CONDITION SCORE

### ROOF INFORMATION

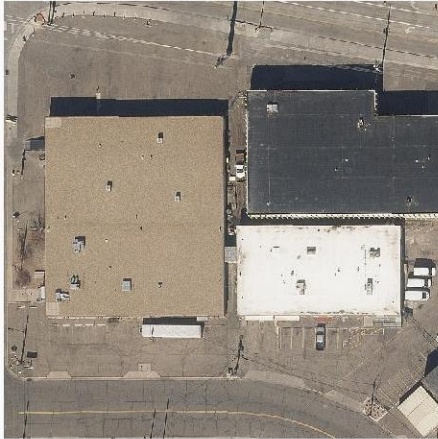
SELECTED AERIAL IMAGE - DENVER GIS AS OF 03/11/2018 - 03/17/2018

| VISIBLE CONCERNS | dark staining/color variation; many penetrations/units; Dark uniform roof areas and isolated discoloration are visible on the darker roof field; these may reflect membrane aging, staining, or prior repairs. |

1. Industrial warehouse property with multiple flat/low-slope roof sections.
2. One roof field appears dark and uniform; another appears bright white, indicating different roof surfaces or a reflective surface treatment.
3. Multiple rooftop penetrations are visible, including small vents/curbs and mechanical-related protrusions.
4. Perimeter drainage and edge conditions are visible but not clearly showing severe blockage from the aerial view.
5. No obvious tree overhang onto the roof is visible in this image.

Aerial imagery dated 03/11/2018 - 03/17/2018 shows a low-slope industrial warehouse roof with mixed roof field appearances: one dark membrane field and one bright white reflective field. Visible condition appears generally serviceable, but the darkened roof area and isolated discoloration suggest aging, prior repair activity, or localized moisture-related staining potential. Multiple penetrations and rooftop details increase flashing and seal risk. No clear severe ponded

Have a qualified commercial roofing contractor perform an onsite inspection, including moisture testing where warranted, to confirm the roof system, identify any required repairs, and verify whether a silicone roof restoration is appropriate for the apparently restorable low-slope areas before considering overlay or replacement. A properly designed and installed silicone system can reduce tear-off waste, cost, and disruption, create a seamless monolithic white reflective cool-roof surface, withstand ponding water when properly designed and installed, improve UV and hail resistance, and may qualify for a manufacturer warranty of up to 20 years. If onsite findings show widespread moisture, failed insulation, structural or deck deterioration, or incompatible substrate conditions, pursue overlay or full replacement evaluation instead.
