## 5200 E SMITH RD

PROPERTY TYPE  
INDUSTRIAL-WAREHOUSE 401: MFG/PROC...

### OVERALL ROOF CONDITION SCORE

**59** /100  
POOR

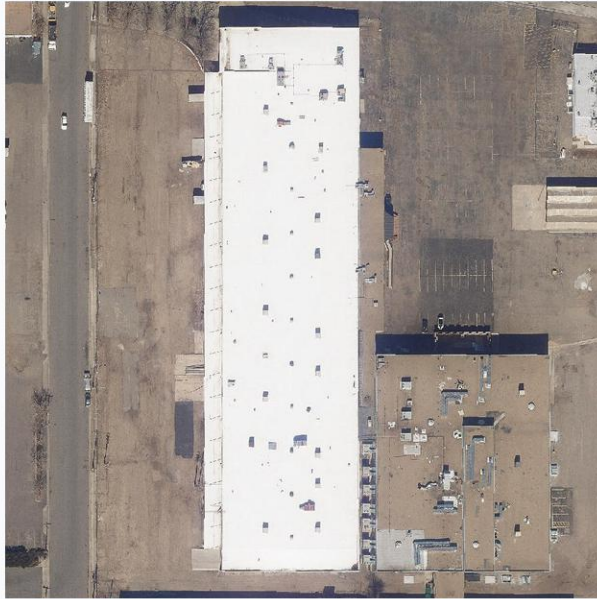
SELECTED AERIAL IMAGE - DENVER GIS AS OF 03/11/2018 - 03/17/2018

| VISIBLE CONCERNS | dark staining/color variation; many penetrations/units; Main white roof field is mostly uniform but shows scattered darker spots and a few localized discolorations that could reflect staining, prior repairs, or minor moisture-related wear. |

1. Main roof field is bright white and generally uniform, suggesting a reflective low-slope membrane or coated surface.
2. Several small rooftop penetrations and mechanical items are distributed across the main field.
3. Adjacent lower roof areas are more heavily populated with rooftop equipment and ductwork, increasing service complexity.
4. Localized dark spots/discoloration are visible on the white field.
5. No clear tree overhang or major debris accumulation is visible in the roof areas shown.

Aerial imagery dated 03/11/2018 - 03/17/2018 shows a large low-slope industrial roof with a predominantly white reflective membrane on the main field and a more equipment-dense tan roof area adjacent to it. The main roof appears generally serviceable, but scattered discoloration and the presence of multiple penetrations and rooftop units increase leak and flashing risk. No obvious ponding is visible, though drainage performance cannot be verified from aerial-only imagery

Recommend a qualified commercial roofing contractor perform an onsite inspection to confirm roof system type, condition, flashing integrity, drainage, and any moisture-related issues; moisture testing should be performed where warranted. For the apparently restorable low-slope white roof area, evaluate silicone roof restoration before a more costly overlay or replacement, provided the substrate and warranty criteria are confirmed and needed repairs/preparation are completed. A properly designed and installed silicone system can create a seamless monolithic white reflective cool-roof surface, may reduce tear-off waste, cost, and disruption, can improve UV and hail resistance, withstand ponding water when properly designed and installed, and may qualify for a manufacturer warranty of up to 20 years. If onsite findings reveal widespread moisture, failed insulation, deck deterioration, or an incompatible substrate, then overlay or full roof
