# Partial Roof Overview

Harold Wood Sports Association · Aerial imagery, 11 August 2026 · Drone Studio ·  
Demonstration document

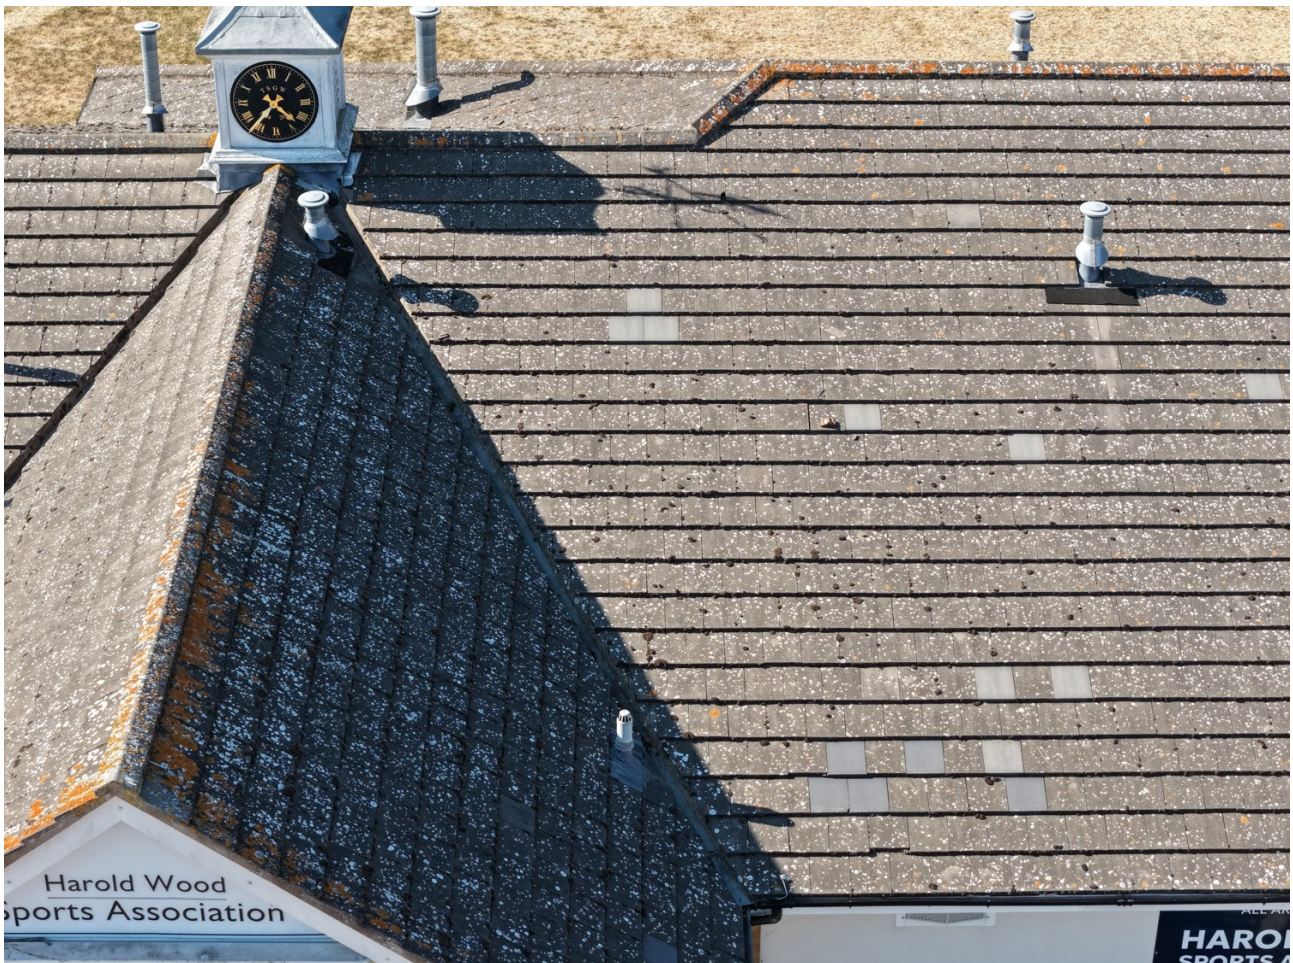
General view of the section covered, with the clock turret and part of the front elevation.

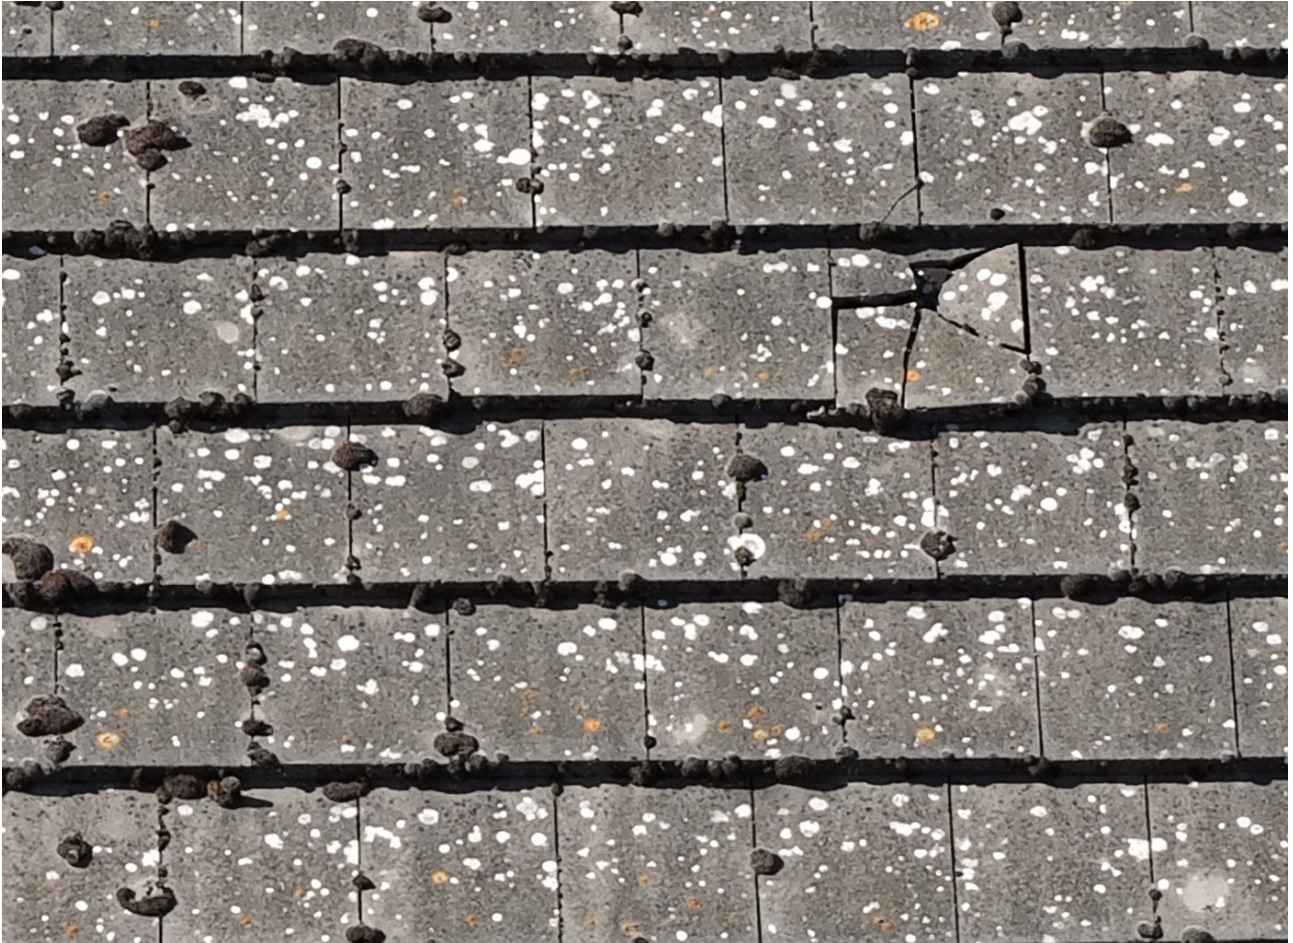
**1. Cracked tile.** One tile has split, with a fragment displaced and lifted clear of the surface. A gap of this kind lets water past the covering in wind-driven rain, and the loose piece can slide further in a storm.

Cracked tile with a displaced fragment. Full-resolution detail from 23 metres.

Within the area we could see, the roof appears sound in overall form: ridge lines run straight and there was no sign of sagging or widespread tile movement. The two damaged tiles are worth having a roofer look at, ideally before winter, along with clearing moss from the gutters. Everything else we saw is maintenance rather than repair.

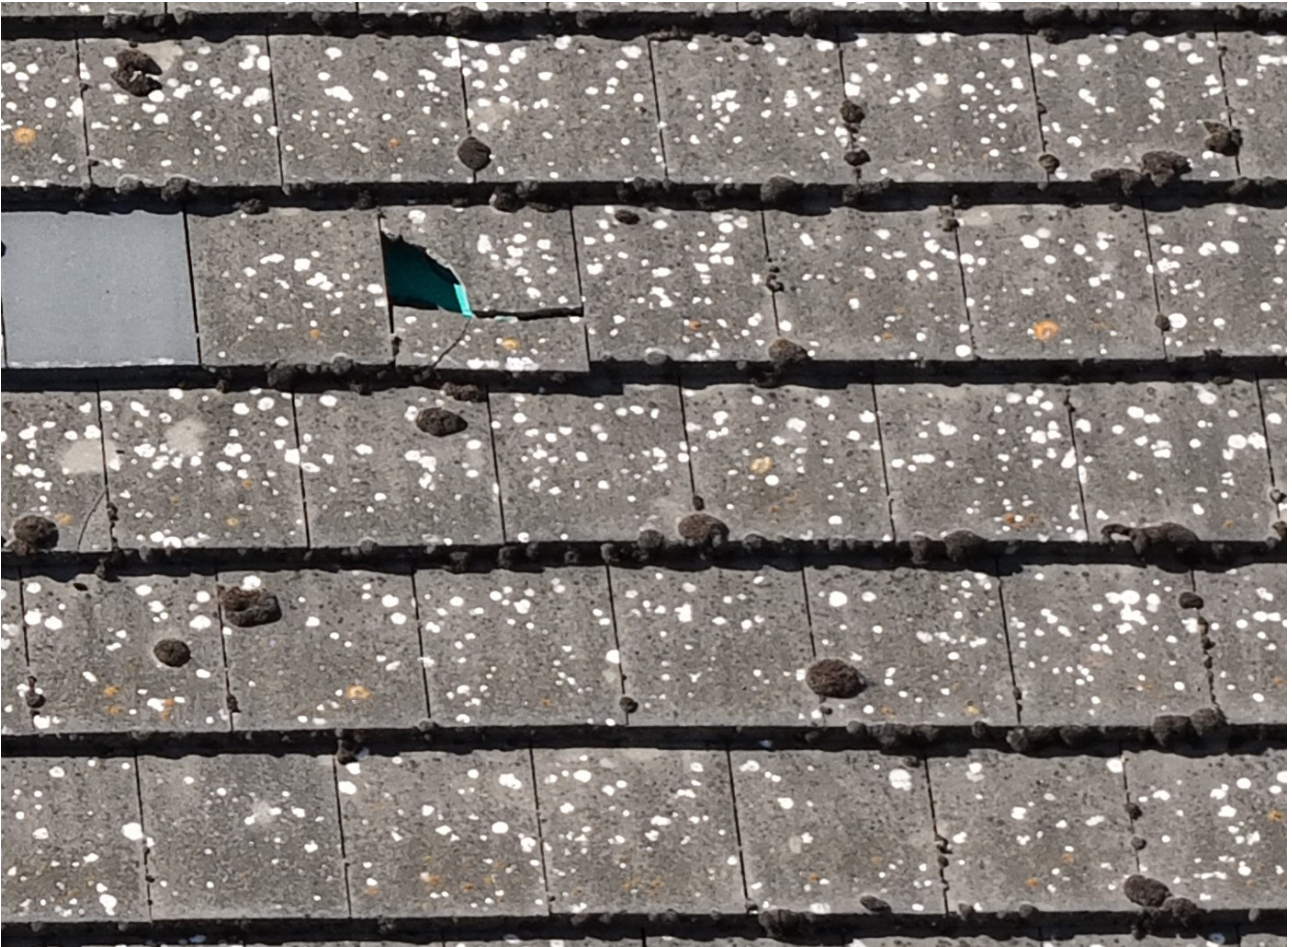
**2. Missing section of tile, underlay exposed.** Part of another tile is absent and what appears to be the green underlay membrane is visible through the opening. Where that happens, the covering at that point is doing nothing and the membrane alone is holding the weather out — and membranes degrade quickly once exposed to sunlight. Note the replacement tile immediately beside it, suggesting this area has needed attention before.

Opening in the covering with underlay visible, next to a previously replaced tile.

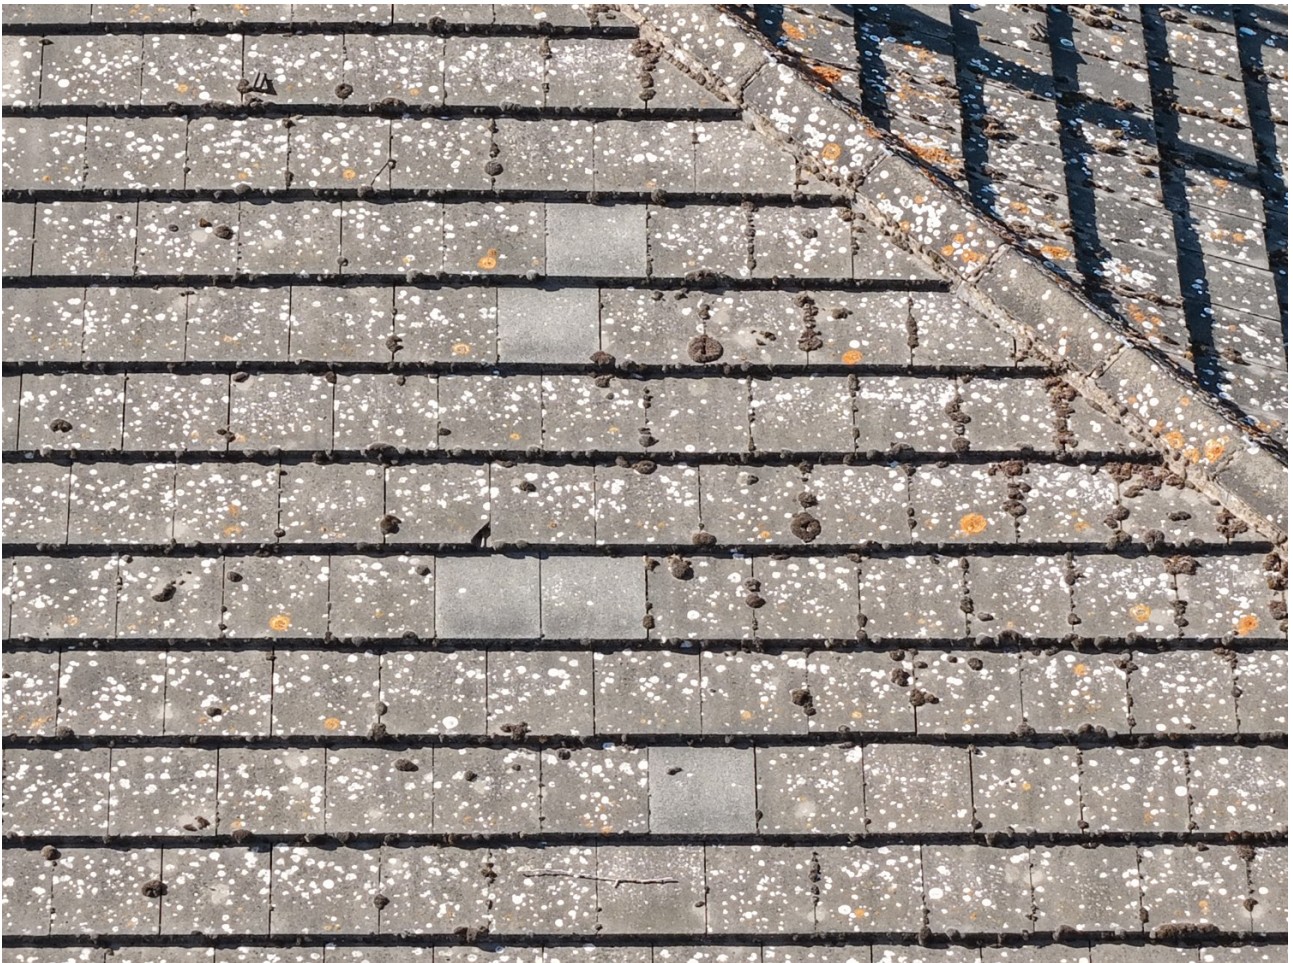
**Moss along the tile laps.** Dark clumps have formed along the horizontal overlaps, heaviest on the shaded slopes. Moss holds water against the tile surface, and in freezing weather that trapped water accelerates surface breakdown. Loose growth also washes down into gutters and downpipes.

Moss along the laps, with white and orange lichen colonies across the tile faces.

**Extensive lichen cover** across most of what was photographed. Lichen itself is largely cosmetic, but its spread marks surfaces that stay damp for long periods. **Several previously replaced tiles** are visible, differing in colour from those around them — useful to know where past problems occurred. A number of **vent terminals and a rooftop condenser unit** sit on the main slopes; points where anything passes through the covering are the usual places for water ingress to begin.
