## Fault Code: 5946

### Transmission (or Gearbox) Oil Temperature - Data Valid But Above Normal Operating Range - Moderately Severe Level

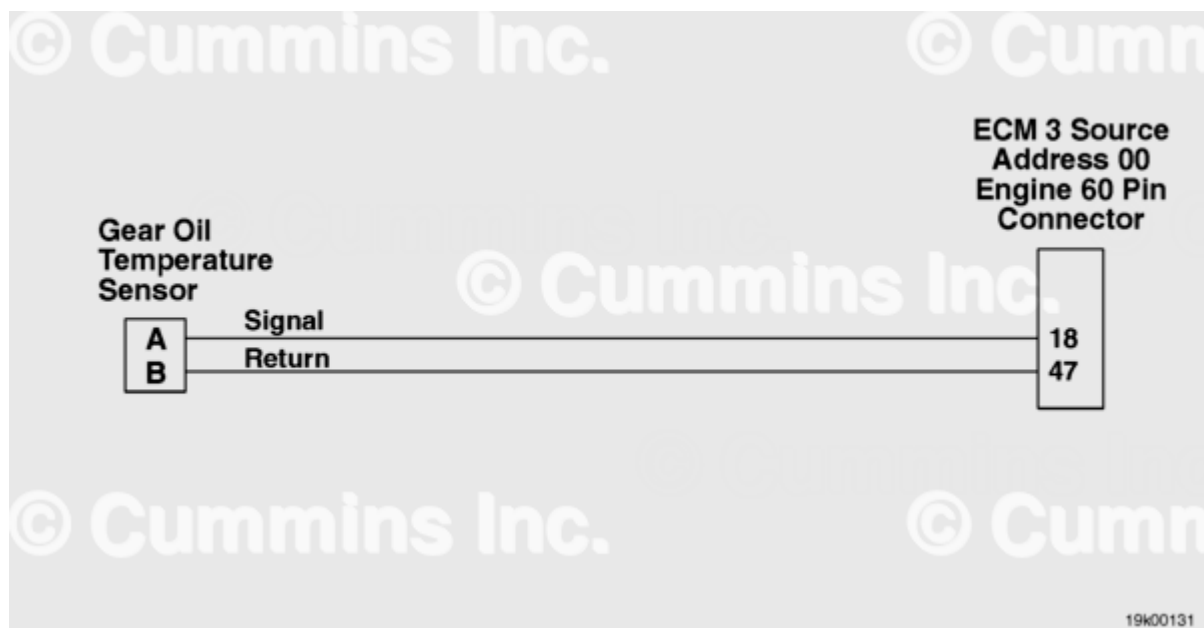
Engine Oil Temperature 1 Sensor Circuit

The transmission (or gearbox) oil temperature sensor is used by the engine control module (ECM) to monitor the transmission oil temperature. The ECM monitors the voltage on the SIGNAL pin and converts it to a temperature value.
