## Fault Code: 1984

### Intake Manifold 2 Temperature - Data Valid But Above Normal Operating Range - Moderately Severe Level

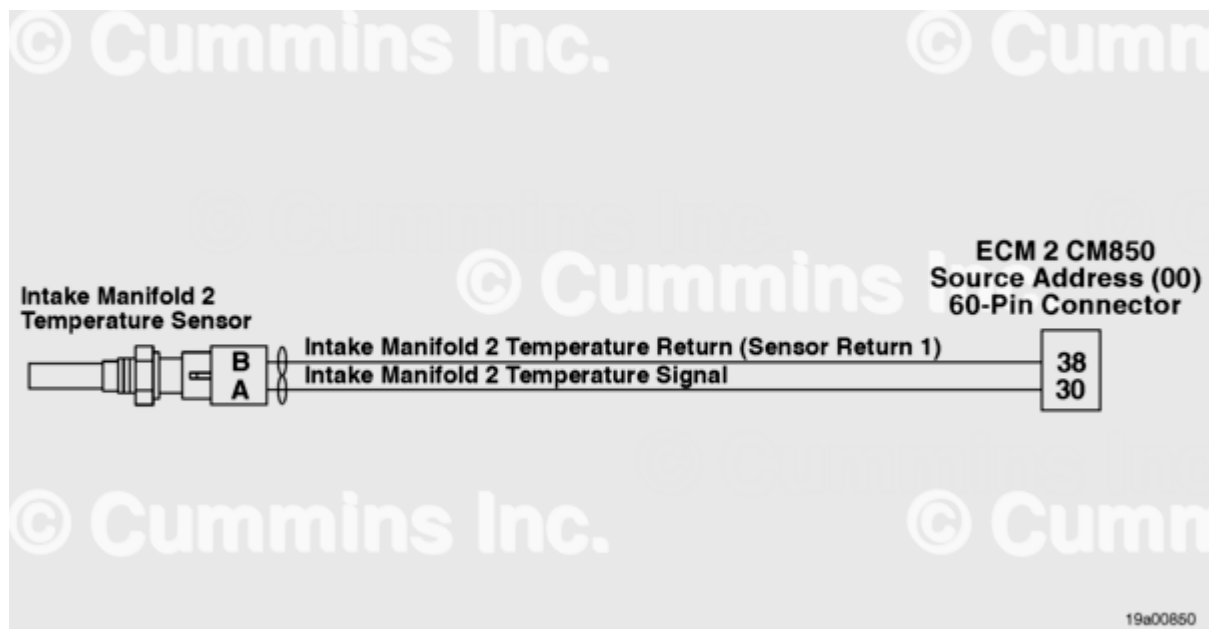
Intake Manifold 2 Temperature Sensor Circuit

The intake manifold temperature sensor is a variable resistor sensor used by the ECM to monitor the intake manifold temperature. The intake manifold temperature sensor has two circuits: signal, and return circuits. The signal voltage indicates the intake manifold temperature.

The intake manifold 2 temperature sensor is located in the right bank rear air intake manifold.
