## Fault Code: 386

### Sensor Supply 1 Circuit - Voltage Above Normal or Shorted to High Source

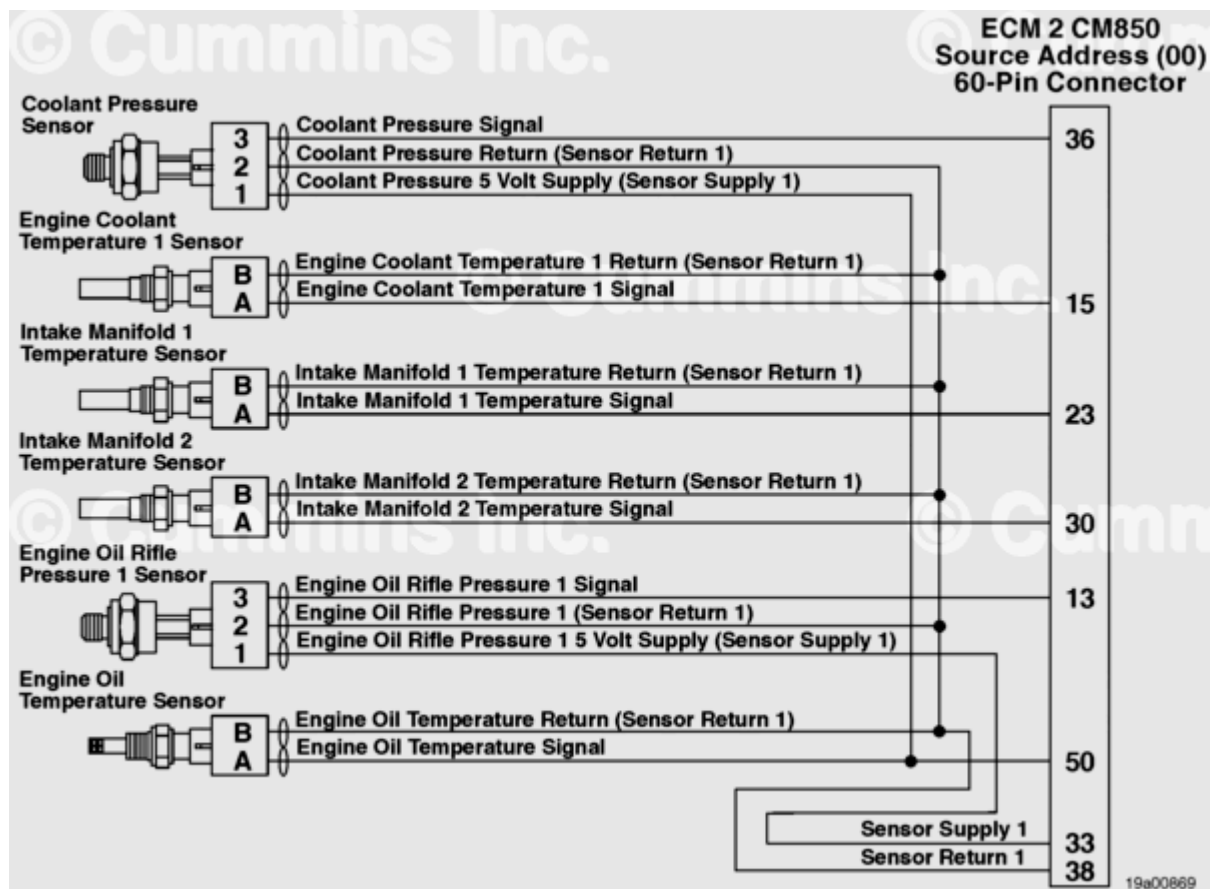
Sensor Supply 1 Circuit.

The Engine Control Module (ECM) detected the sensor supply 1 voltage was out of range high.

- Malfunctioning or damaged engine wiring harness.

- To validate the repair, start the engine and let it run for 1 minute at no load.
- The generator set controller will turn off the warning indicator immediately after the user presses reset.
- The "Reset All Faults" command in the recommended Cummins® electronic service tool or equivalent can be used to clear active faults.
