# Fault Code: 227

## Sensor Voltage Supply

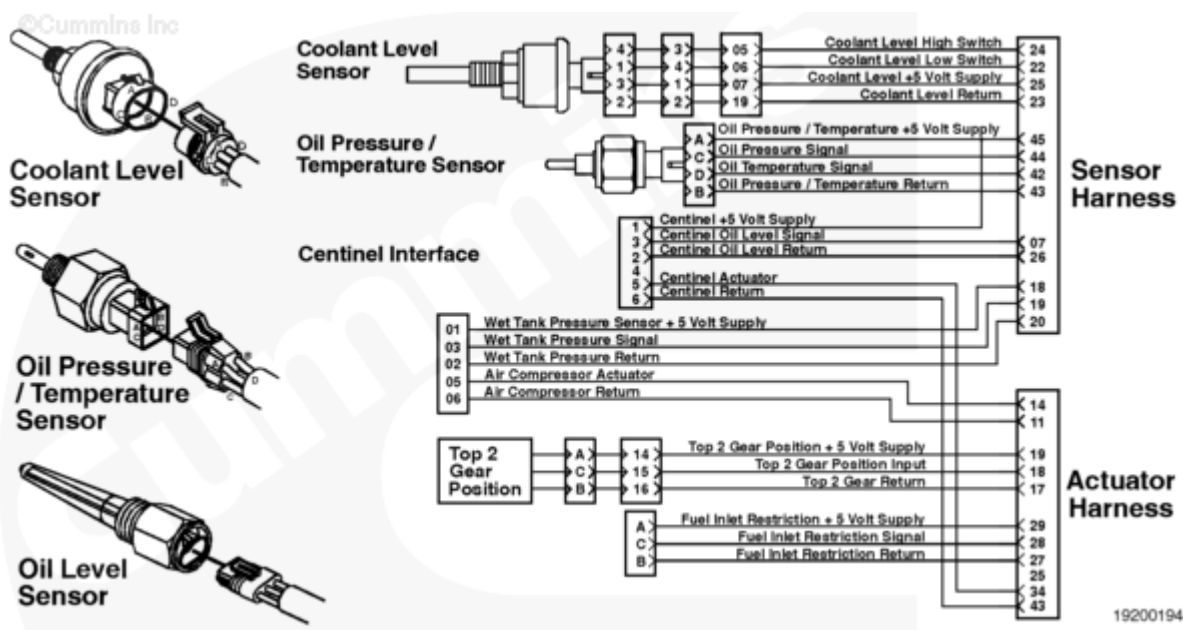
Sensor Supply Voltage Circuit

| Codes | Reason | Effect |
|---|---|---|
| Fault Code: 227<br><br>PID(P): S232<br>SPN: 620<br>FMI: 3<br>Lamp: Yellow<br>SRT: | High voltage detected on the electronic control module (ECM) voltage supply line to some sensors. (VSEN 2) | Engine will run derated. No engine protection for oil pressure and coolant level. |

The ECM supplies each of these sensors with + 5 VDC. If the supply wire to any sensor is damaged, the sensor will **not** work correctly.

High voltage on the sensor + 5-VDC supply line will be caused by a short to battery in the supply line or a short between an actuator wire and the supply wire.

Refer to Troubleshooting Fault Code t05-227 (</qs3/pubsys2/xml/en/procedures/82/82-t05-227.html>)
