## Fault Code: 286

### J1939 Datalink Multiplexing

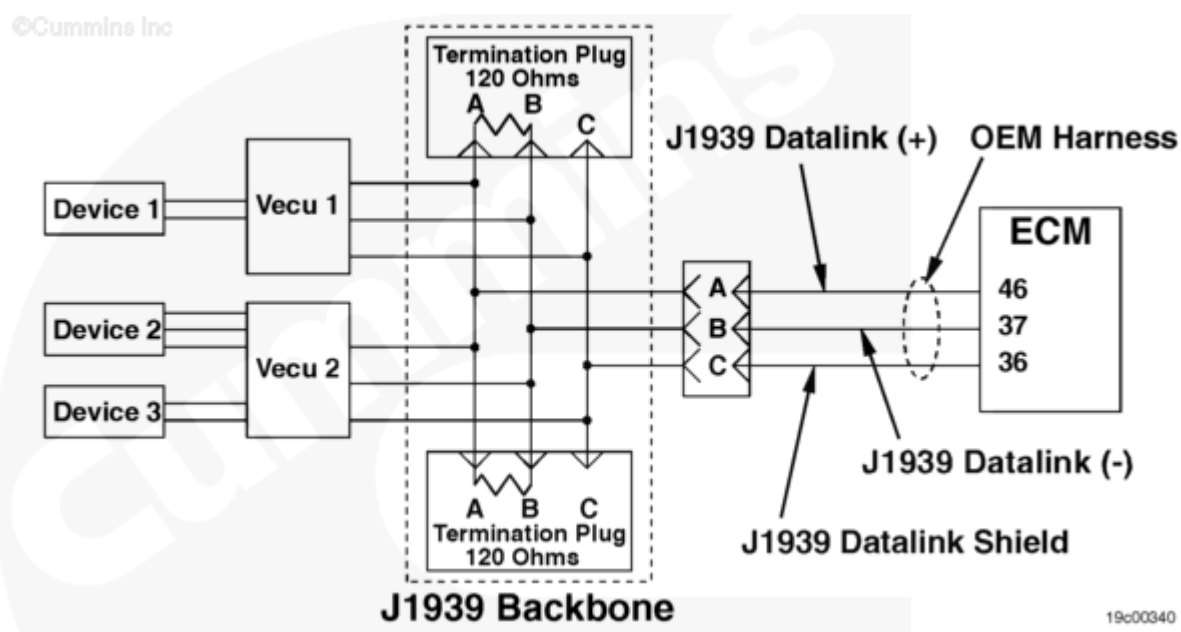
J1939 Datalink Multiplexing Circuit

This fault occurs when the ECM is set up to receive information from several multiplexed switches from VECU(s) and **only** gets some of the switches. It indicates the ECM is set up to receive too many switches or the VECU(s) is set up to transmit too few switches.
