# Fault Code: 319

Real-Time Clock Power Circuit

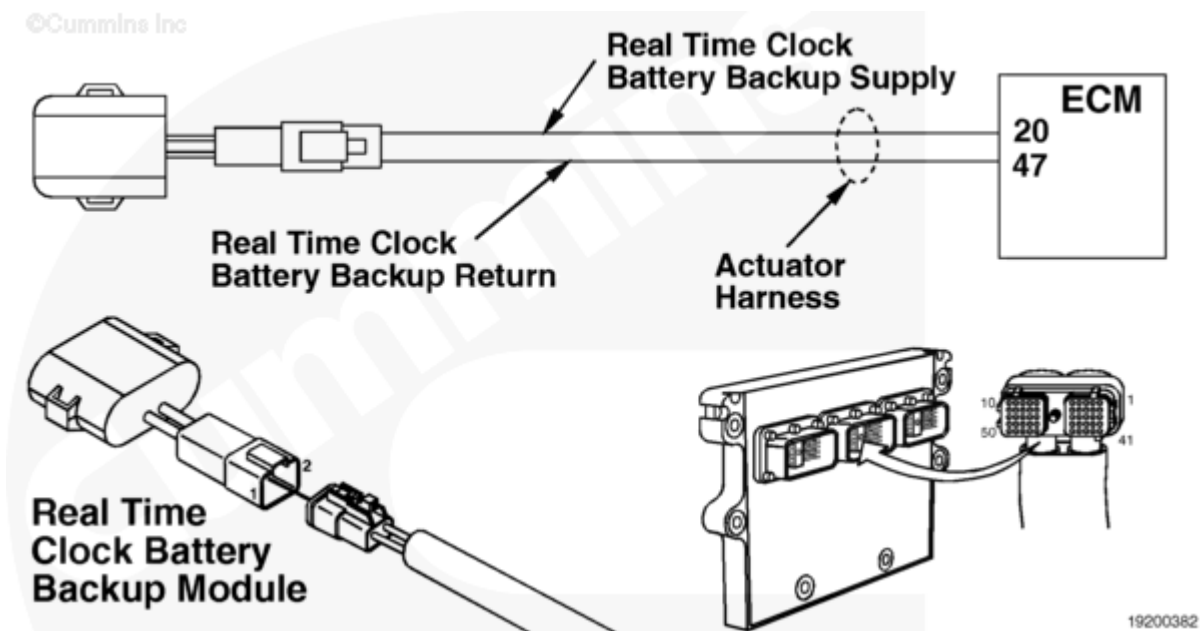
Real-Time Clock Power Circuit

| Codes | Reason | Effect |
|---|---|---|
| Fault Code: 319<br><br>PID(P): P251<br>SPN: 251<br>FMI: 2/2<br>Lamp: Maintenance<br>SRT: | Real-time clock lost power. | None on performance. Data in the ECM will <b>not</b> have accurate time and date information. |

Under ordinary operating conditions, the real-time clock in the ECM is powered by the vehicle's batteries. If battery power to the ECM is lost, then the real-time clock will be powered by a battery backup module (if equipped).

This fault indicates that the real-time clock in the ECM lost power. Possible causes for this fault:

- A weak or failed battery backup module
- Failed wiring or connectors between the battery backup module and ECM
- The engine is **not** equipped with a battery backup module, and lost vehicle battery power to the ECM.

Refer to Troubleshooting Fault Code t05-319 (</qs3/pubsys2/xml/en/procedures/82/82-t05-319.html>)
