# Fault Code: 386

## Sensor Voltage Supply

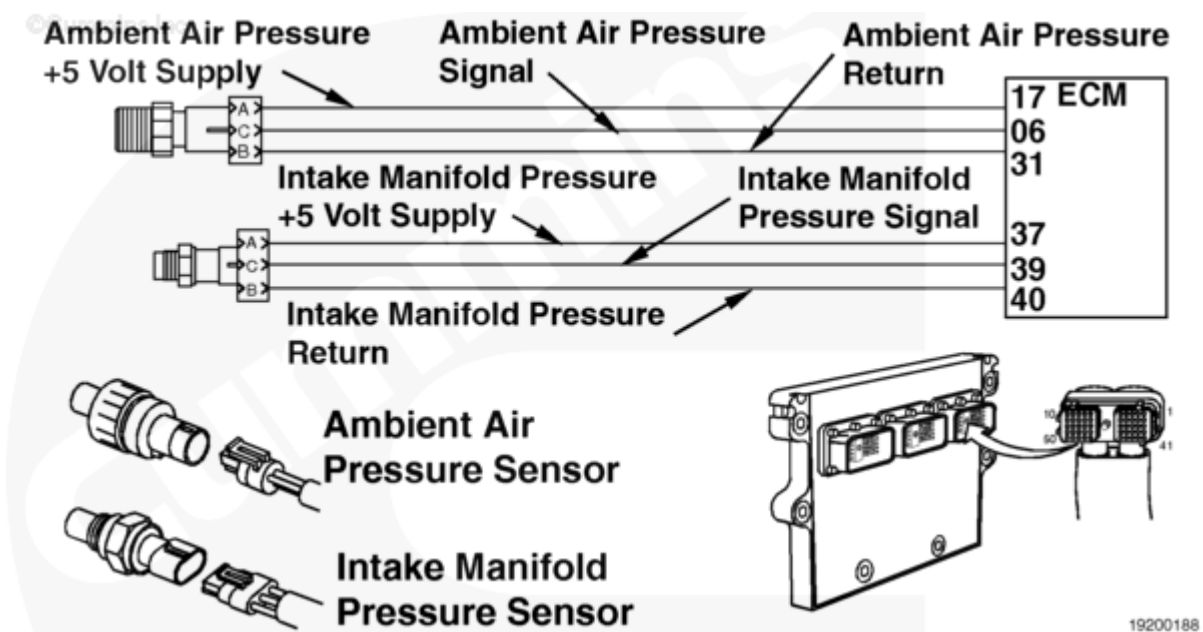
Sensor Voltage Supply Circuit

| Codes | Reason | Effect |
|---|---|---|
| Fault Code: 386<br><br>PID(P): S232<br>SPN: 620<br>FMI: 3<br>Lamp: Yellow<br>SRT: | High voltage detected on the internal electronic control module (ECM) supply wire to the sensors. | Engine is derated to no-air setting. |

The ECM supplies each of these sensors with +5 VDC. If the supply wire to any sensor is damaged, the sensor will **not** work correctly.

High voltage on the sensor +5-VDC supply wire will be caused by a short to battery of the supply wire or a short between an actuator wire and the supply wire.

Refer to Troubleshooting Fault Code t05-386 (</qs3/pubsys2/xml/en/procedures/82/82-t05-386.html>)
