# Fault Code: 387

## Throttle Voltage Supply

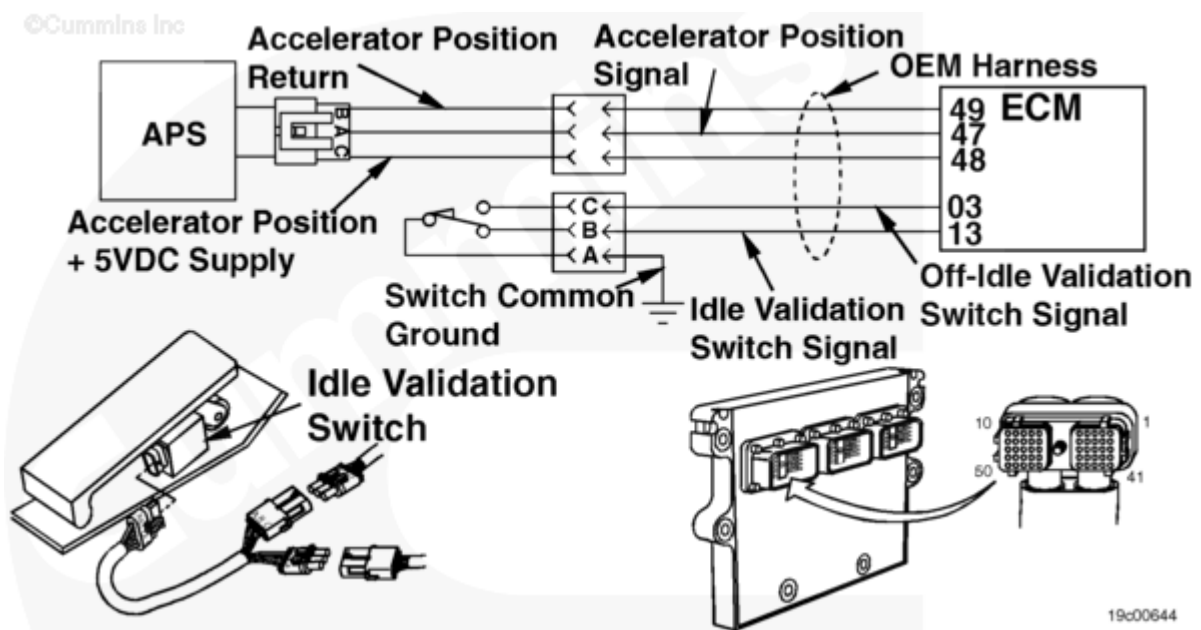
Throttle Sensor Supply Voltage Circuit

The ECM supplies the throttle and remote throttle with +5 VDC. If the supply line to the throttles is damaged, the throttle will **not** work correctly.

High voltage on the + 5-VDC supply line will be caused by a short circuit to battery of the supply line or a short circuit between an actuator and the supply line.

Refer to Troubleshooting Fault Code t05-387 (</qs3/pubsys2/xml/en/procedures/82/82-t05-387.html>)
