# Fault Code: 422

## Coolant Level Sensor Circuit

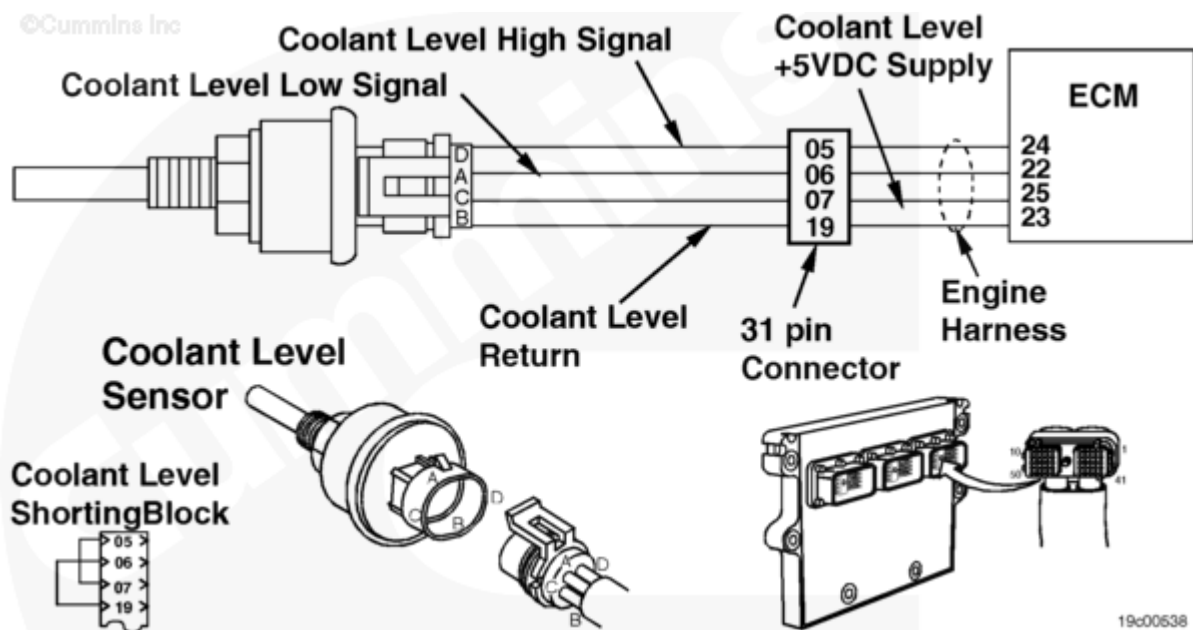
Coolant Level Sensor Circuit

| Codes | Reason | Effect |
|---|---|---|
| Fault Code: 422<br><br>PID(P): P111<br>SPN: 111<br>FMI: 2/2<br>Lamp: Yellow<br>SRT: | Voltage detected simultaneously on both the coolant level high and low signal circuits <b>or</b> no voltage detected on <b>both</b> circuits. | No engine protection for coolant level. |

The coolant level sensor monitors the coolant level within the coolant system and passes information to the electronic control module (ECM) through the sensor harness. This sensor is very complex. Do **not** use a multimeter to check the coolant level sensor. If the radiator coolant level drops below a certain level, a power derate will occur and become greater as time goes by.

- Open circuit
- Short circuit to ground
- Short circuit to another wire.

Refer to Troubleshooting Fault Code t05-422 (</qs3/pubsys2/xml/en/procedures/82/82-t05-422.html>)
