## Fault Code: 426

### J1939 Datalink Communication

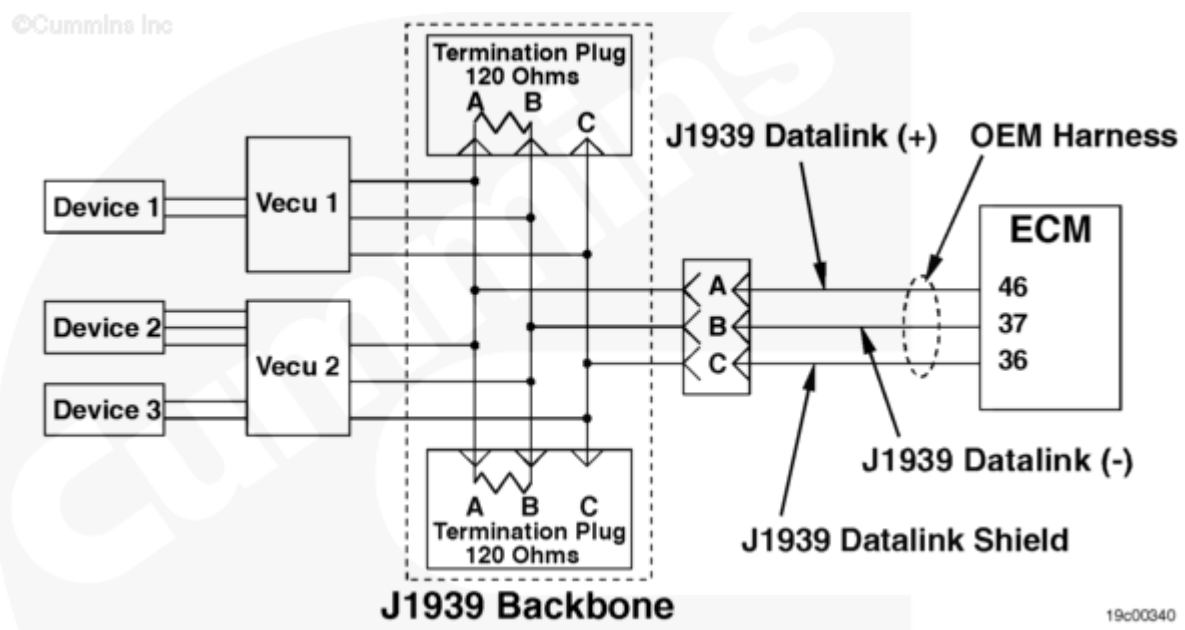
J1939 Datalink Circuit

| Codes | Reason | Effect |
|---|---|---|
| Fault Code: 426<br><br>PID(P): S231<br>SPN: 639<br>FMI: 2/2<br>Lamp: None<br>SRT: | Communication between the electronic control module (ECM) and another device on the J1939 datalink has been lost. | None on performance.<br>J1939 devices possibly do <b>not</b> operate. |

This fault occurs whenever the ECM starts communicating with **any** other device using the J1939 datalink and then can no longer transmit on the datalink. Possible causes could be the following: Unplugging an electronic service tool before keying off the ECM, the J1939 datalink having an intermittent electrical problem, the ECM (or another J1939 device) tying up communications by an electrical problem, or by sending too many messages without stopping.

Refer to Troubleshooting Fault Code t05-426 (</qs3/pubsys2/xml/en/procedures/82/82-t05-426.html>)
