## Fault Code: 428

### Water-In-Fuel (WIF) Sensor Circuit

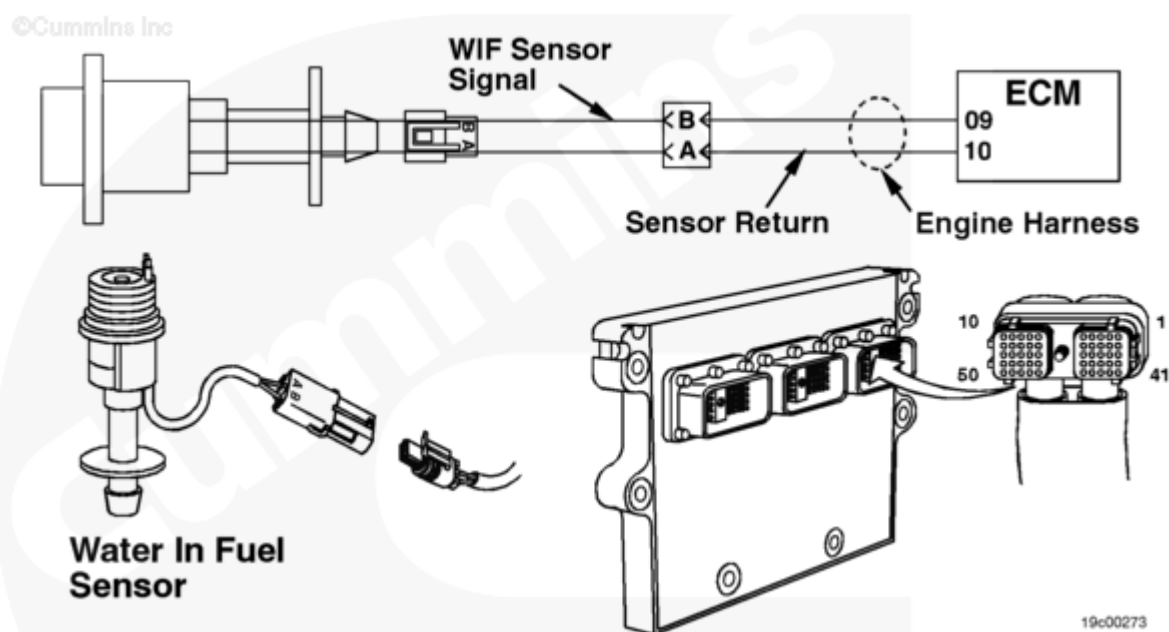
WIF Sensor Circuit

| Codes | Reason | Effect |
|---|---|---|
| Fault Code: 428<br><br>PID(P): P097<br>SPN: 97<br>FMI: 3/3<br>Lamp: Yellow<br>SRT: | High voltage detected at water-in-fuel (WIF) sensor circuit. | None on performance. |

#### Circuit Description

The WIF sensor is attached to the fuel filter. The WIF sensor sends a signal to the electronic control module (ECM) when a set volume of water has accumulated in the fuel filter. The WIF circuit contain two wires: A return ground (pin 10) and a signal wire (pin 9).

Possible causes for this fault code include: Short circuit to a + 5-VDC supply wire.

Refer to Troubleshooting Fault Code t05-428 (</qs3/pubsys2/xml/en/procedures/82/82-t05-428.html>)
