## Fault Code: 429

### Water-In-Fuel (WIF) Sensor Circuit

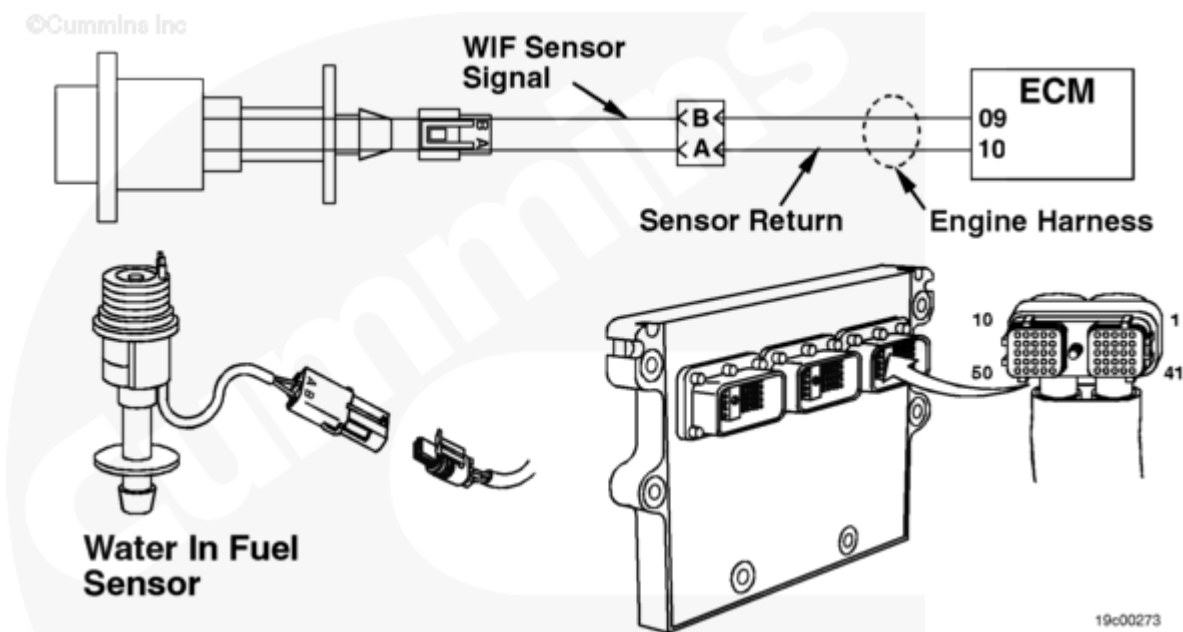
WIF Sensor Circuit

| Codes | Reason | Effect |
|---|---|---|
| Fault Code: 429<br><br>PID(P): P097<br>SPN: 97<br>FMI: 4/4<br>Lamp: Yellow<br>SRT: | Low voltage detected at water-in-fuel (WIF) sensor circuit. | None on performance. |

The WIF sensor is attached to the fuel filter. The WIF sensor sends a signal to the electronic control module (ECM) when a set volume of water has accumulated in the fuel filter. The WIF circuit contains two wires: A return ground (pin 10) and a signal wire (pin 9).

The WIF sensor uses the same internal ECM power supply as sensors on engine harness. If Fault Code 352 is also active, use that troubleshooting logic and tree.
