# Fault Code: 113

## Sleeve Actuator Circuit

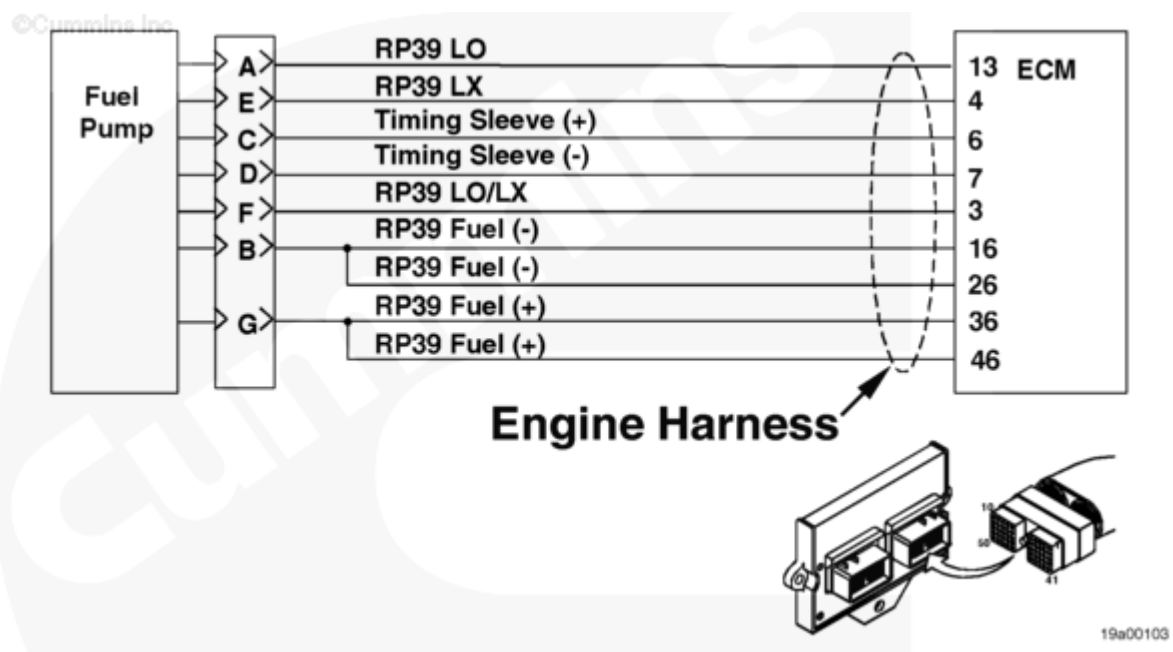
Sleeve Actuator Circuit

The sleeve actuator circuit is used to control the start of injection through pin 6 of the engine harness. The ECM monitors the current on pin 6 and expects to see the amperage vary between 1.0 and 6.2 amps during normal engine operation. Amperage above 6.2 amps on pin 6 will trip Fault Code 113.
