## Fault Code: 122

### Intake Manifold Pressure Sensor Circuit

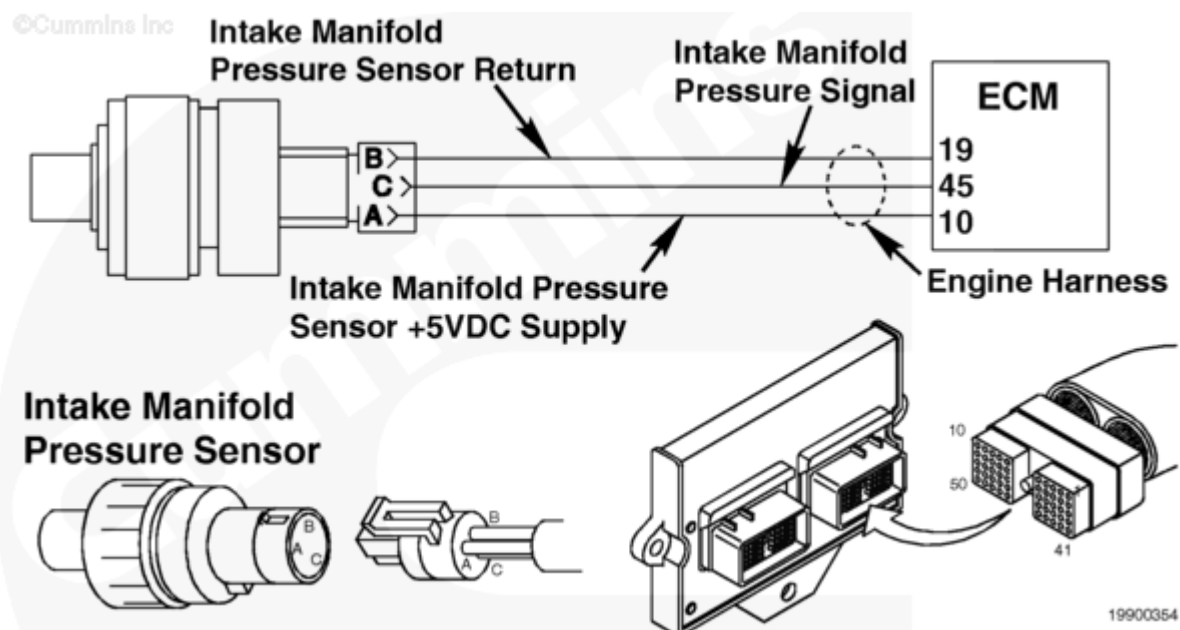
Intake Manifold Pressure Sensor Circuit

The intake manifold pressure sensor monitors boost pressure and passes information to the electronic control module (ECM) through pin 45 of the engine harness. The ECM monitors the voltage on pin 45 and expects to see the voltage vary between 0.5 and 4.5 VDC during normal engine operation. Voltage above 4.72 VDC on pin 45 will trip Fault Code 122.
