## Fault Code: 185

### Primary Electronic Control Module/Secondary Electronic Control Module (ECM) Communication

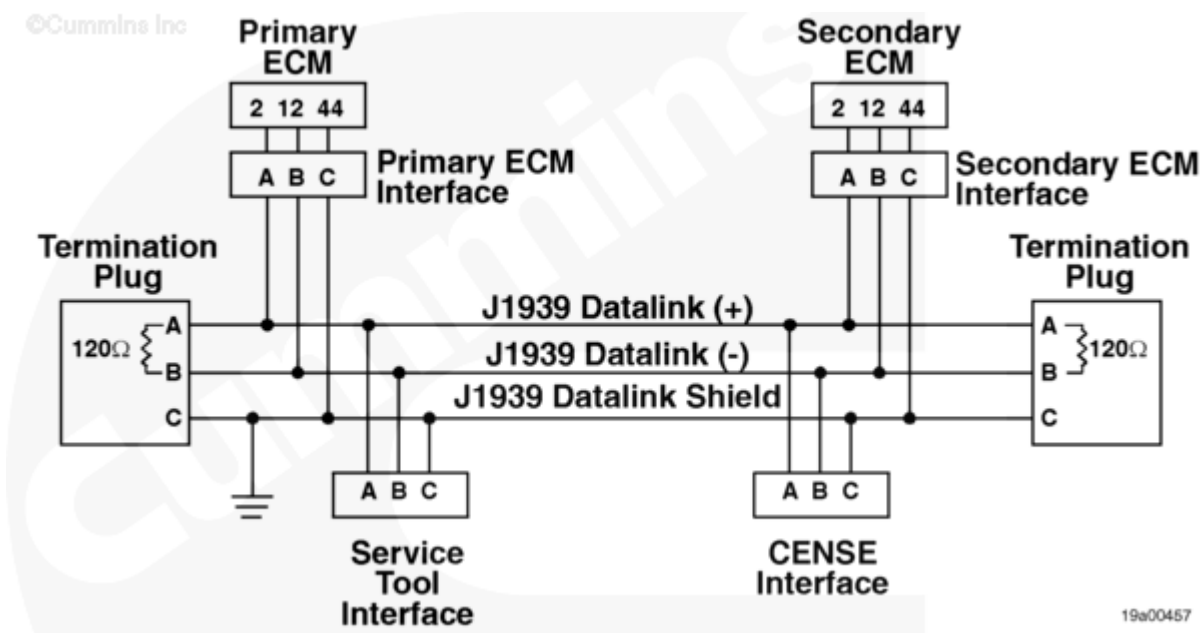
J1939 Backbone Harness Circuit Diagram

| Codes | Reason | Effect |
|---|---|---|
| Fault Code: 185<br><br>PID(P): 231<br>SPN: 639<br>FMI: 2<br>Lamp: Yellow<br>SRT: | Communication between the primary electronic control module (ECM) and secondary ECM has been interrupted. | Engine can <b>only</b> run on the left or right bank. Possible loss of performance. |

The QST30 electronic control system utilizes an SAE J1939 backbone harness for communication between the primary and secondary ECMs. If this backbone fails, communication between the ECMs will stop, causing the engine to run poorly.

Refer to Troubleshooting Fault Code t05-185 (</qs3/pubsys2/xml/en/procedures/87/87-t05-185.html>)
