# Fault Code: 231

## Coolant Pressure Sensor Circuit

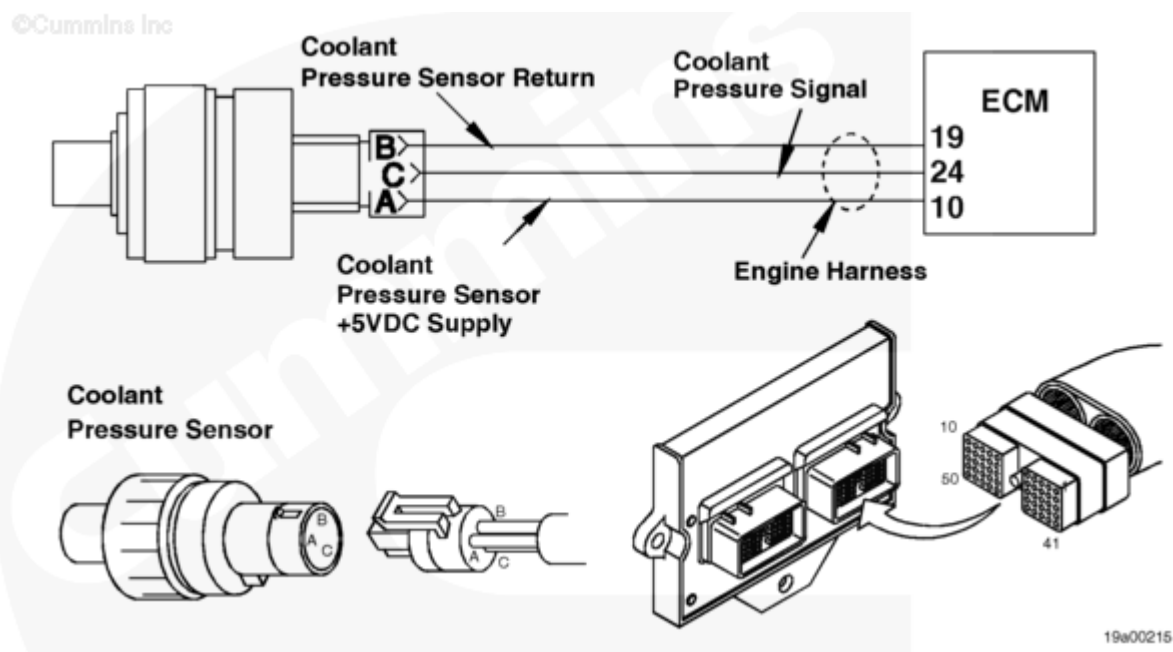
Coolant Pressure Sensor Circuit

| Codes | Reason | Effect |
|---|---|---|
| Fault Code: 231<br><br>PID(P): P109<br>SPN: 109<br>FMI: 3<br>Lamp: Yellow<br>SRT: | More than 4.69 VDC detected at the coolant pressure sensor signal pin 24 of the engine harness. | Engine protection for coolant pressure is disabled. |

The coolant pressure sensor monitors coolant pressure and passes information to the electronic control module (ECM) through pin 24 of the engine harness. The ECM monitors the voltage on pin 24 and expects to see the voltage vary between 0.5 and 4.5 VDC during normal engine operation. Voltage above 4.69 VDC on pin 24 will trip Fault Code 231 and can be caused by short circuits in the supply, signal, or return wires, an open in the return wire, or a failed sensor. Voltage below 0.30 VDC on pin 24 will trip Fault Code 232.

- Confirm that the radiator cap is installed correctly.
- Check the radiator cap for proper operation.
