## Fault Code: 232

### Coolant Pressure Sensor Circuit

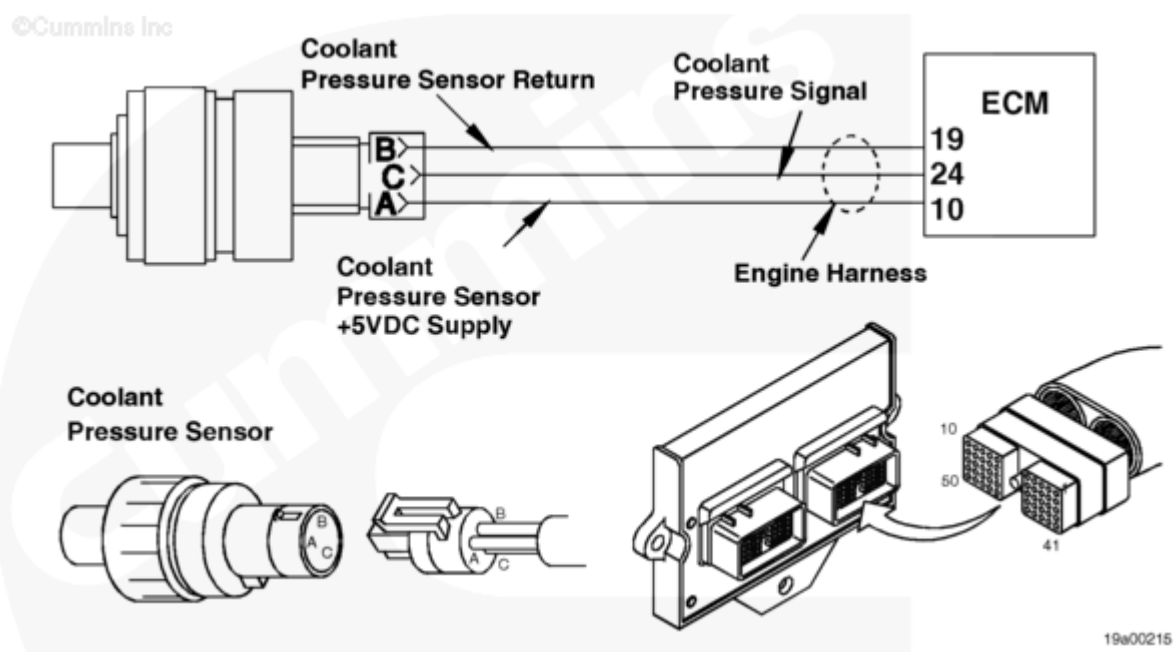
Coolant Pressure Sensor Circuit

| Codes | Reason | Effect |
|---|---|---|
| Fault Code: 232<br><br>PID(P): P102<br>SPN: 102<br>FMI: 4<br>Lamp: Yellow<br>SRT: | Less than 0.30 VDC detected at the coolant pressure sensor signal pin 24 of the engine harness. | Engine protection for coolant pressure is disabled. |

The coolant pressure sensor monitors coolant pressure and passes information to the electronic control module (ECM) through pin 24 of the engine harness. The ECM monitors the voltage on pin 24 and expects to see the voltage vary between 0.5 and 4.5 VDC during normal engine operation. Voltage below 0.30 VDC on pin 24 will result in Fault Code 232.

- Confirm that the radiator cap is installed correctly.
- Check the radiator cap for proper operation.
