# Fault Code: 422

## Coolant Level Sensor Circuit

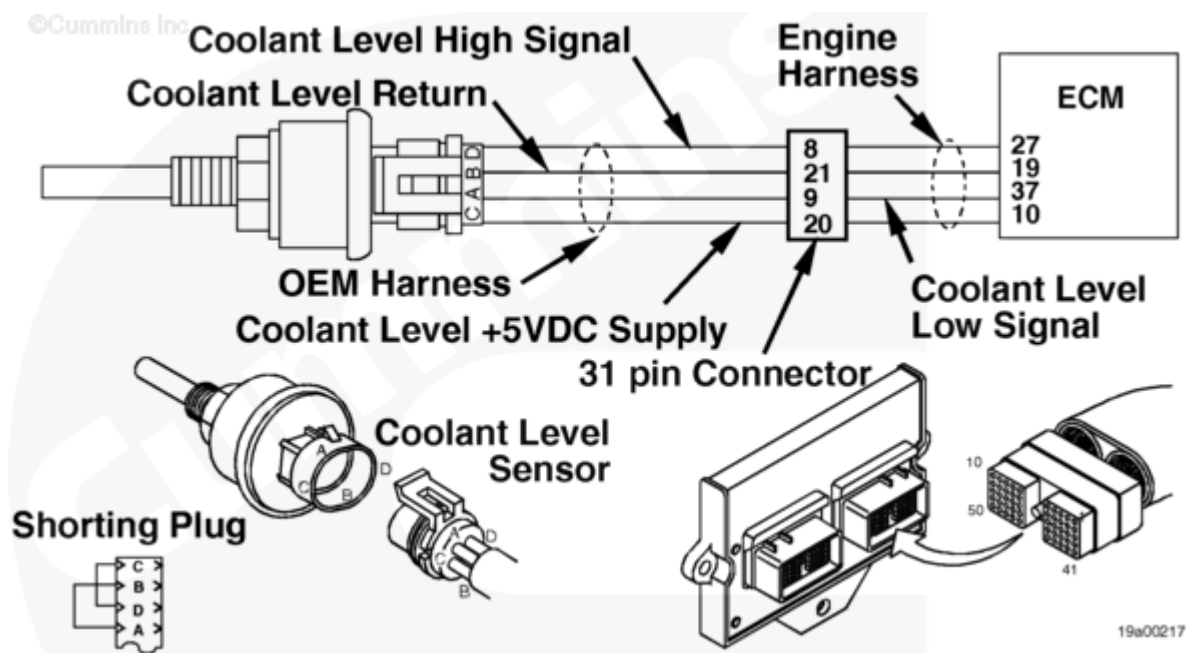
Coolant Level Sensor Circuit

| Codes | Reason | Effect |
|---|---|---|
| Fault Code: 422<br><br>PID(P): P111<br>SPN: 111<br>FMI: 2<br>Lamp: Yellow<br>SRT: | Voltage detected simultaneously on both the coolant level high and low signal pins 27 and 37 of the engine harness, or no voltage detected on either pin. | Engine protection for coolant level is disabled. |

- If a shorting plug is used in the coolant level circuit, verify that it is wired correctly.
- Inspect the wiring harness between the 4-pin Weather-Pack connector and the coolant level sensor for damage.
