## Fault Code: 772

### Left Bank Needle Lift Sensor Reading Is Not Being Detected or Is Out of Range.

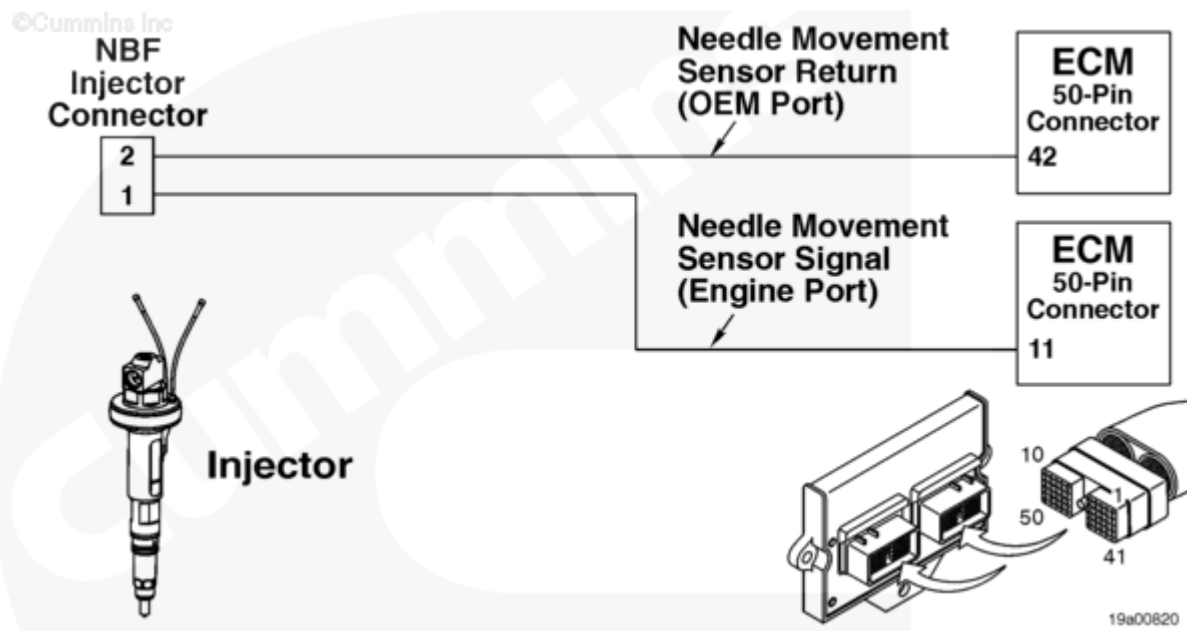
| Codes | Reason | Effect |
|---|---|---|
| Fault Code: 772<br><br>PID(P): S118<br>SPN: 1657<br>FMI: 11<br>Lamp: None<br>SRT: | Left Bank Needle Lift Sensor Reading Is <b>Not</b> Being Detected or Is Out of Range. | No action is taken by the engine control module. Power output can be low and engine can produce white smoke. |

The needle lift sensor is used to sense the start of injection. The engine control module (ECM) monitors the pulses from the sensor to determine when injection occurs in the cycle. The ECM monitors the pulses on pin 11.

The needle lift sensor is an integral part of the NBF injectors (number 1 left bank and number 1 right bank injectors).

A common cause of a needle lift sensor fault is a loose connection.

The fault code will **not** become active at engine speed less than 800 RPM.

If the engine is showing either Fault Code 772 or 773 (but **not** both), then exchange the needle lift injector from the left bank number 1 with the right bank number 1 and see if the fault code follows the damaged injector.
