## Fault Code: 773

### Right Bank Needle Lift Sensor Reading Is Not Being Detected or Is Out of Range.

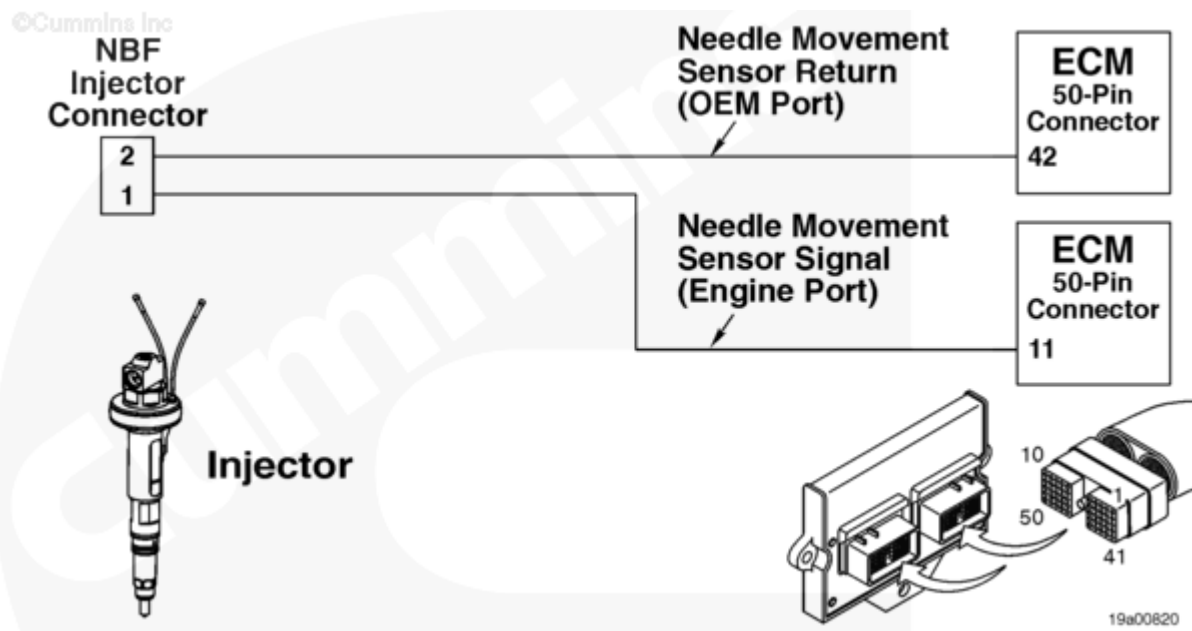
| Codes | Reason | Effect |
|---|---|---|
| Fault Code: 773<br><br>PID(P): S118<br>SPN:<br>FMI: 11<br>Lamp: None<br>SRT: | Right Bank Needle Lift Sensor Reading Is <b>Not</b> Being Detected or Is Out of Range. | No action is taken by the engine control module. Power output can be low and engine can produce white smoke. |

The needle lift sensor is used to sense the start of injection. The engine control module (ECM) monitors the pulses from the sensor to determine when injection occurs in the cycle. The ECM monitors the pulses on pin 11.

A common cause of a damaged needle lift sensor is a loose connection.

If the engine is showing either Fault Code 772 or 773 (but **not** both), then exchange the needle lift injectors from left bank Number 1 with right bank number 1 and see if the fault code follows the damaged injector.
