Service Bulletin Number: 4021468

Articulated Piston Skirt Reuse Guidelines for Signature, ISX, and QSX15 Engines

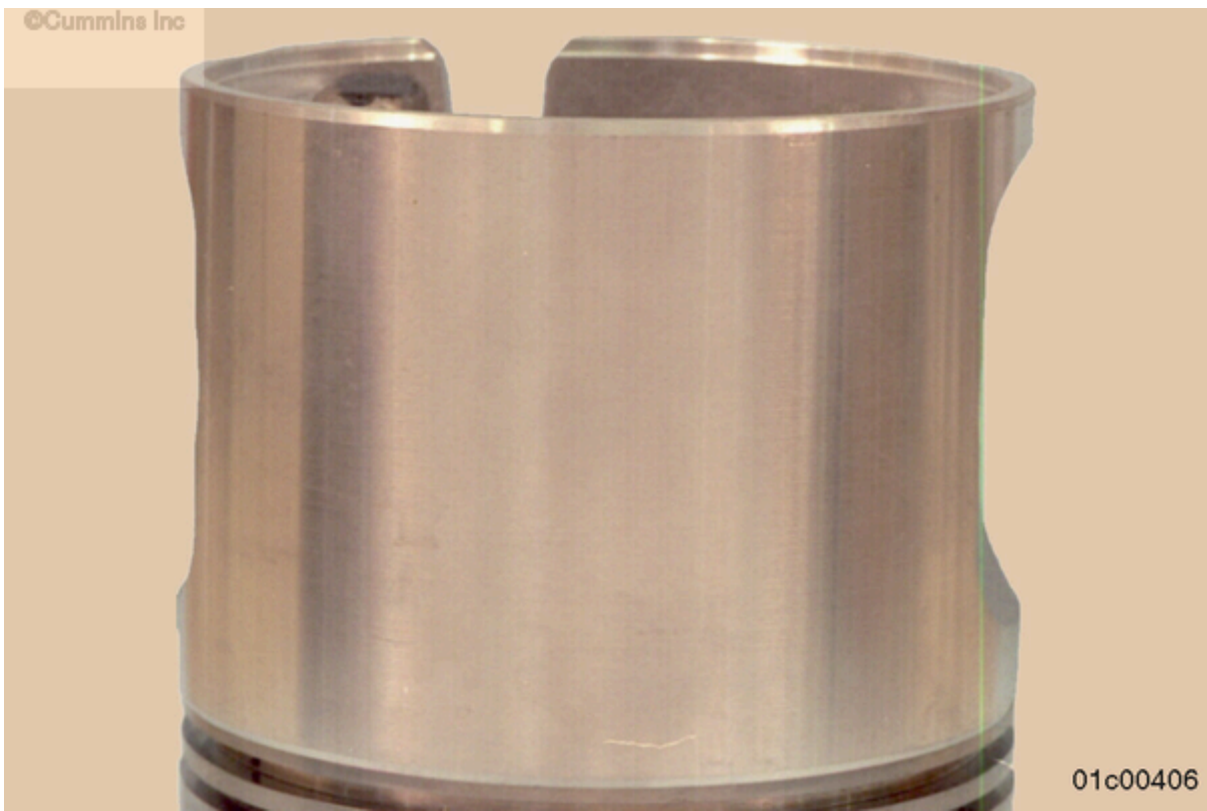
01c00406

The digital photographs on this page depict piston skirts that are acceptable for reuse. The scratches are **not** deep and can **not** be felt with a fingernail.

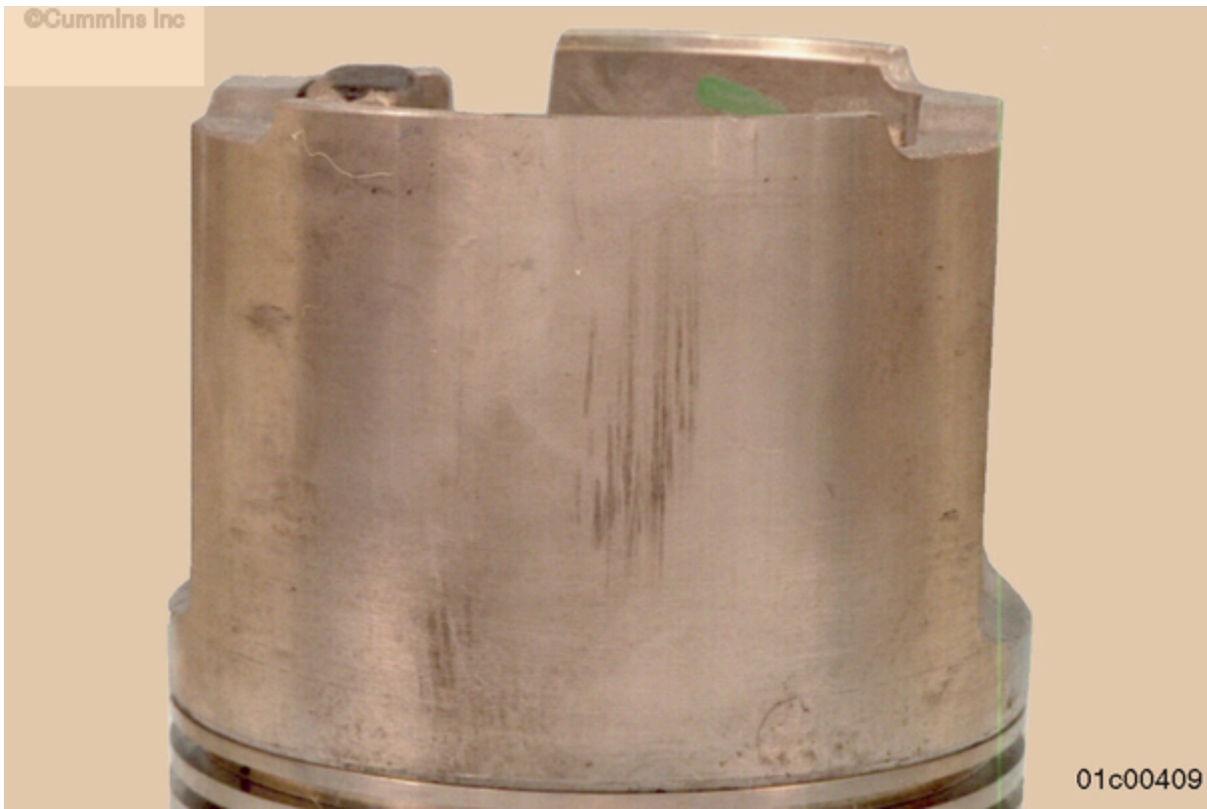
01c00409

The six digital photographs below depict piston skirts that are **not** acceptable for reuse. The scratches are deep enough to be felt with a fingernail.
