**Service Bulletin Number:** 4021925

**Single Piece, Open Skirt Piston Reuse Guidelines**

This Service Bulletin applies inspection criteria for single piece, open skirt pistons in Signature™, ISX, QSX15, ISX11.9 CM2250, ISX15 CM2250 ECF, QSX11.9 CM2250 ECF, PowerGen QSX15 CM2250, PowerGen QSX15 CM2250 ECF, QSX15 CM2350 X105, and QSX15 CM2350 X106 engines. Cummins Inc. distributors and dealers are encouraged to consult these guidelines when seeking to determine if used single piece, open skirt pistons are acceptable for reuse.

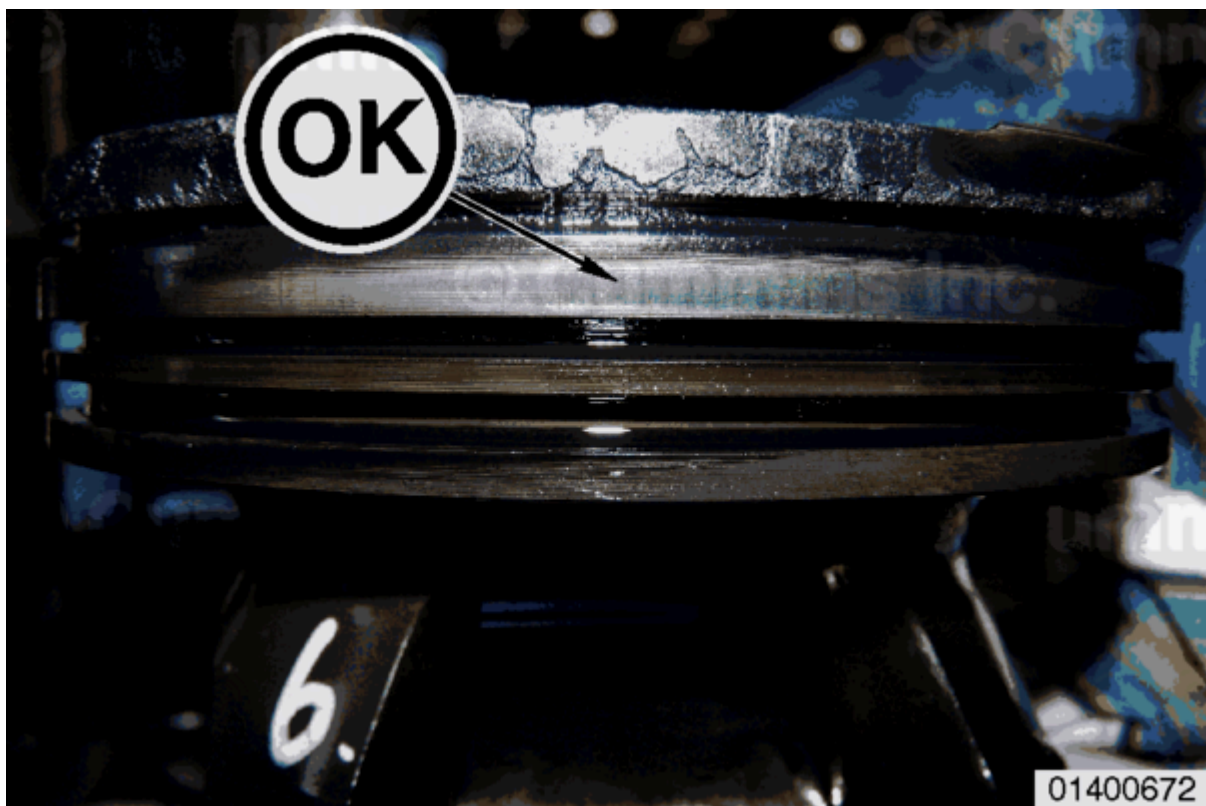
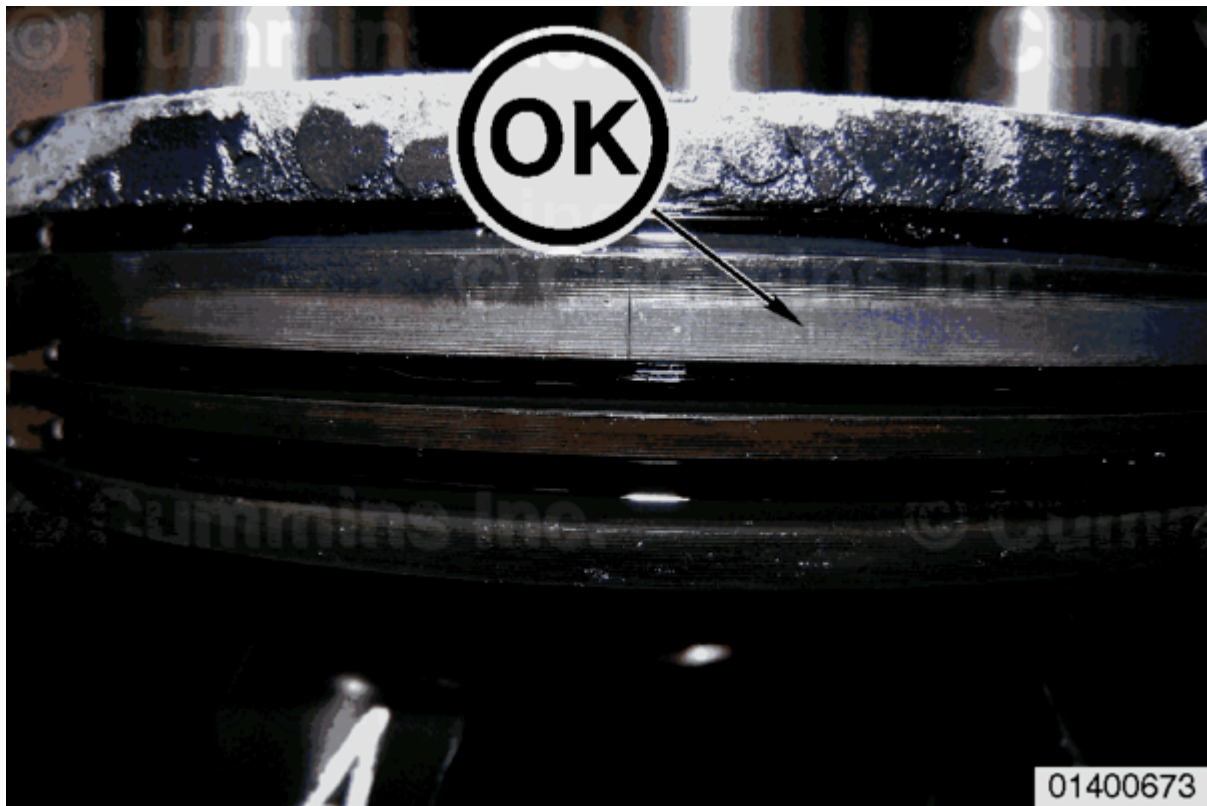
The photographs below illustrate the reuse guidelines for second land wear. The first two illustrations display second land polish and are OK for reuse.

Second land polish

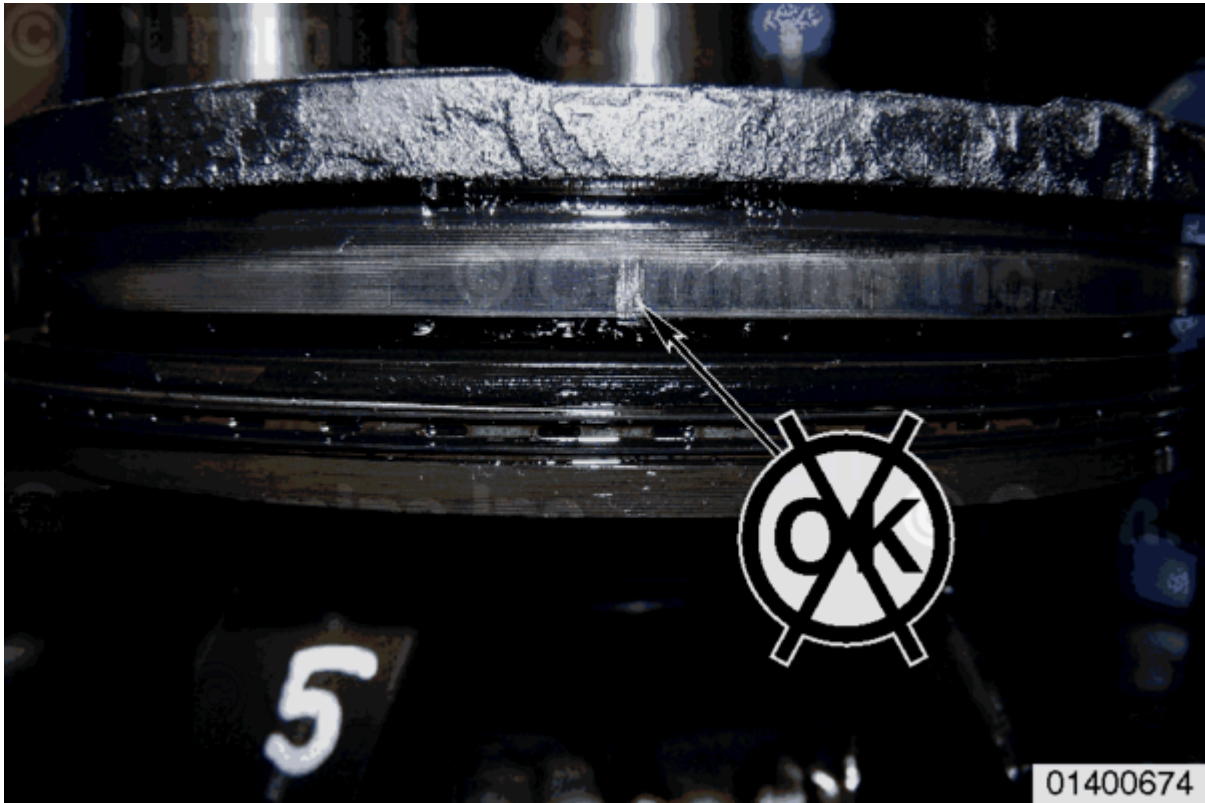
The following three photographs illustrate pistons that are **not** acceptable for reuse. These pistons have second land scuffing. This is visible by the presence of vertical scratches.

Light scuffing of second land

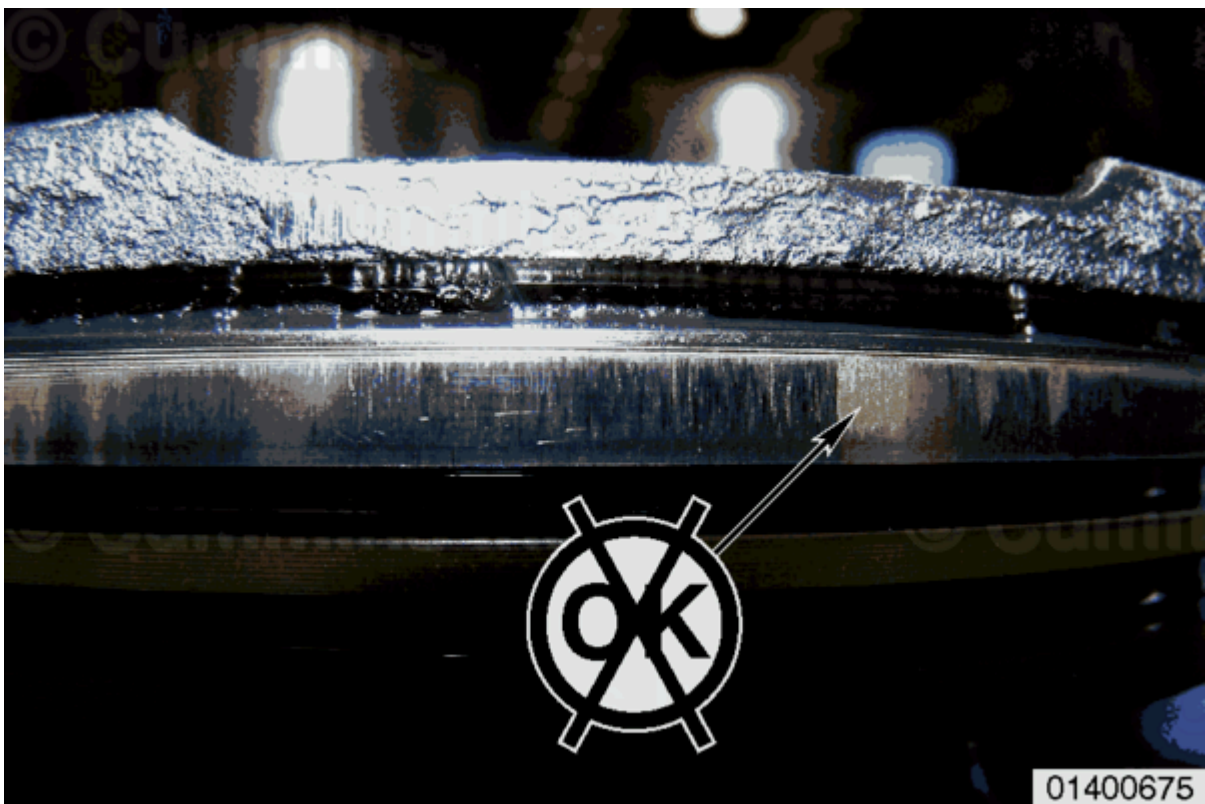
Moderate scuffing of second land

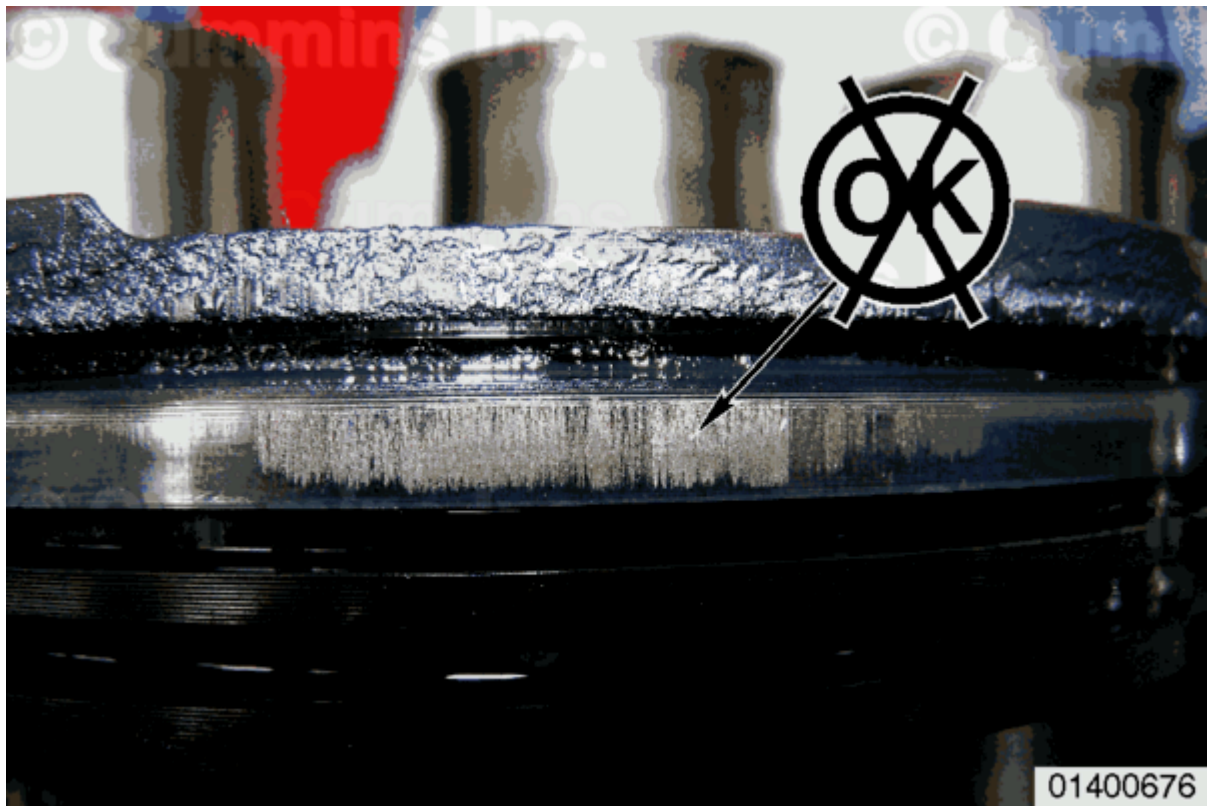
Heavy scuffing of second land

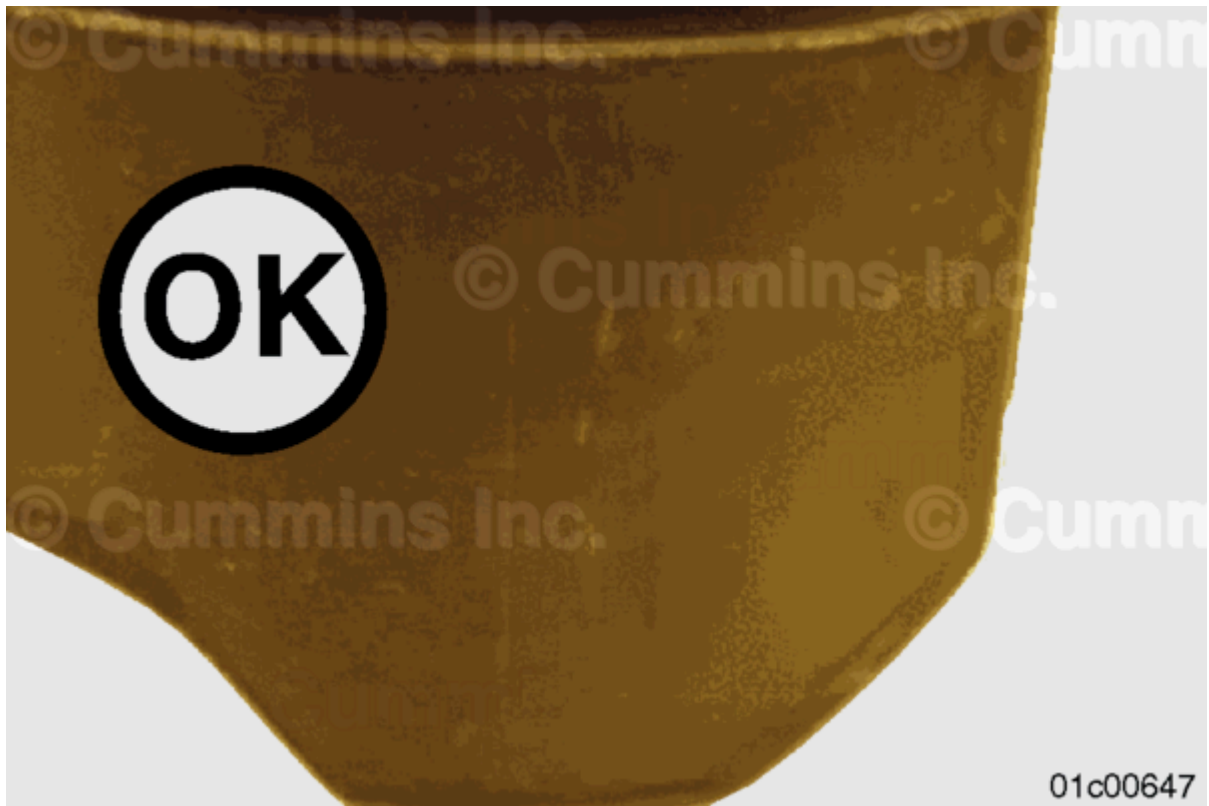
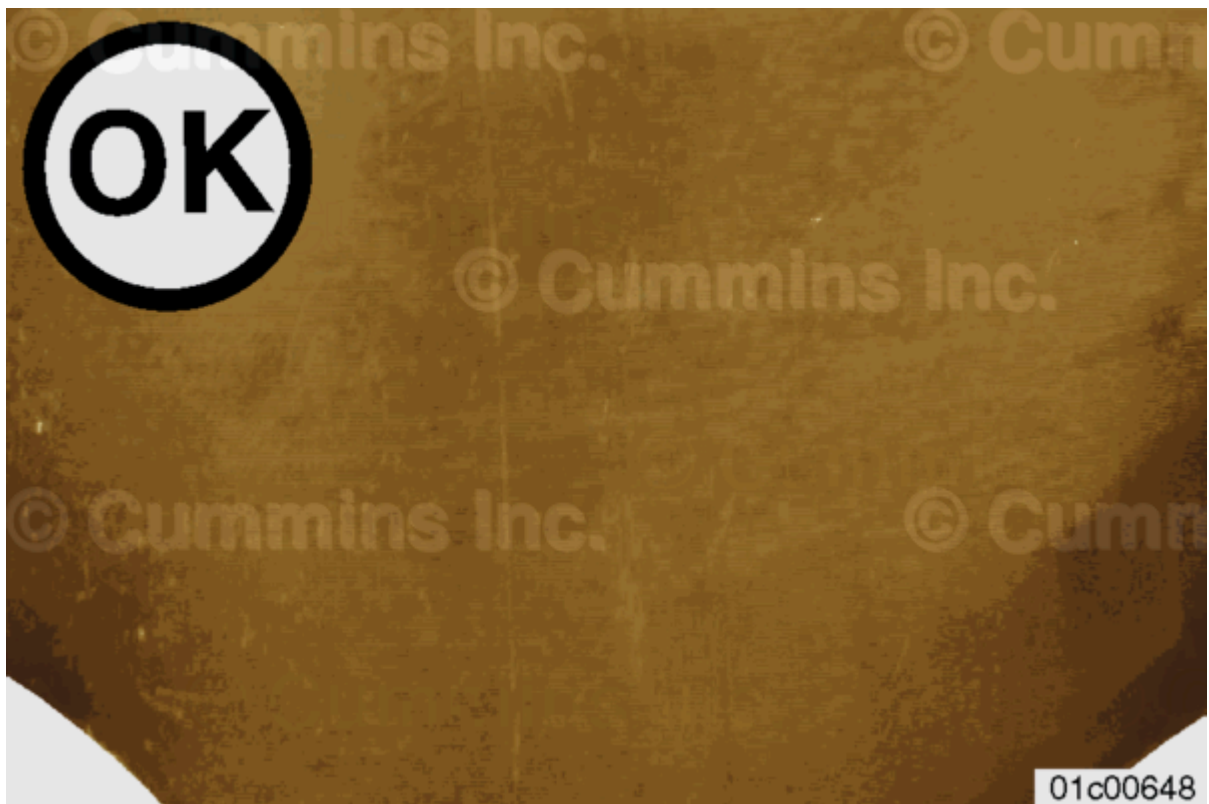
The following photographs illustrate the reuse guidelines for piston skirt wear. The first two photographs display light piston skirt scratching and are OK for reuse.

Light skirt scratching

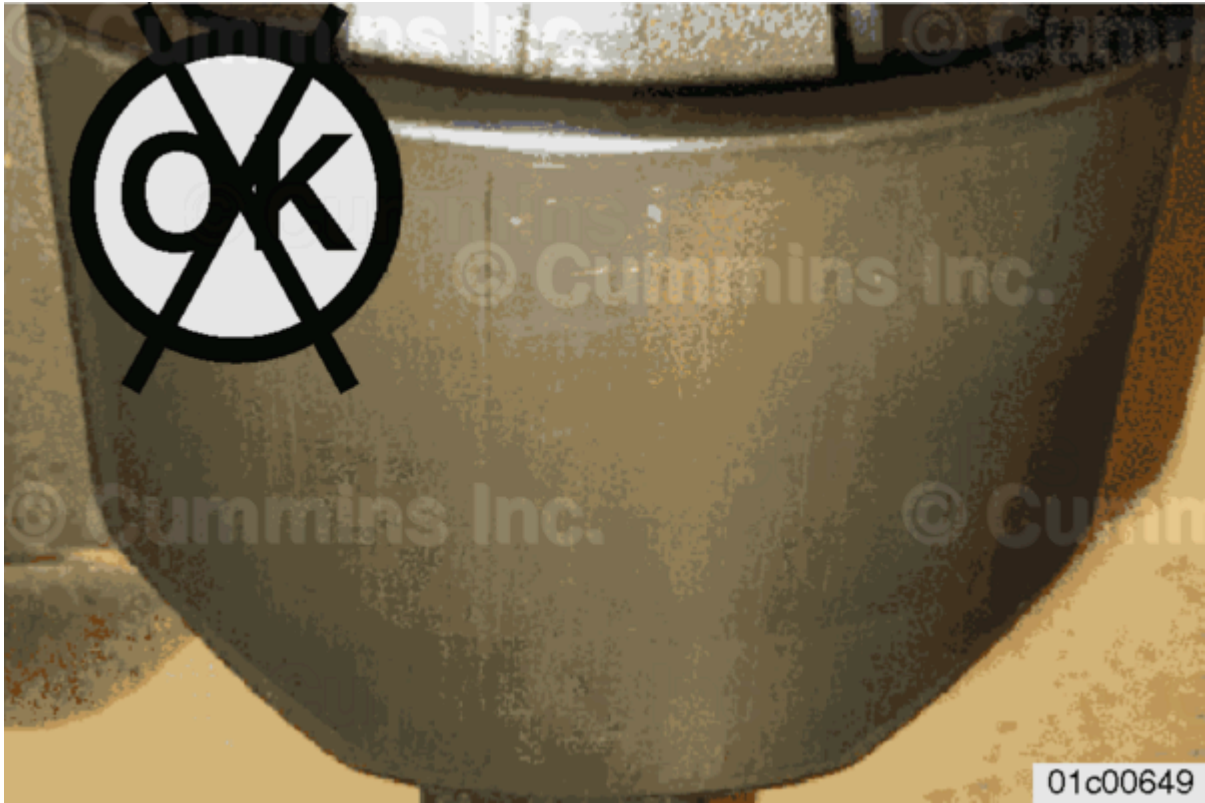
The following three photographs below illustrate piston skirts which are **not** acceptable for reuse. These pistons have skirt scuffing that is apparent by the presence of heavy vertical scratching. In general, if these scratches can be felt with a fingernail, the piston should be replaced.

Heavy scratching of piston skirt

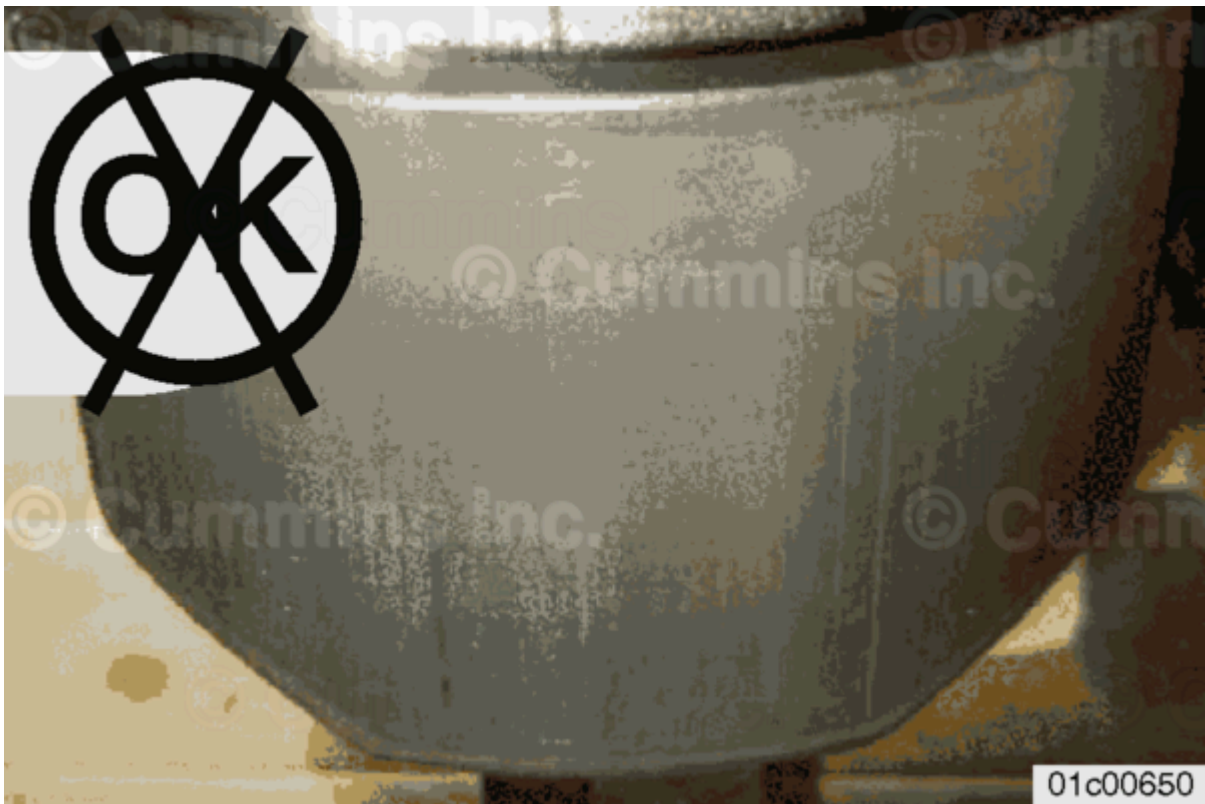
Heavy scratching of piston skirt

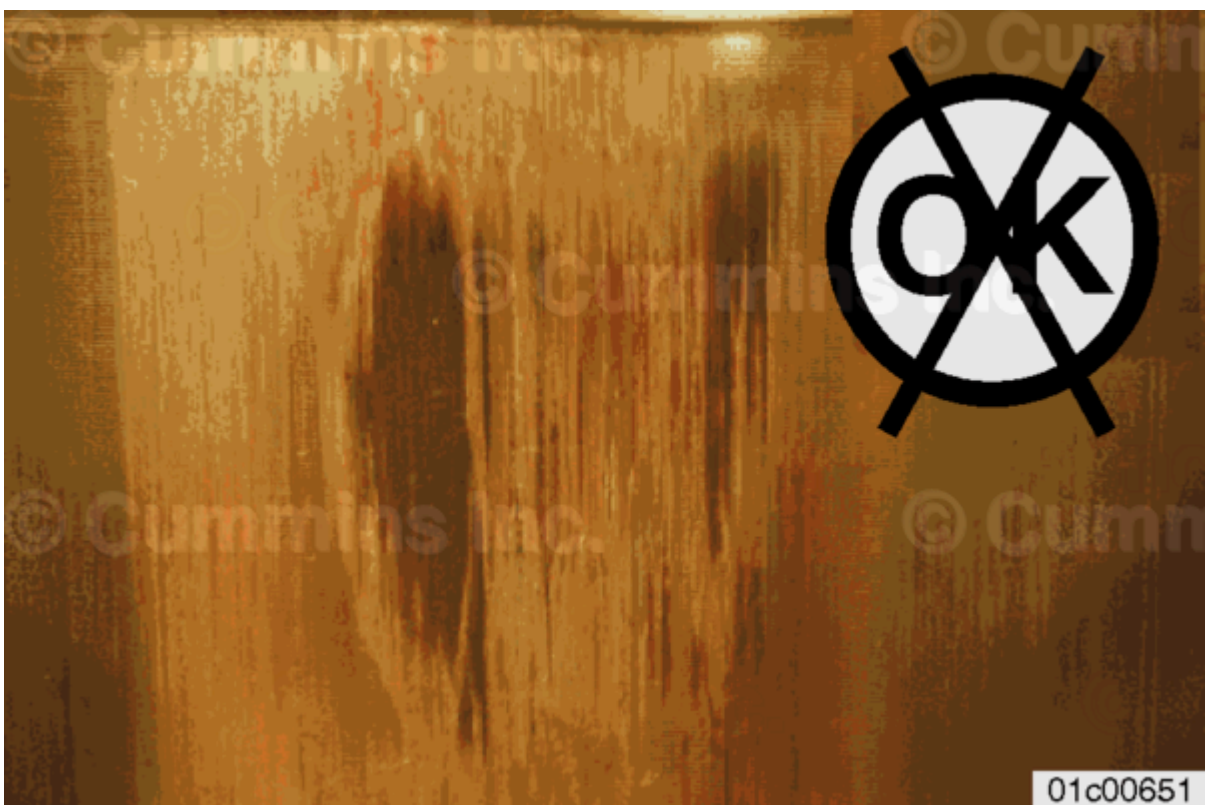
Heavy scuffing of piston skirt
