Service Bulletin Number: 4383630

Ignition Coil Malfunctions

This document provides guidelines for the reuse and replacement of ignition coils. Use this information in conjunction with the content provided in the corresponding service manual.

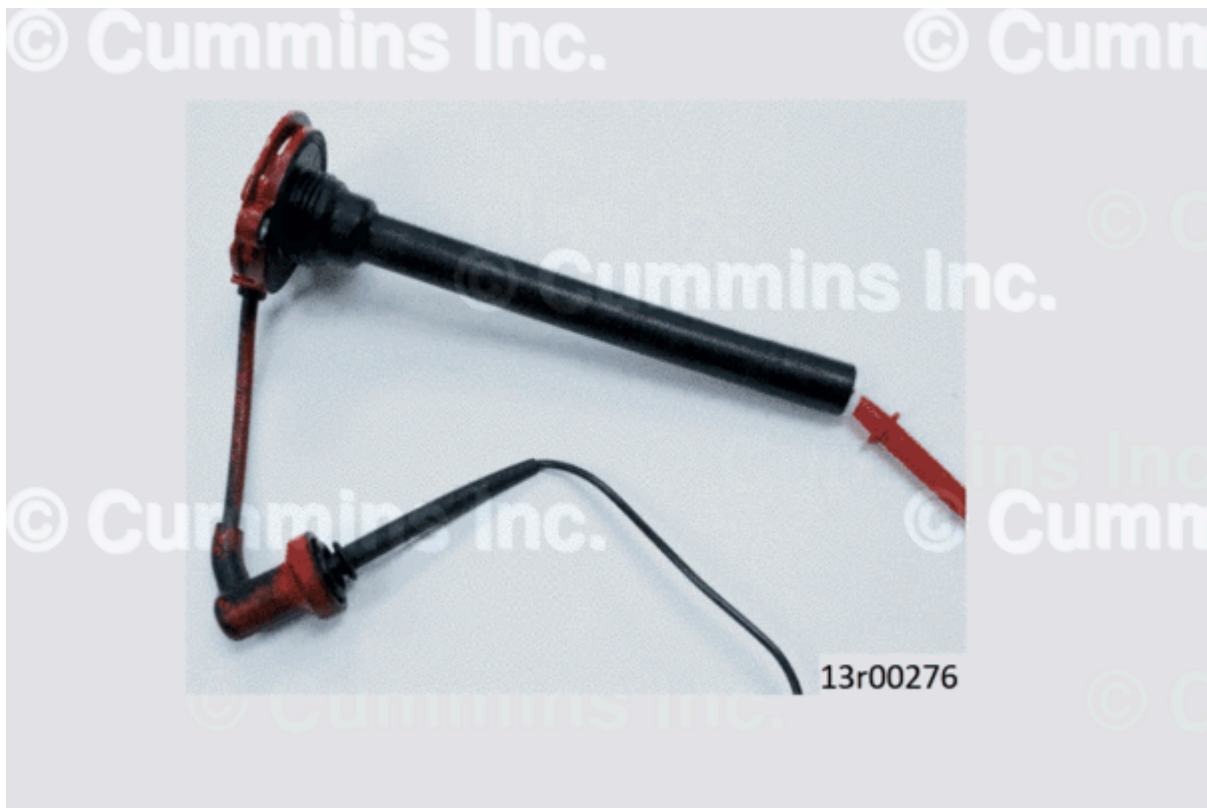
Figure 7.

**Figure 7, High or Erratic Spark Plug Wire Resistance**

| Appearance | No visual indications. Measure the resistance of the ignition coil extension when detached from the ignition coil. |
| Cause | Loose, damaged, or corroded internal connection. |

| Action | If resistance is not within 1300 to 2200 ohms, replace spark plug wire. |

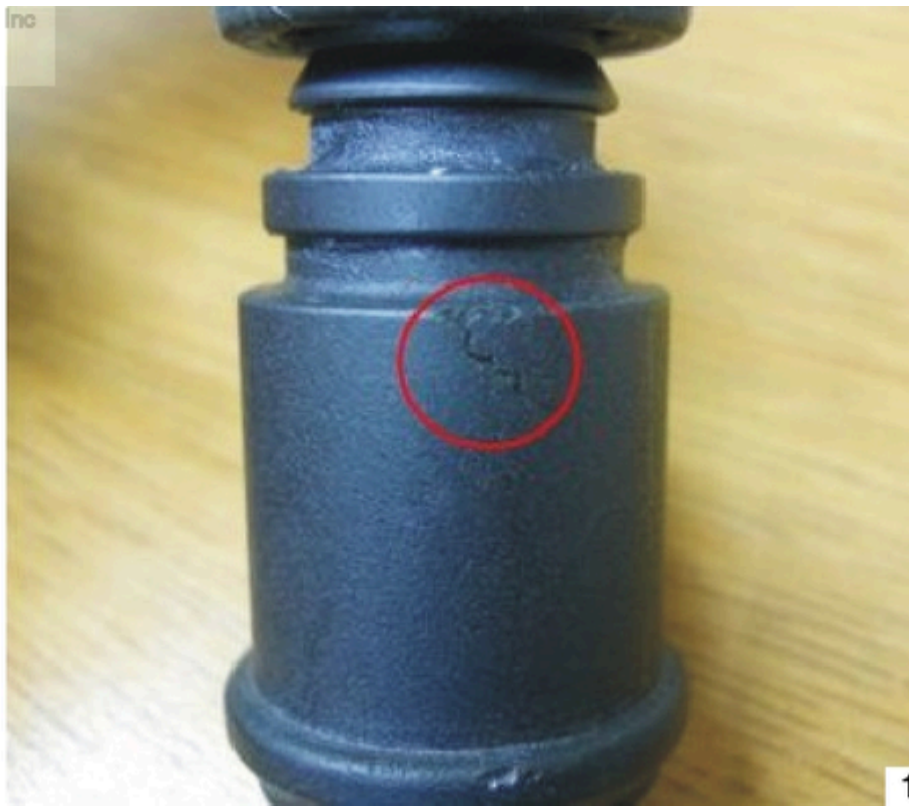
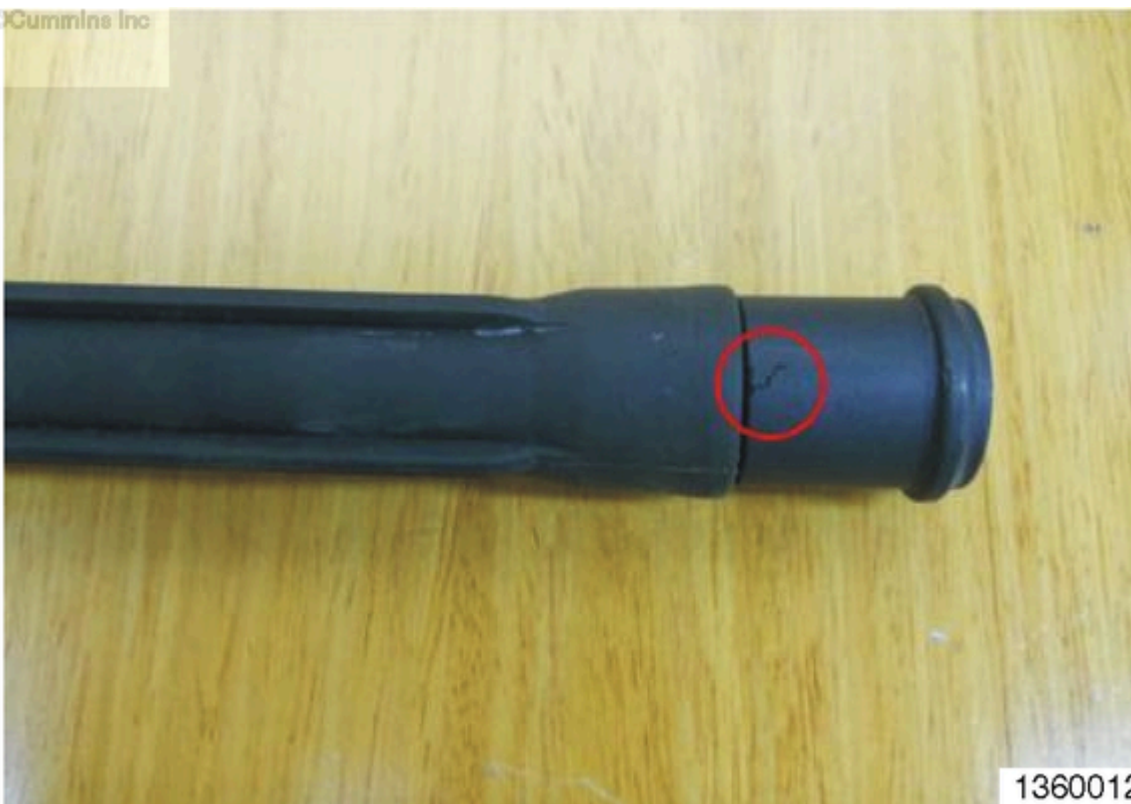
**Figure 8 and 9, Arcing Along Inner Circumference of Ignition Coil Extension**

| Appearance | Etched through the spark plug boot adapter |
| Cause | Arcing through or inside the boot adapter |

| Action | Replace ignition coil extension. |

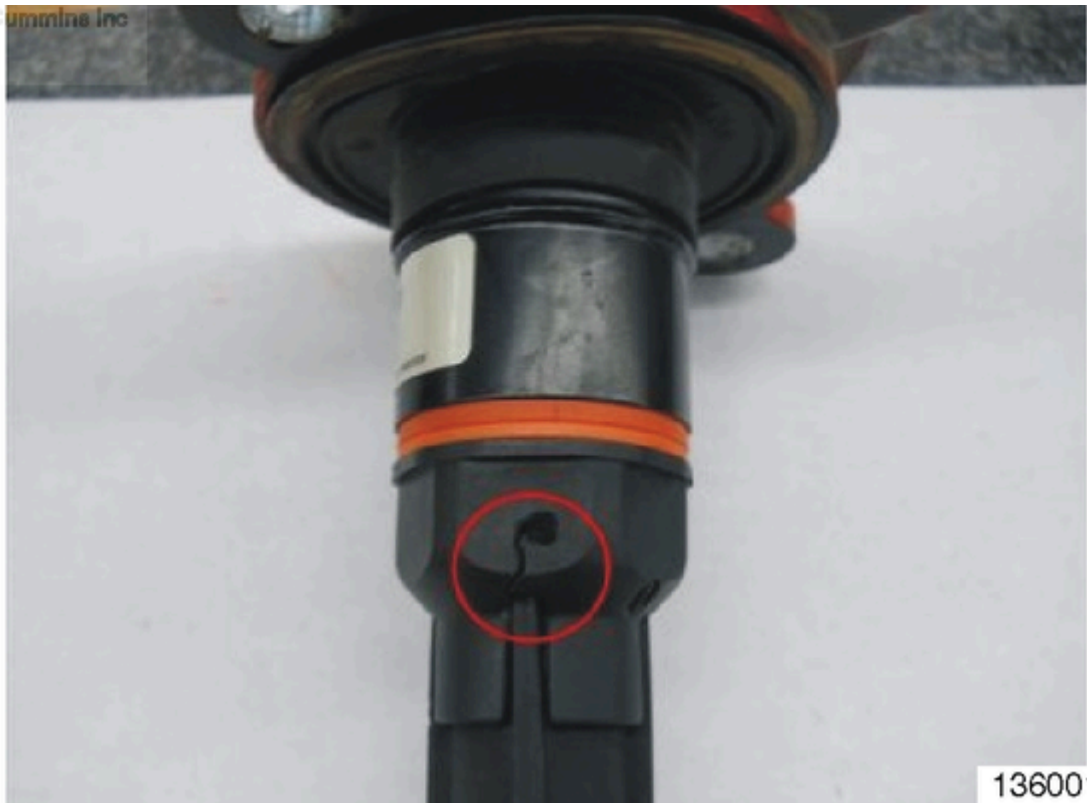
Figure 10.

| Figure 10, Arcing Between Ignition Coil Extension and Coil Adapter | |
| Appearance | Etched through coil nut |
| Cause | Ignition coil extension undertightened, low dielectric seal |

| Figure 10, Arcing Between Ignition Coil Extension and Coil Adapter | |
|---|---|
| Action | Replace ignition coil. Properly tighten ignition coil extension. |

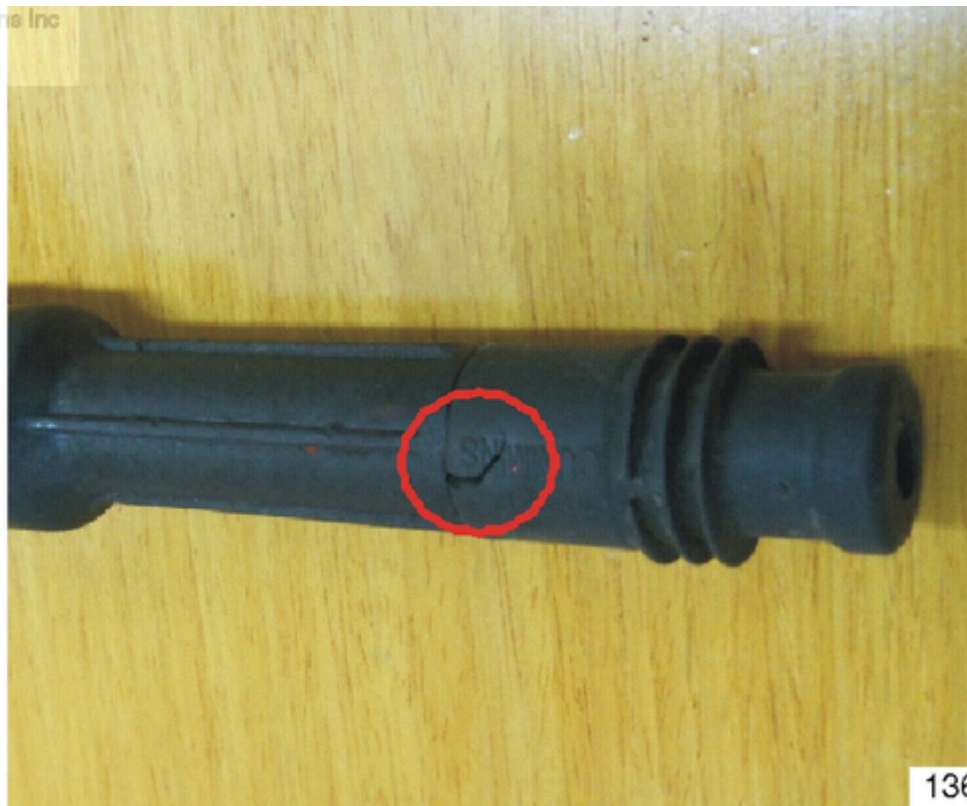
Figure 12.

**Figure 12, Torn Spark Plug Boot**

| Appearance | Tear in the spark plug boot |
| Cause | Mishandling when attempting to remove the spark plug boot from the ignition coil extension. |

| Action | Replace spark plug kit. Twist, bend, and pull when removing spark plug boot from spark plug. |

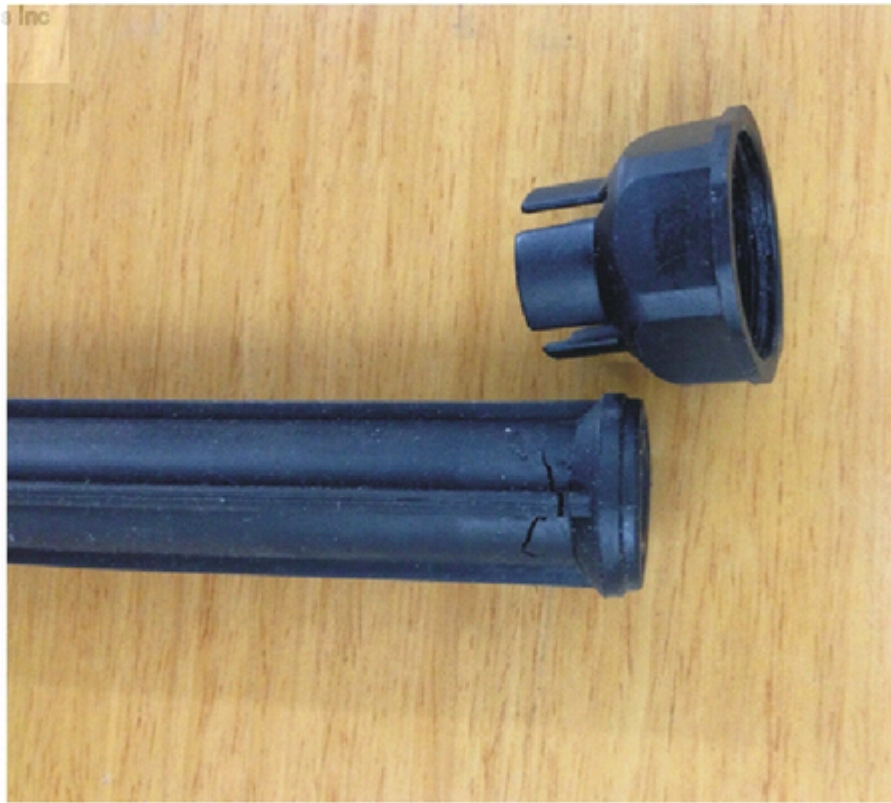
Figure 13

**Figure 13, Ignition Coil Extension Damaged and Pulled Out of Ignition Coil Adapter**

| Appearance | Separated coil nut and ignition coil extension tube |
| Cause | Spark plug boot stuck on spark plug, requiring excessive force to remove coil |

| Action | Replace ignition coil extension. |

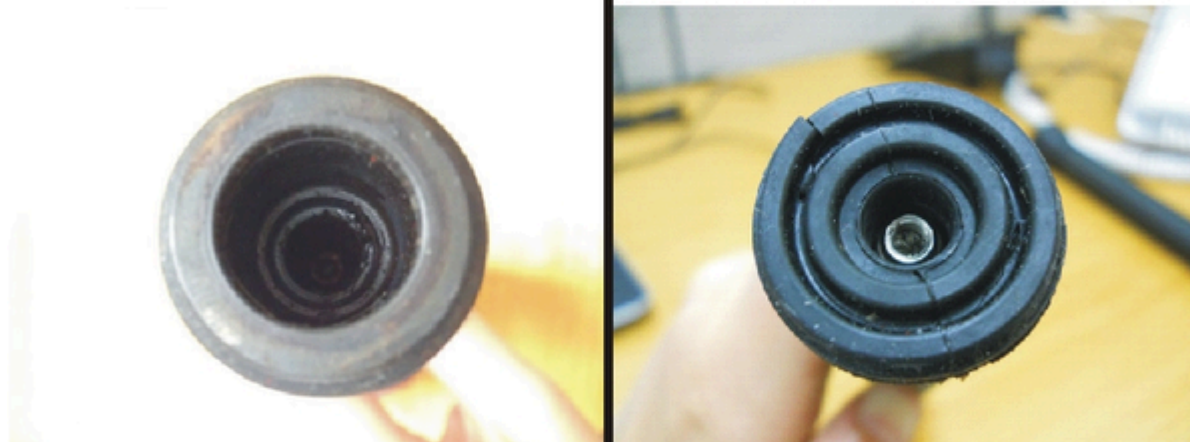
Left: Figure 14. Right: Figure 15.

**Figure 14 and 15, Missing Spring**

| Appearance | Spring is <b>not</b> present; Figure 14 - Bottom view, Figure 15 - Top view |
| Cause | Mishandling, spring lost during service |

| Action | Replace ignition coil extension. Do <b>not</b> attempt to reinstall a spring into the coil ignition coil extension. |

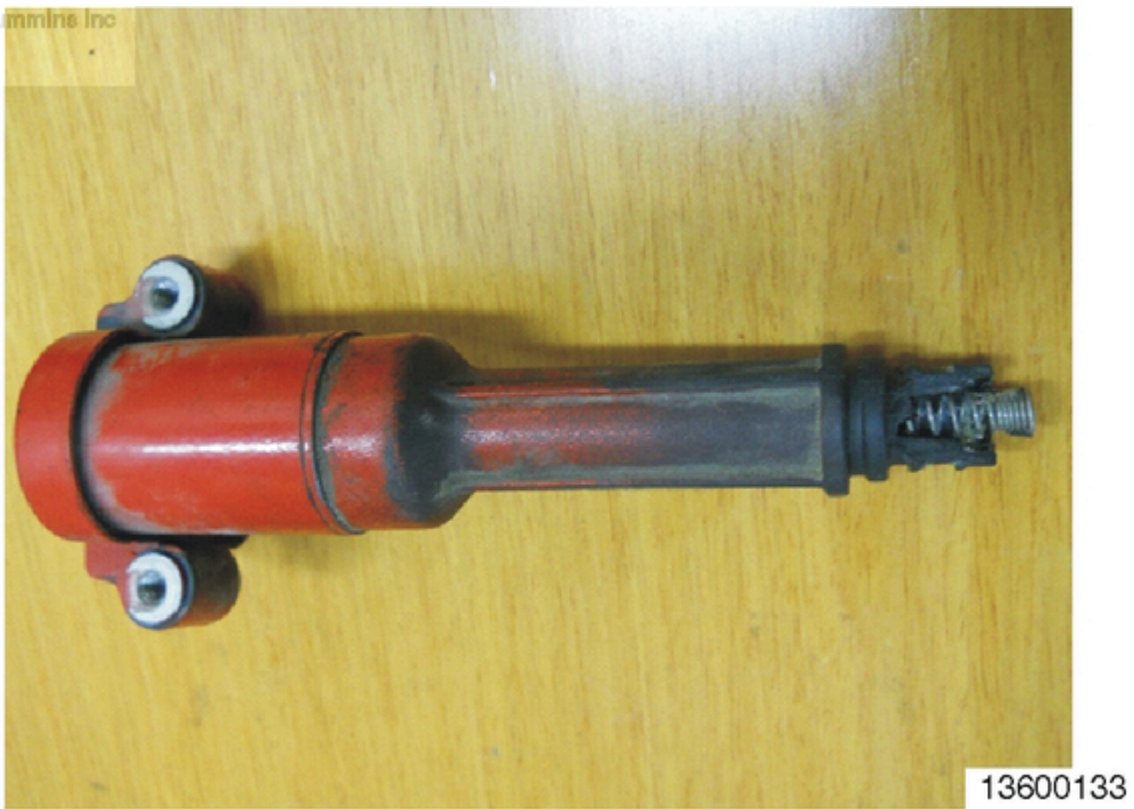
Figure 16.

**Figure 16, Broken Ignition Coil Extension**

| Appearance | Ignition coil extension cracked or broken |
| Cause | Ignition coils removed while installed on coil bracket |

| Action | Replace ignition coil extension. Remove ignition coils individually. Position to the top of the bracket slots during assembly. |

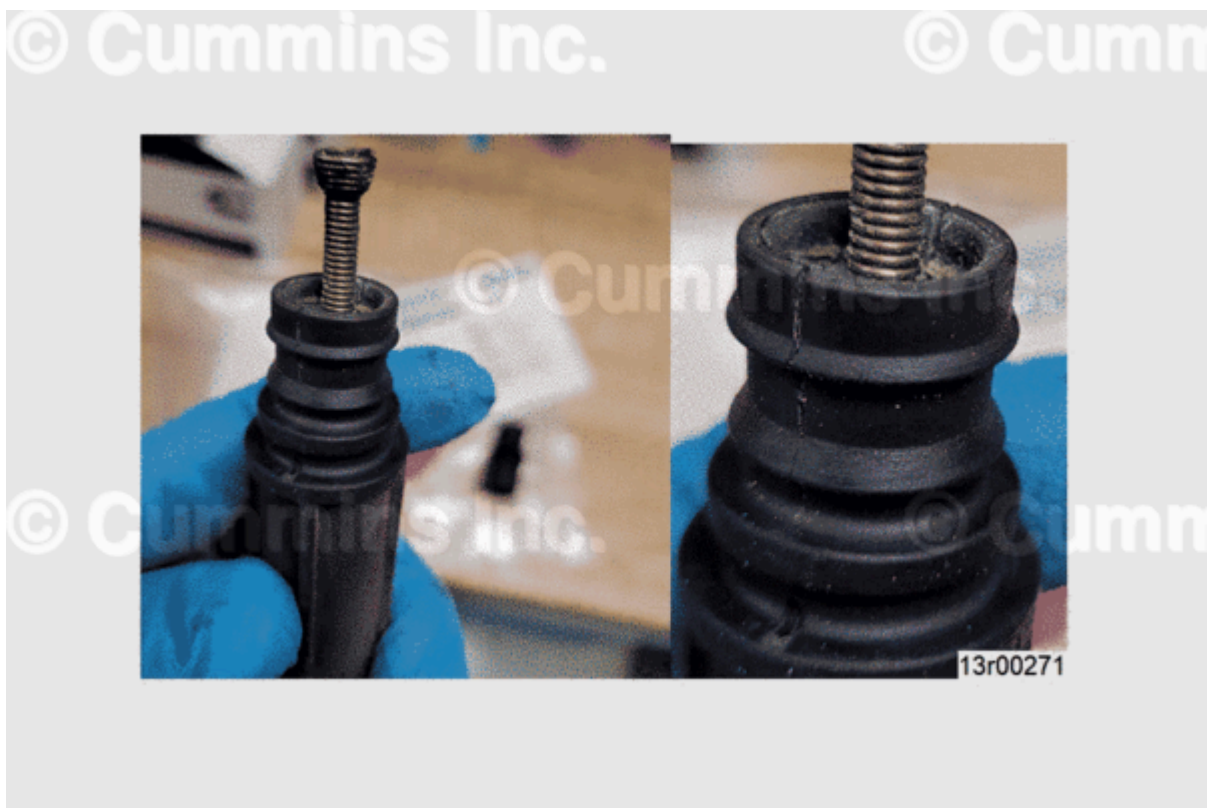
Figure 17.

**Figure 17, Cracked Ignition Coil Extension**

| Appearance | Ignition coil extension cracked or broken |
| Cause | Quality defect accelerated by mishandling, improper ignition coil installation, improper ignition coil bracket installation.<br>Crack along casting weld line(s) on ignition coil extension, Figure 17 shows two cracks 180 degrees across from each other. |

| Action | Replace ignition coil extension. Remove ignition coils individually. Position coil to the top of the bracket slots during reassembly. |

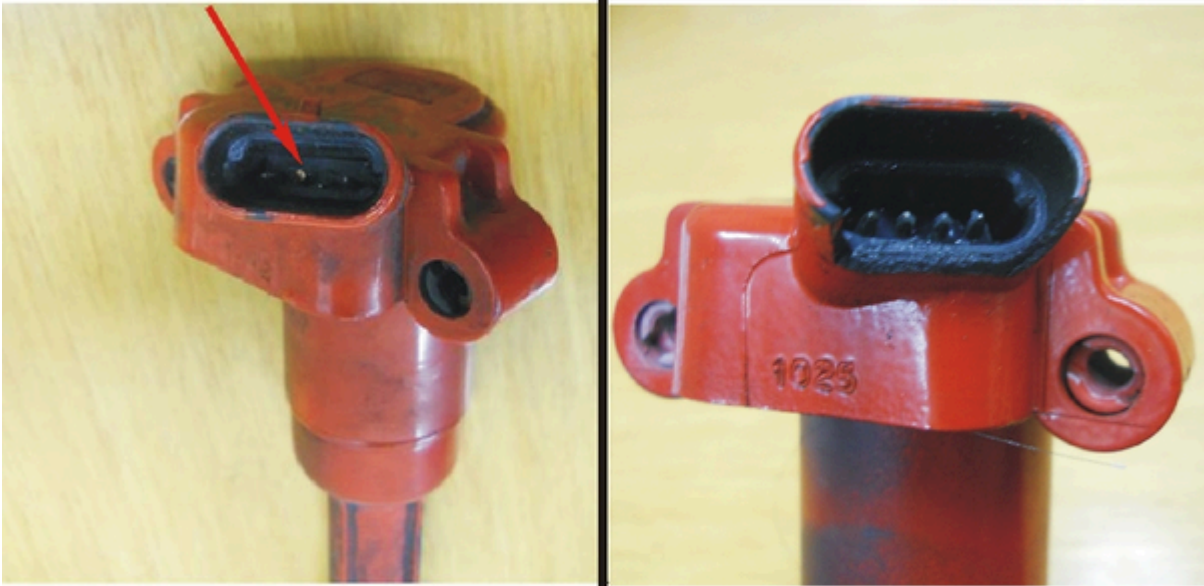
Figure 18.

| Figure 18, Broken Connector or Connector Pins | |
| Appearance | Damaged connector pins or connector housing |
| Cause | Mishandling or improper removal |

| Figure 18, Broken Connector or Connector Pins | |
|---|---|
| Action | Replace ignition coil. |

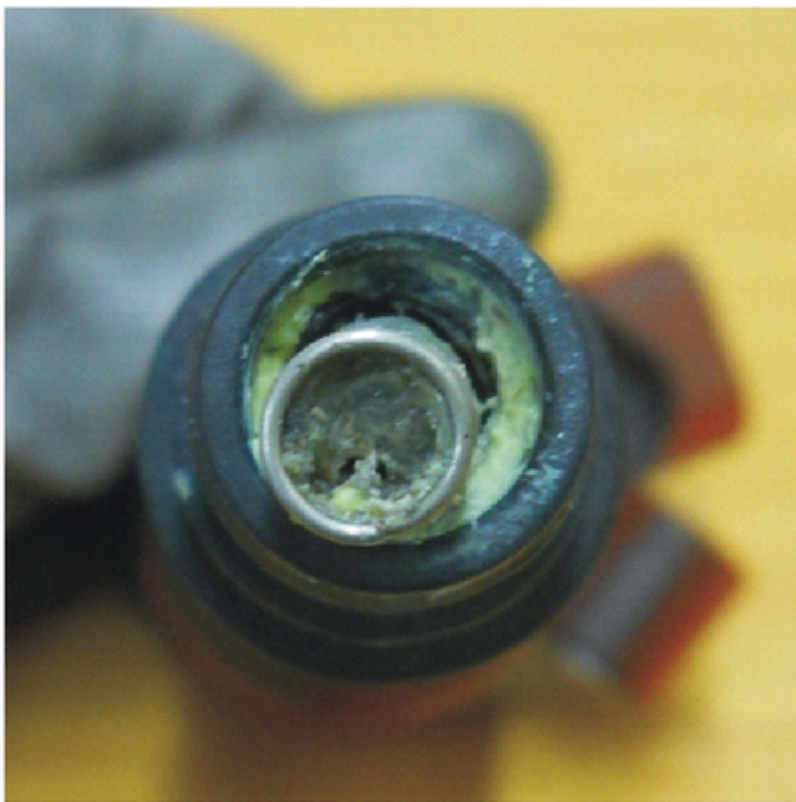
Figure 19.

**Figure 19, Excessive Dielectric Grease**

| Appearance | Excessive amount of dielectric grease around boot and spring |
| Cause | Incorrect application of dielectric grease, grease buildup in spark plug boot |

| Action | Remove grease deposits and reuse. New boots do <b>not</b> require any grease to be added. |

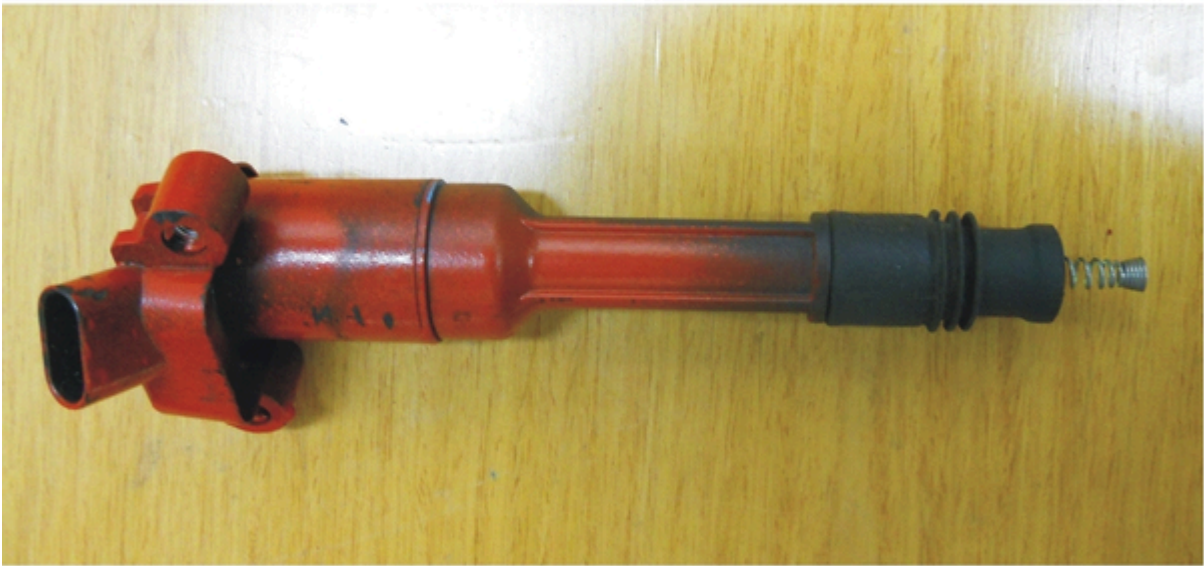
Figure 20.

| Figure 20, Spring Pulled Out | |
| Appearance | Spring protruding from spark plug boot |
| Cause | Spring stuck on spark plug during removal |

| Figure 20, Spring Pulled Out | |
|---|---|
| Action | Replace ignition coil extension. |

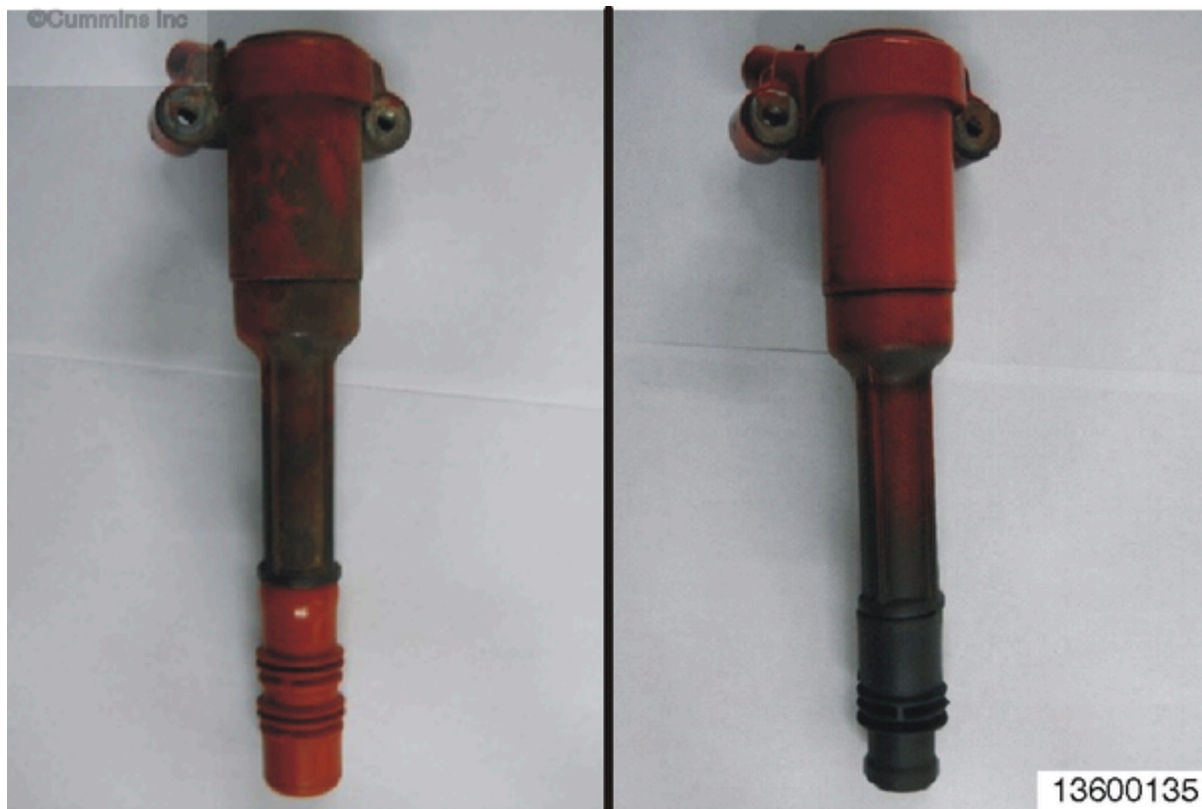
Left: Figure 21. Right: Figure 22.

**Figure 21 and 22, Wrong Spark Plug Boot - ISL G**

| Appearance | Larger, orange spark plug boot; Figure 21 - Wrong spark plug boot, Figure 22 - Correct boot for ISL G |
| Cause | Spark plug kit ordered for C Gas engine |

| Action | Replace with spark plug kit for ISL G. |

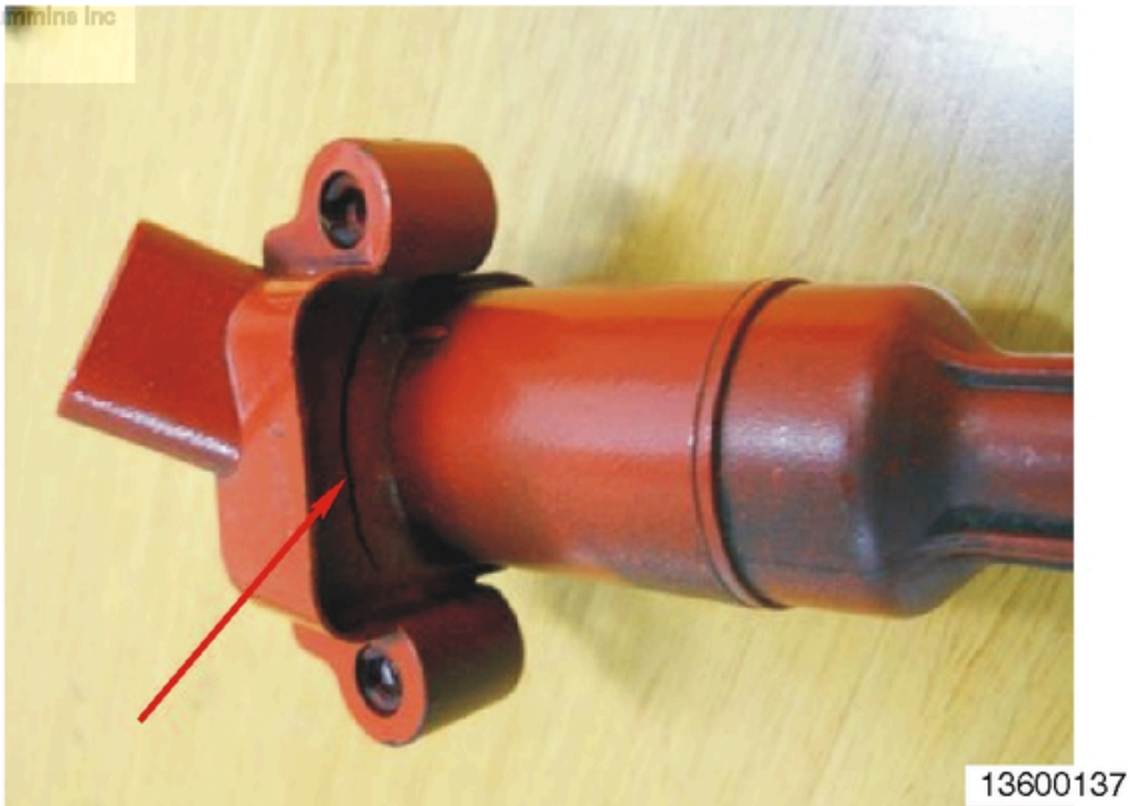
Figure 23.

**Figure 23, Cracked Potting**

| Appearance | Fractured underside at top of ignition coil |
| Cause | Ignition coil bracket out of specifications, ignition coils removed while on bracket |

| Action | Replace ignition coil. Remove ignition coils individually. Position to the top of the bracket slots. |

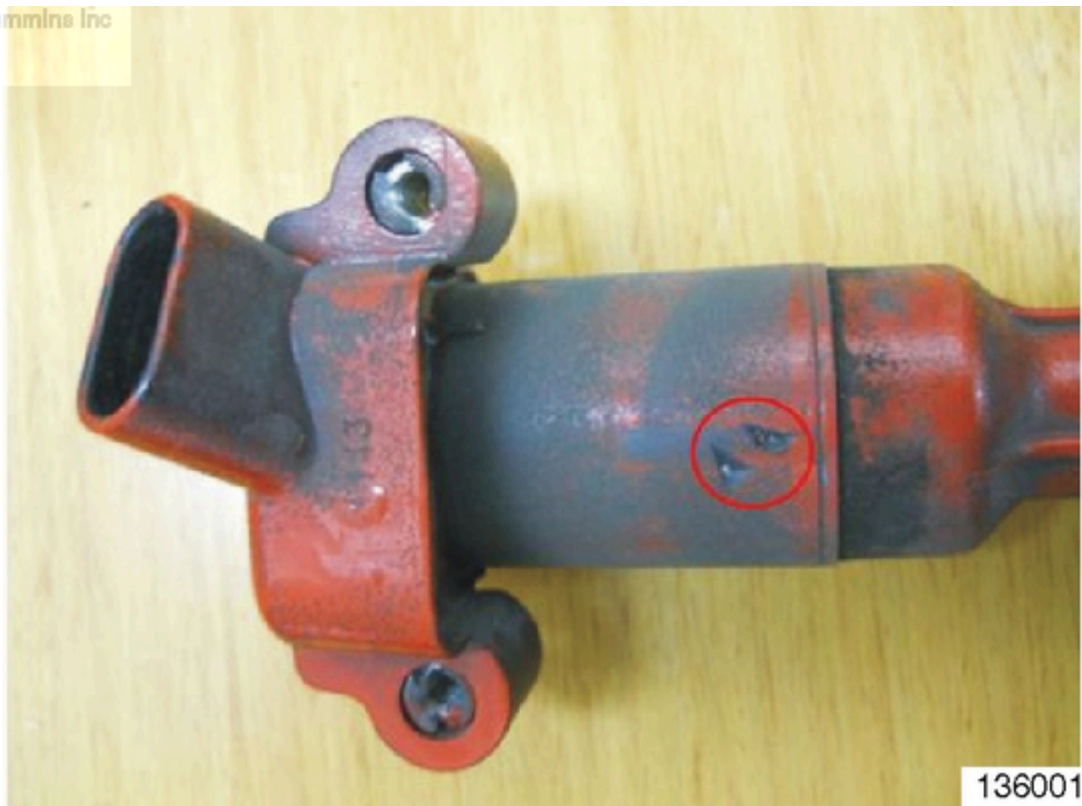
Figure 24.

**Figure 24, Damaged Housing**

| Appearance | Chipped, cracked, or dented housing |
| Cause | Mishandling |

| Action | Replace ignition coil <b>only</b> if ignition coil fails any ignition coil troubleshooting steps. |

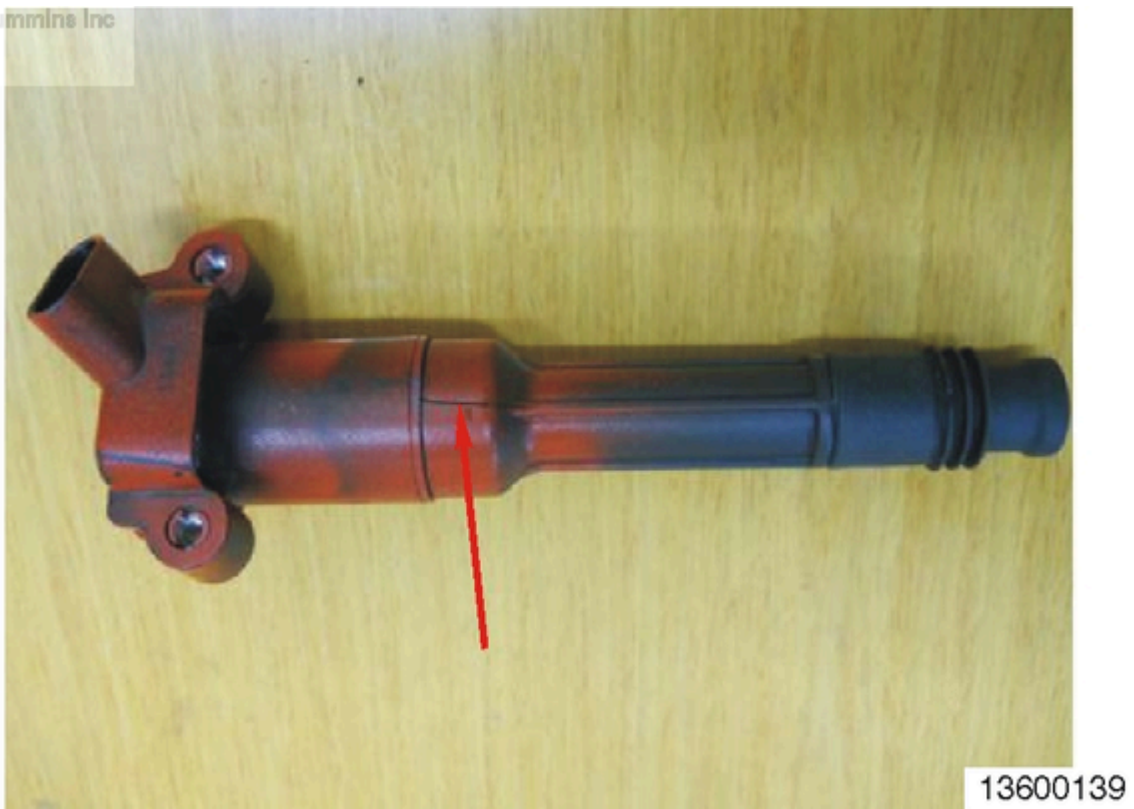
Figure 25.

**Figure 25, Ignition Coil Extension Cracked**

| Appearance | Crack in ignition coil extension |
| Cause | Overtightened ignition coil extension |

| Action | Replace ignition coil extension. Properly tighten ignition coil extension. |

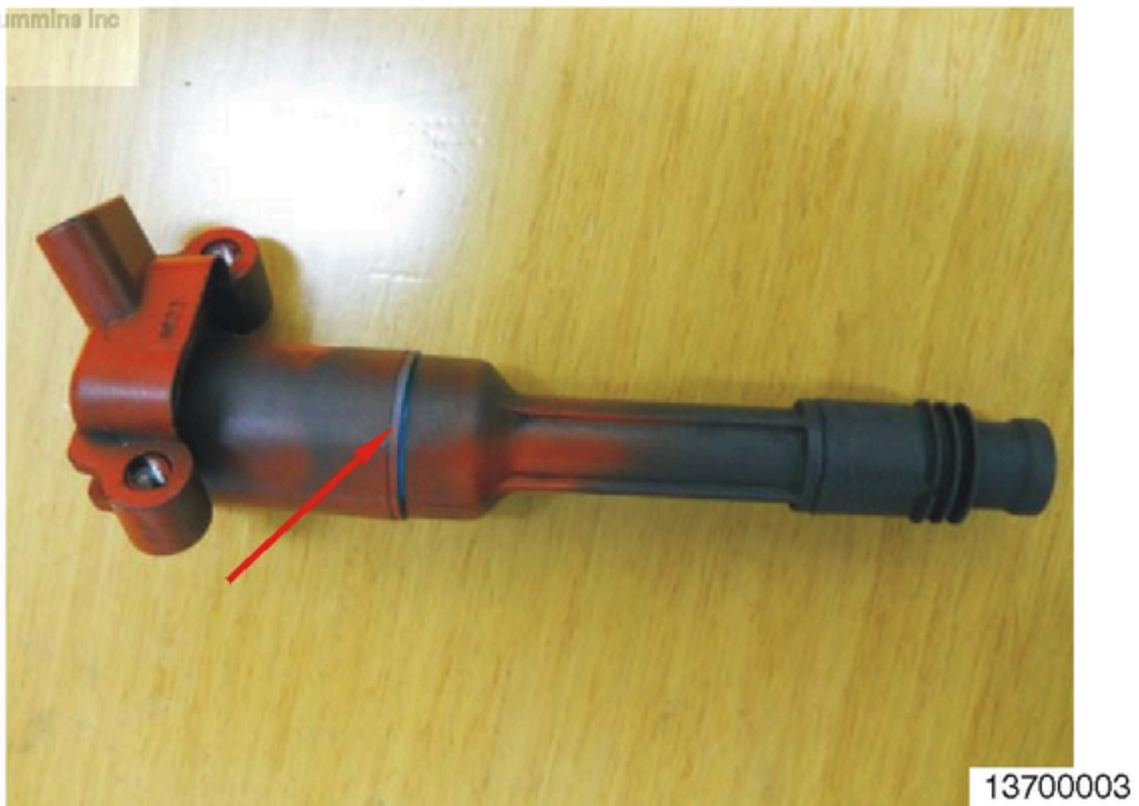
Figure 26.

**Figure 26, Ignition Coil Extension Cross Threaded**

| Appearance | Gap between ignition coil extension and coil |
| Cause | Improper assembly |

| Action | <b>Only</b> replace ignition coil extension if there is no damage to the ignition coil. Replace ignition coil if threads are damaged. |

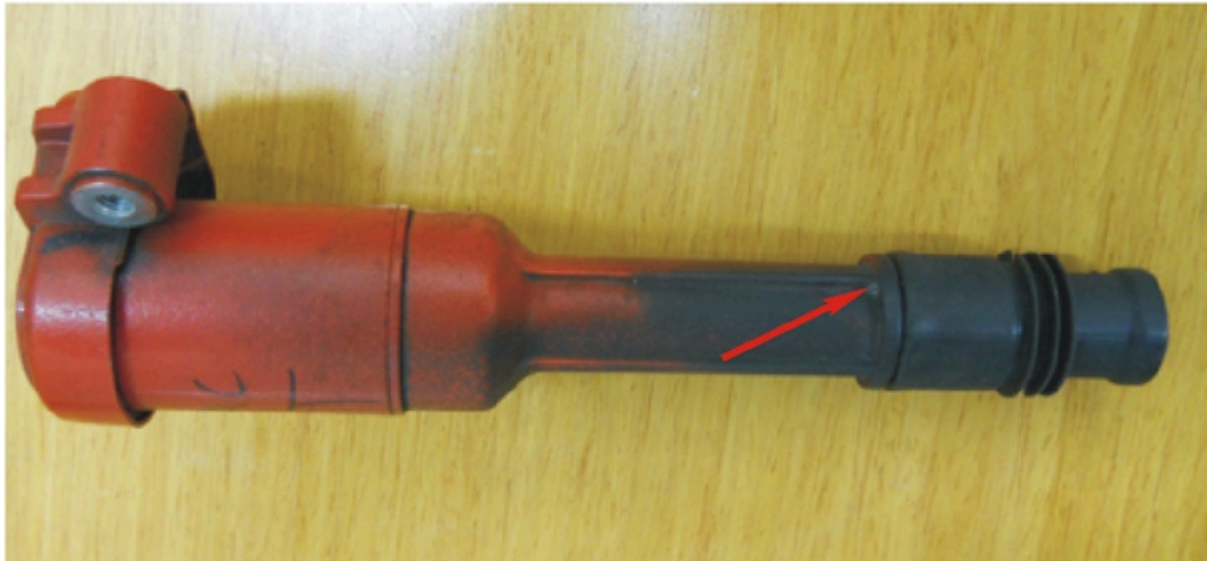
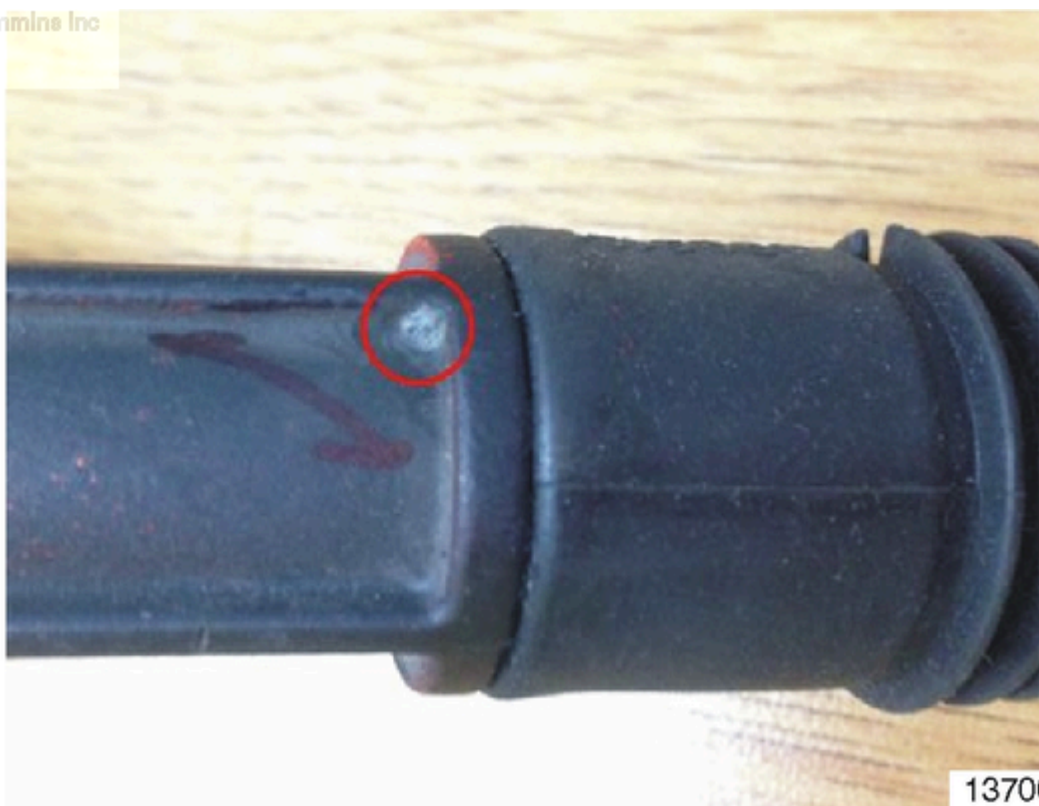
**Figure 27 and 28, Punctured Ignition Coil Extension**

| Appearance | Small, discolored spot on the ignition coil extension |
| Cause | Excessively large spark plug gap |

Replace spark plug kit and ignition coil extension.

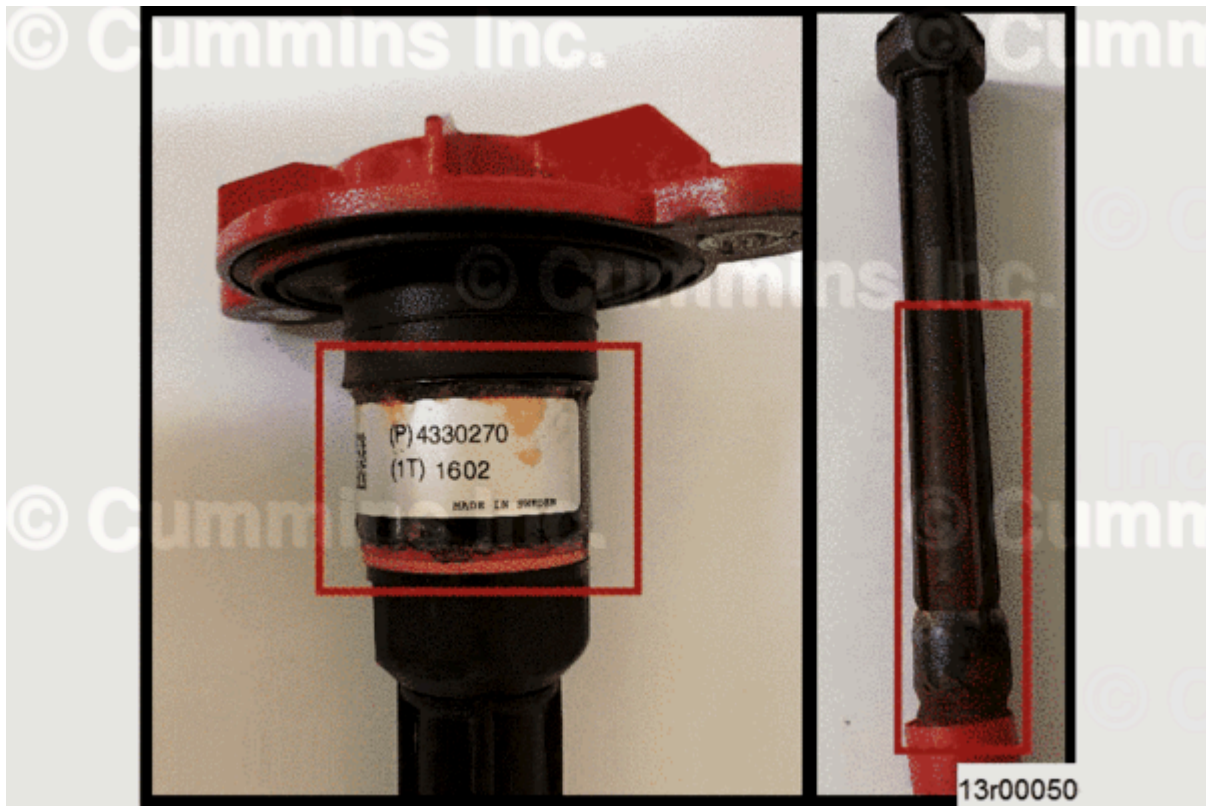
Figure 30.

**Figure 30, Corroded**

| Appearance | Ignition coil or ignition coil extension has yellow/orange deposit. |
| Cause | Water intrusion |

| Action | Clean deposit using an approved cleaner. Inspect grommet for cracks, tears, or cuts. Inspect valve cover sealing surface. Reference Service Manual guidelines to check ignition coil and ignition coil resistance. Reuse ignition coil and ignition coil extension if within specification. Inspect ignition coil top epoxy. |

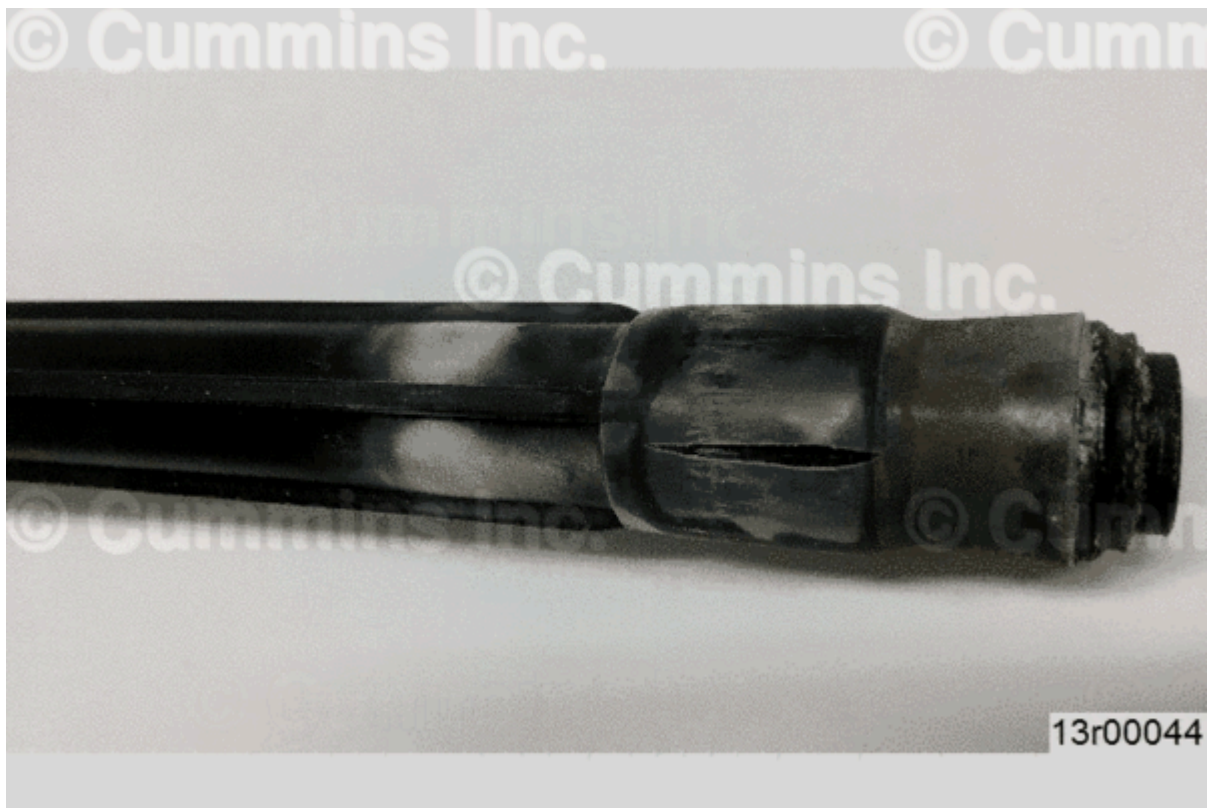
Figure 32.

**Figure 32, Split Heat Shrink (ISX12 G)**

| Appearance | Cracking on heat shrink at tip of ignition coil extension. |
| Cause | Fatigue due to thermal cycling can result in arcing through ignition coil extension. |

| Action | Replace ignition coil extension. |

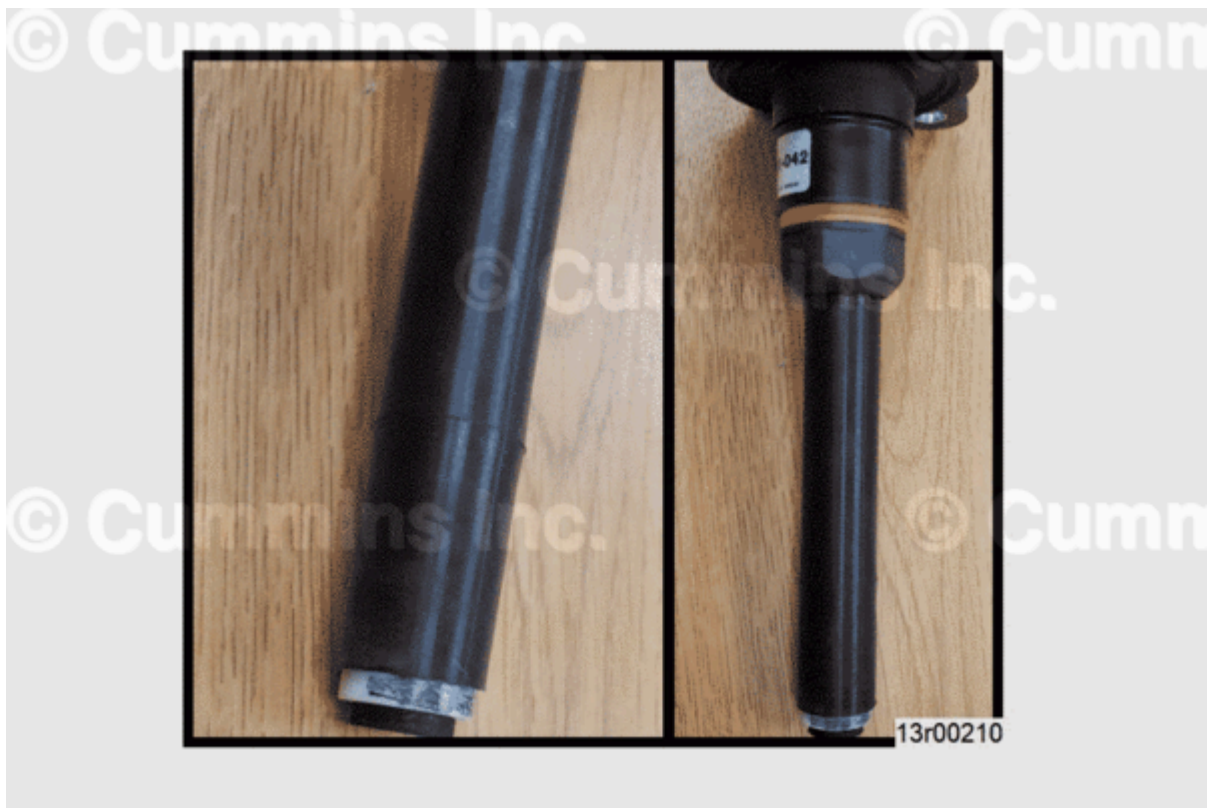
Figure 33.

**Figure 33, Reuse Guideline for Boot Adapter (B6.7N)**

| Appearance | White spark plug boot adapter when new. May appear stained and/or discolored with use. |
| Cause | Multiple service intervals can cause staining of the white material. |

| Action | Unconditional reuse, do <b>not</b> replace for discoloration or stains. |

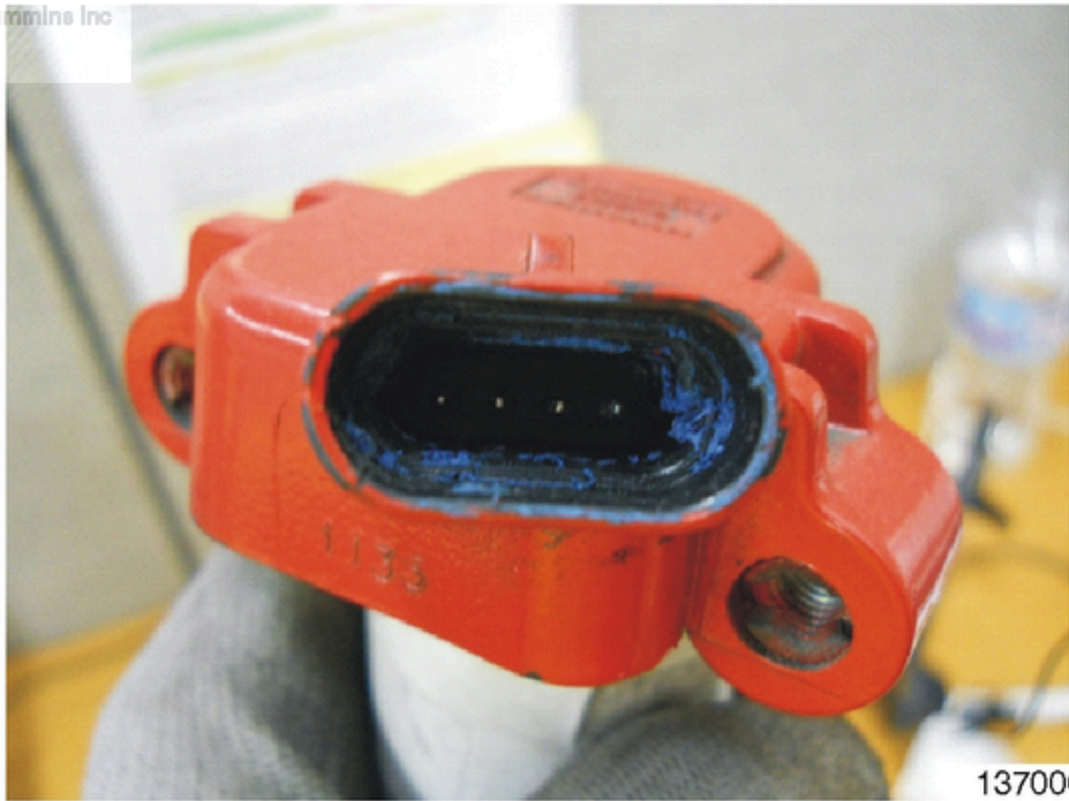
Figure 36.

**Figure 36, Seal Material Transferred into the Connector**

| Appearance | Sticky residue from degraded connector seal or sealant |
| Cause | Application of incompatible chemical cleaner, adhesive, or sealant on electrical connector seal |

| Action | Clean residue using a compatible cleaner. Inspect electrical connector seal and locking tabs on ignition harness. |
